STRUCTURAL REPORT

MASTERTON DISTRICT COUNCIL MUNICIPAL BUILDING & TOWN HALL

Structural Report on the Masterton Town Hall and Masterton Municipal Building

Date: 27th September 2016

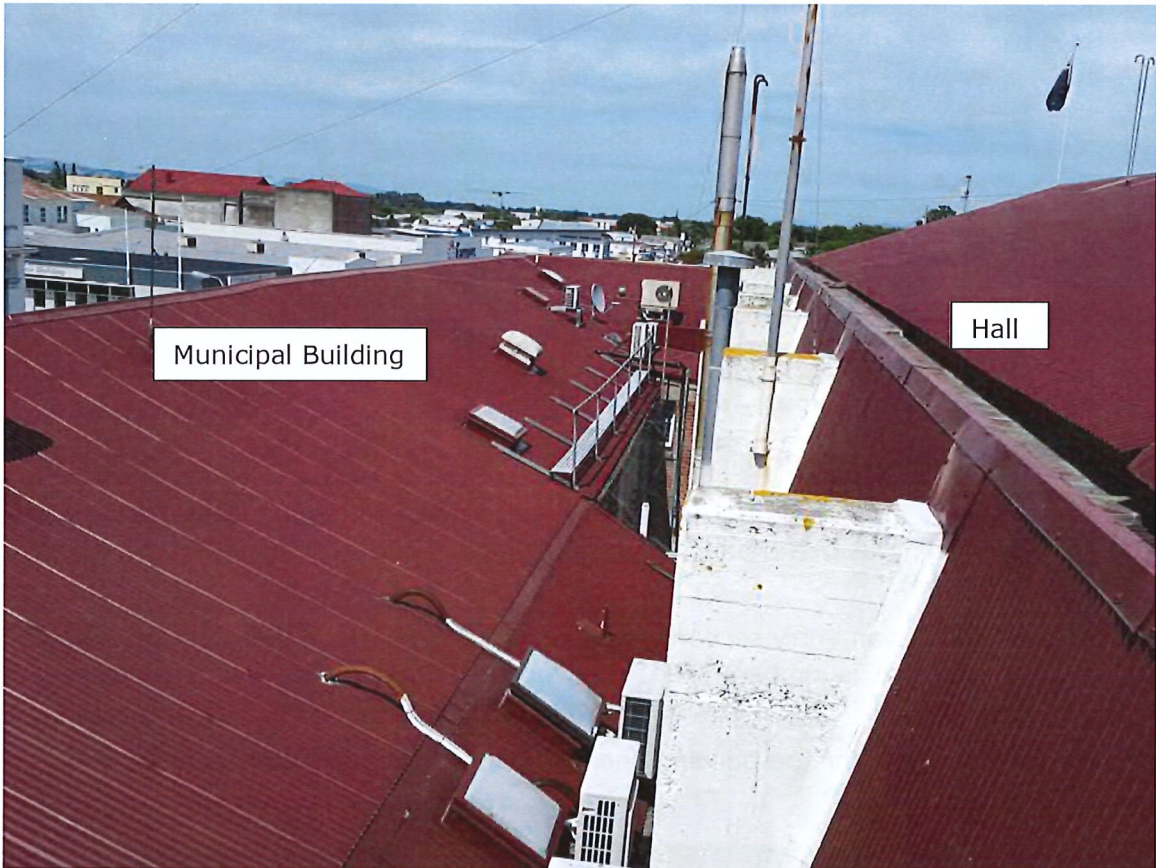
Figure 6 – Photo of roof – note space between the Hall & Municipal Building

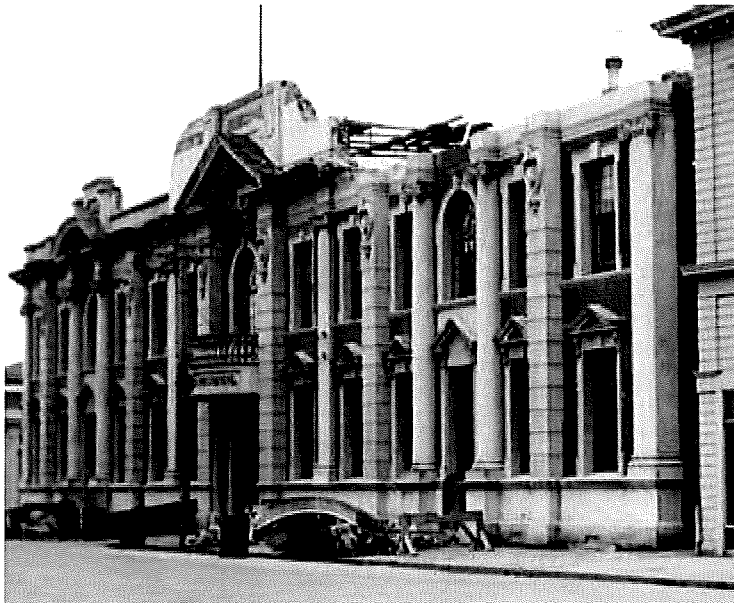
The Municipal building suffered some damage at the time, with a photograph available of the Chapel St frontage. This photograph shows damage to the parapets on Chapel St, with brick sections falling to the street.

Figure 7 – Post 1942 earthquake showing minor damage.

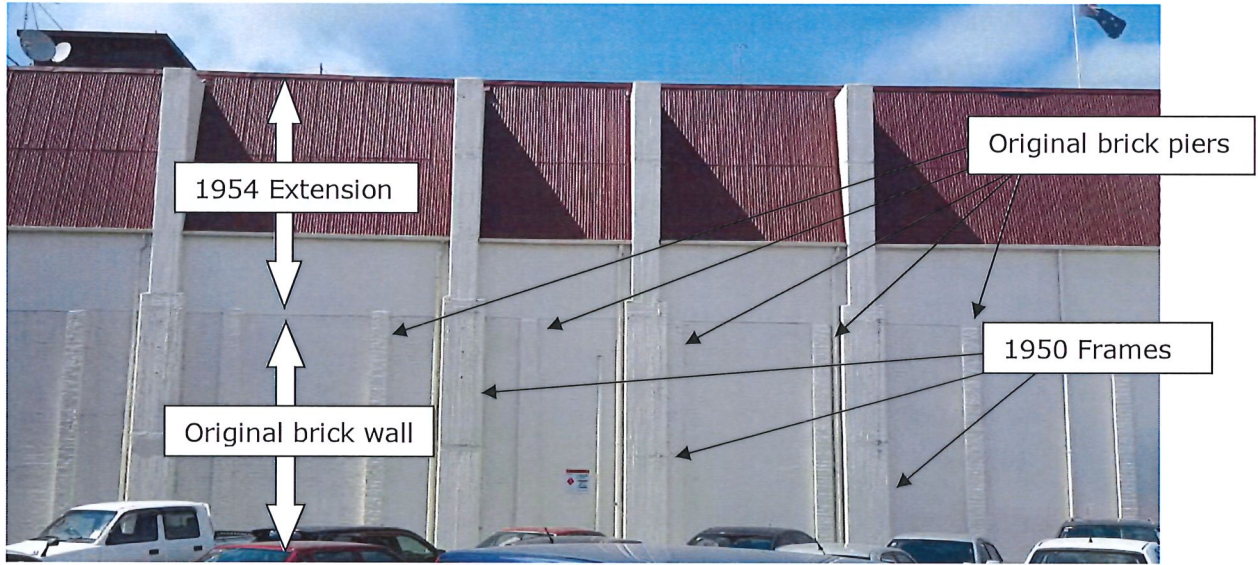
Figure 8 – Side wall of Hall – new frames marked, original brick side wall visible

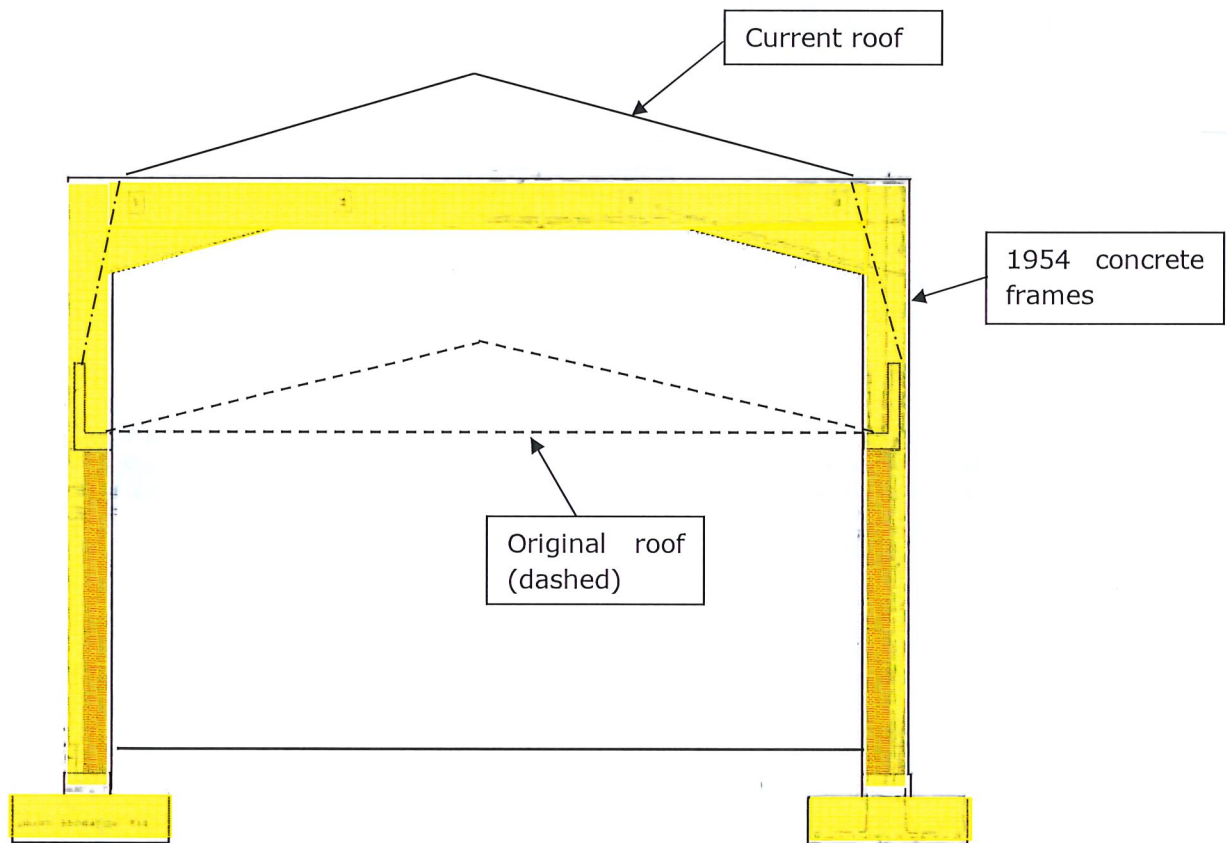
The frames are reasonably well detailed for their era, however they are lightly reinforced.

Figure 9 – Hall Transverse Frames

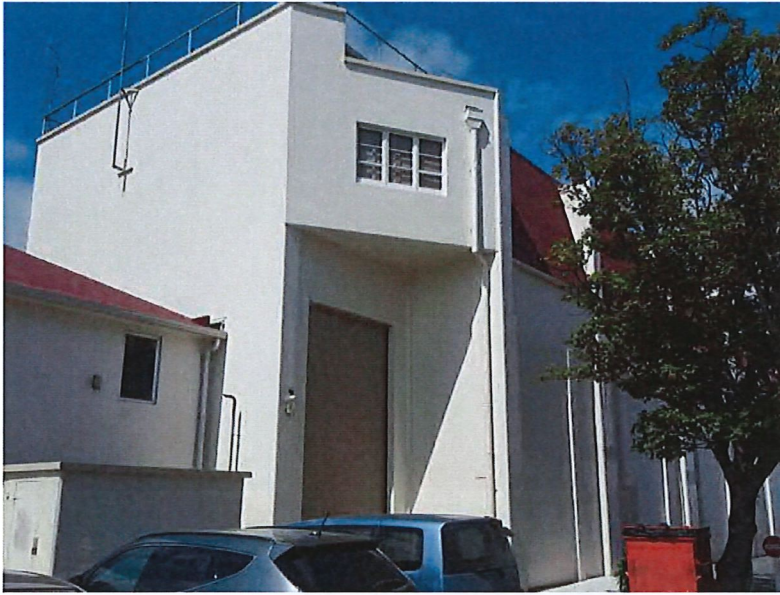
The rear of the Town Hall was extended to form the current stage area. This extension was formed with reinforced concrete walls. The quality of the construction is typical of the era, with areas on “boney” concrete visible and exposed sections of reinforcing steel.

Figure 10 – Rear of Hall showing reinforced concrete extension

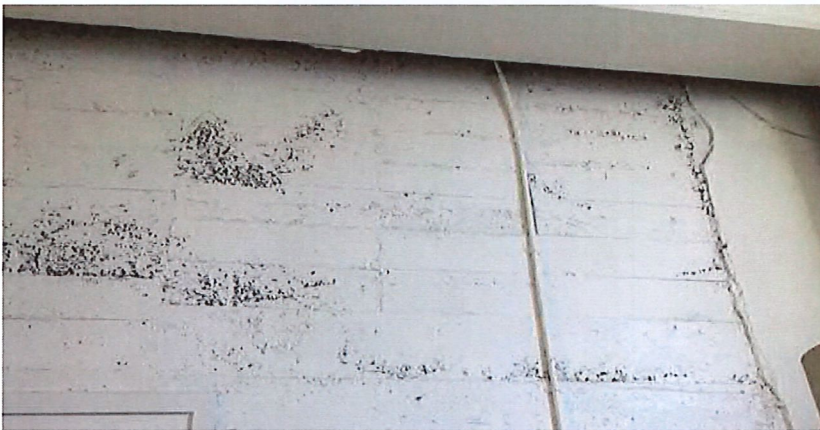
Figure 11 – View of hall extension "boney" concrete – poorly vibrated concrete resulting in exposed aggregate.

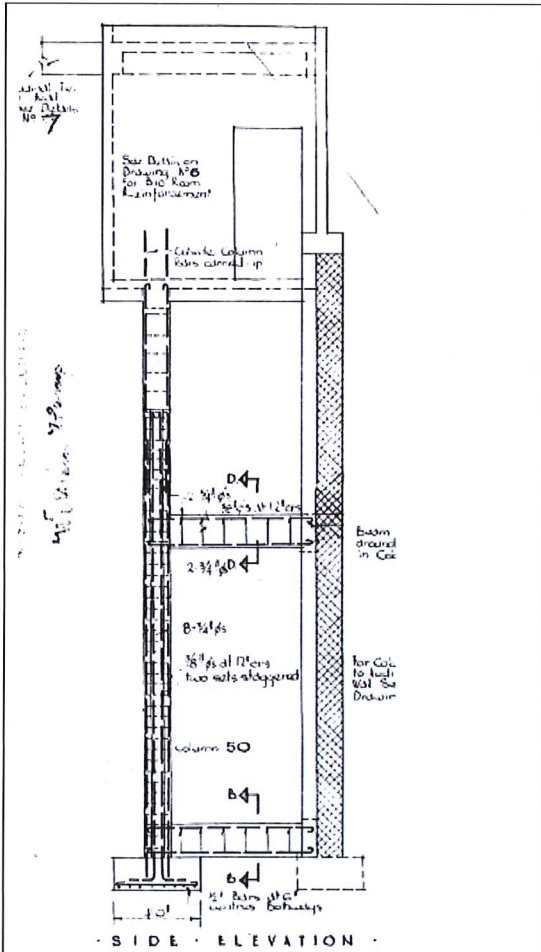
New elevated seating was erected which is supported on a fabricated steel beam spanning across the hall. A new projector room was also constructed. This projector room is formed with reinforced concrete walls, floor and roof. It is supported at the rear via the original brick wall, and the front by two slender reinforced concrete columns

Figure 12a – Elevation of the projector room, showing the heavy concrete 'box' supported on the URM wall at the rear and on concrete columns at the front.

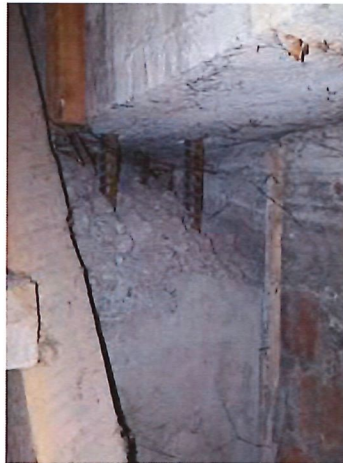
Figure 12c – Poor construction details evident in this beam to column joint

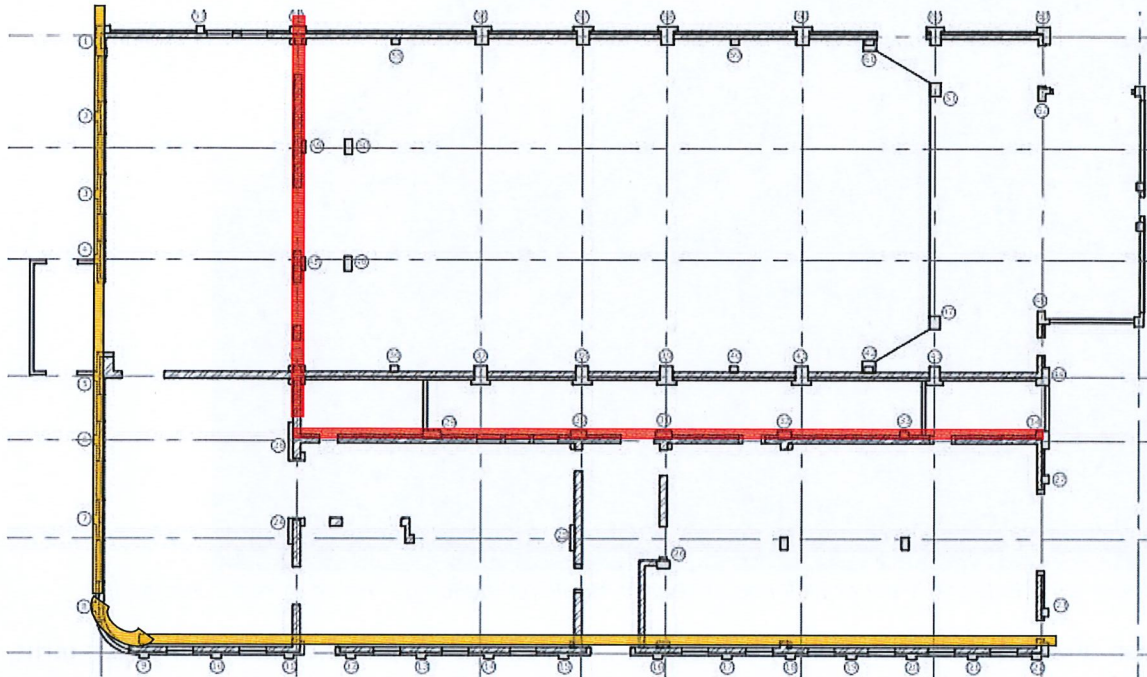
Though the façade (shown in yellow in figure 13) had a complete and substantial reinforced concrete 'skin' wrapped around it, the rear wall line (shown in red in figure 13) of the Municipal office building was left largely as original, (ie 9" thick brick with veneer). The rear wall lines had reinforced concrete bands installed in and around the brick work. The bands do not form a complete frame system, and are offset where

required to accommodate the original structure. There is some poor quality construction in these concrete components.

Figure 13 – Ground floor plan. Façade concrete highlighted yellow. Rear wall line shown in red.

This means that the lateral load resisting system along these external wall lines is still original 9" brick wall.

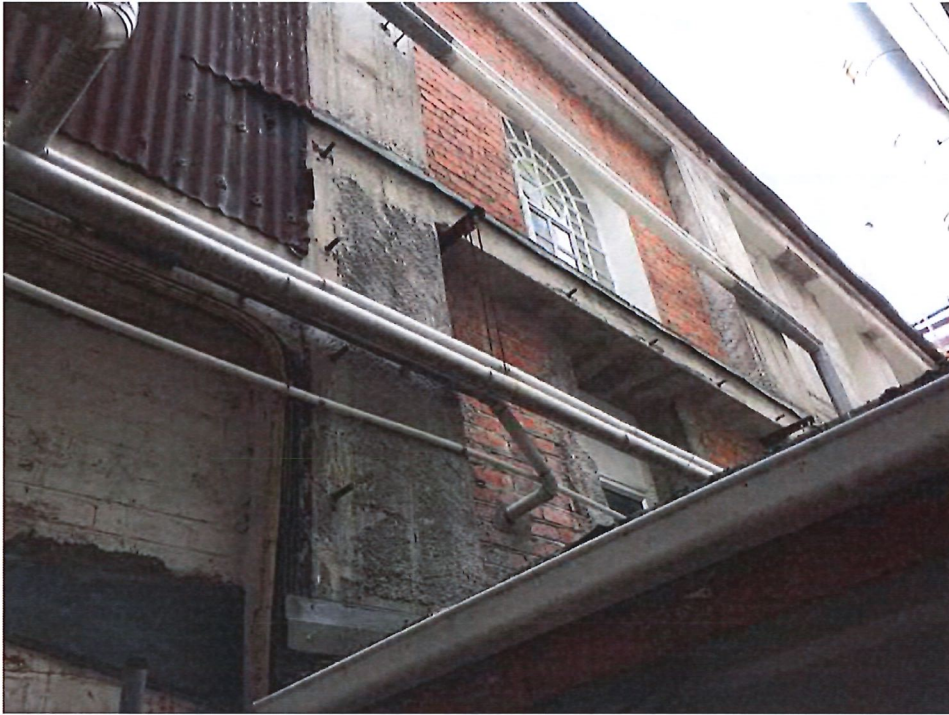
Figure 15 – External view of wall line at rear of Municipal building (shown in red in figure 13)

- New eccentrically braced frames along the rear wall line, both on the ground floor and first floor
- New external wall line footing
- New light timber framing to replace the URM walls and provide the water-tight envelope to the building adjacent to the Hall structure.

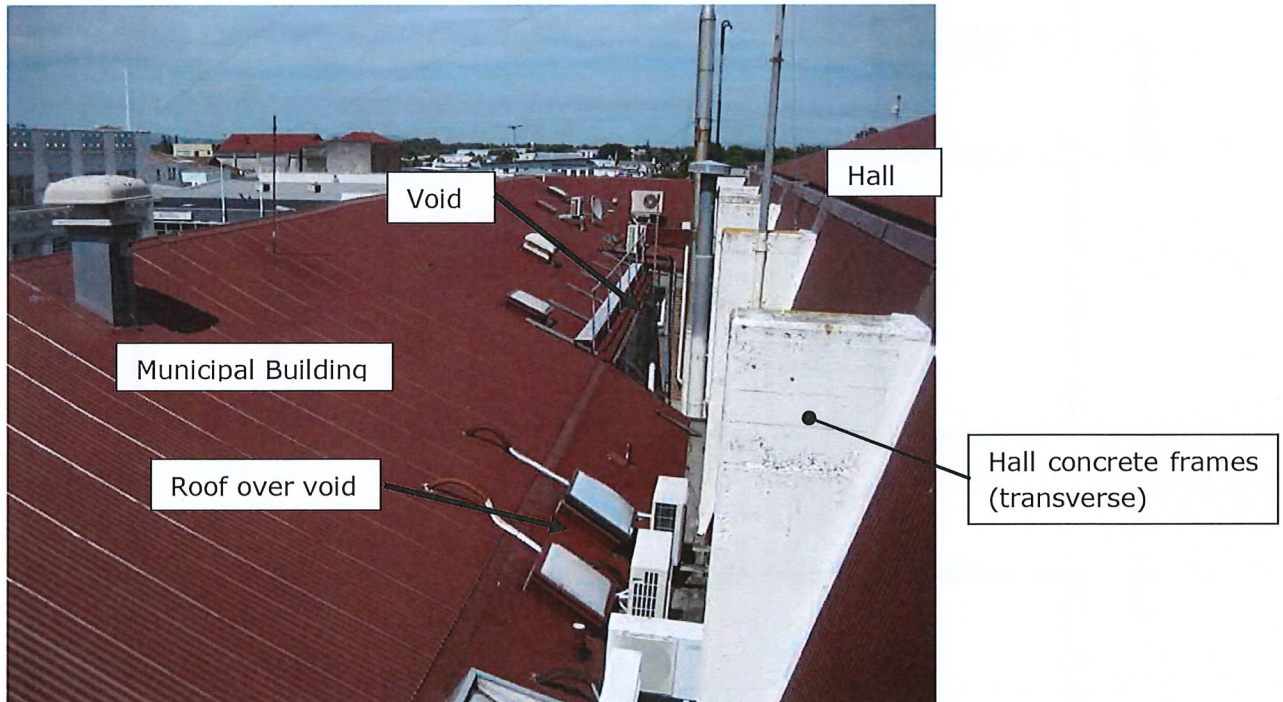
The Hall and the Municipal building are two different structures, ie one has very high concrete frames in the transverse direction (see figure9), while the other is two storied with in-plane URM walls. This means the buildings are likely to move out-of-sync relative to each other during an earthquake. The new flooring spans the void between the two buildings, and is supported on a stringer attached to the Hall. This means there is a potential loss of gravity support to this section of flooring during a seismic event.

Figure 17 – Roof Plan – note new roof bridging the gap between the Hall and Municipal Building

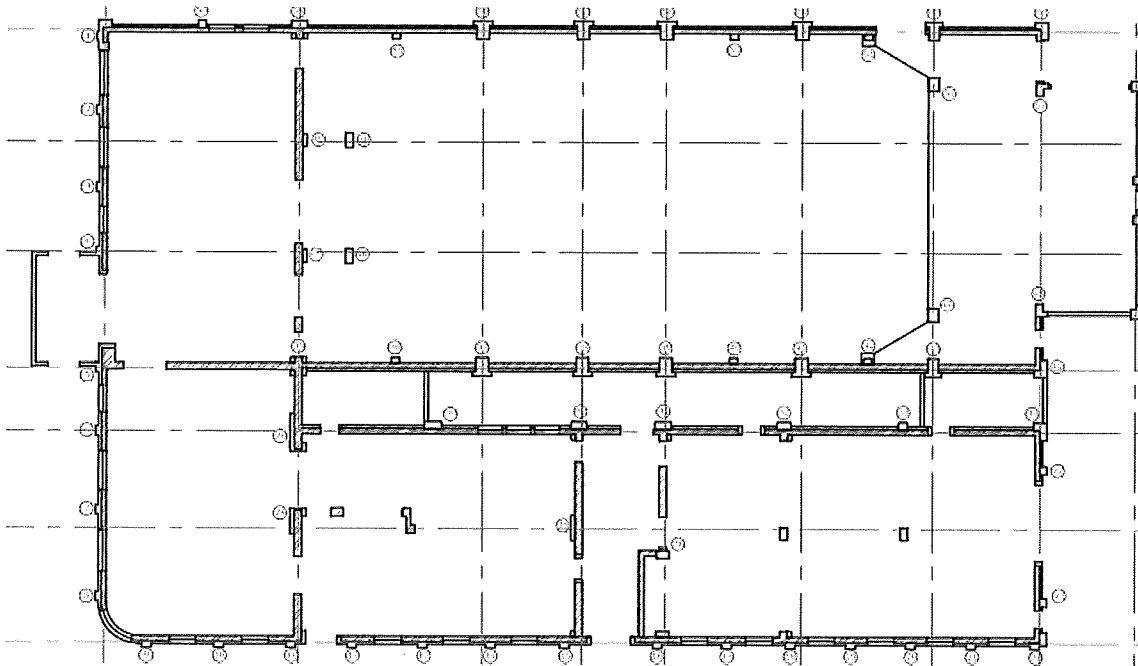
The Municipal Building has also had ongoing alterations, particularly to the ground floor. Internal sections of URM wall have been removed as required to accommodate refurbishments.

Figure 17b - Current floor plan - note internal walls removed
