Asbestos Demolition Survey & Lead Paint Sampling Report

Masterton Town Hall
64 Chapel Street
Masterton, 5810

Masterton District Council

Reference: W-01393

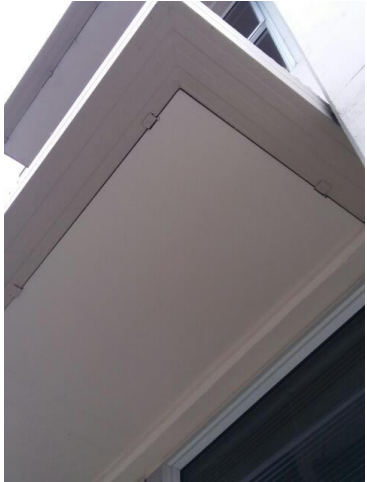
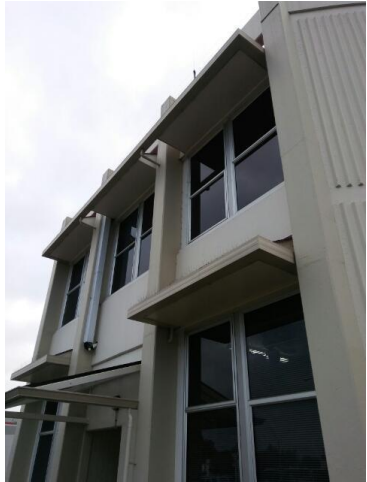
Location	Masterton Town Hall, External, 002, Exterior		Sample Number	4 (S)

Item / Position	Soffit		
	Material:	Cement Product		
	Extent	17no		
	Product Type	N/A	N/A	
	Condition	N/A	N/A	
	Surface Treatment	N/A	N/A	
	Asbestos Type	NAD	N/A	
	Material Assessment	N/A	0	
	Recommendation	No further action required		
Comments:

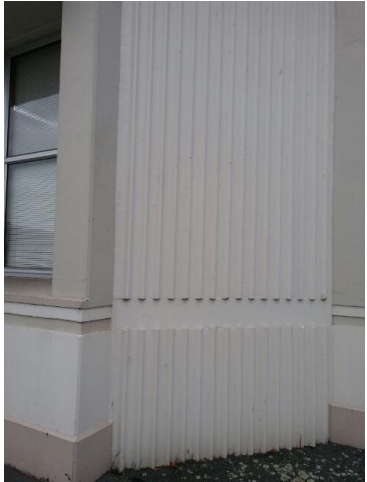
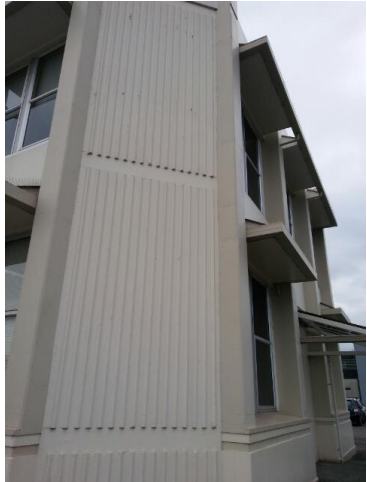
Location	Masterton Town Hall, External, 003, North External Wall		Sample Number	5 (S)

Item / Position	Lead Paint		
	Material:	Painted Surface		
	Extent	100m ²		
	Asbestos Type	53 mg/kg - Lead Below Threshold Value		
	Comments:	Composite of paint colours from 80s era section

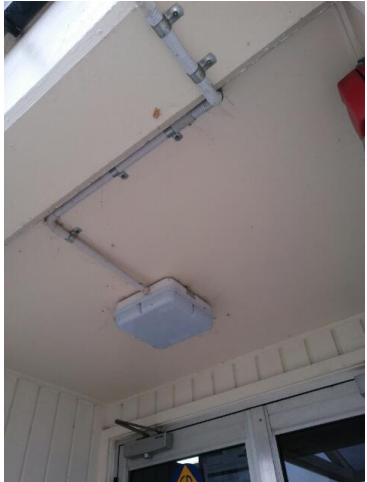
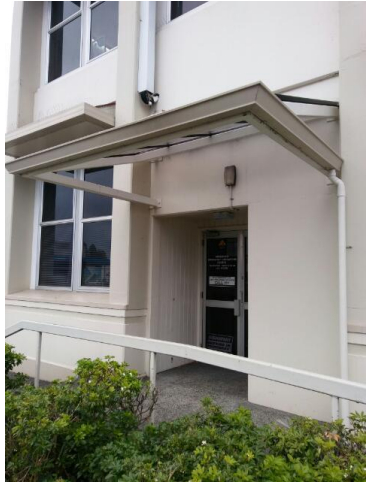
Location	Masterton Town Hall, External, 003, North External Wall		Sample Number	6 (S)

Item / Position	Entrance Soffit		
	Material:	Cement Product		
	Extent	2m ²		
	Product Type	N/A	N/A	
	Condition	N/A	N/A	
	Surface Treatment	N/A	N/A	
	Asbestos Type	NAD	N/A	
	Material Assessment	N/A	0	
	Recommendation	No further action required		
	Comments:

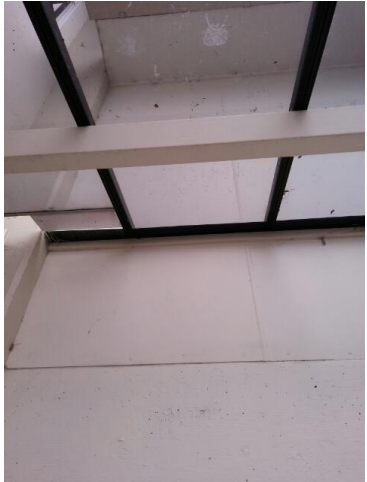
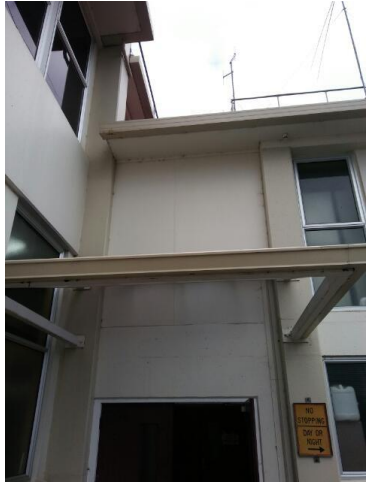
Location	Masterton Town Hall, External, 003, North External Wall		Sample Number	7 (S)

Item / Position	Cement Board			
	Material:	Cement Product			
	Extent	6m ²			
	Product Type	N/A			N/A
	Condition	N/A			N/A
	Surface Treatment	N/A			N/A
	Asbestos Type	NAD			N/A
	Material Assessment	N/A			0
	Recommendation	No further action required			
	Comments:

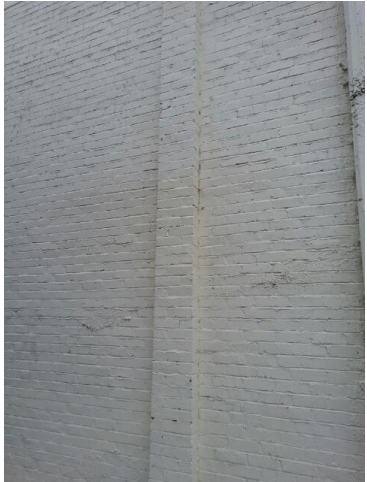
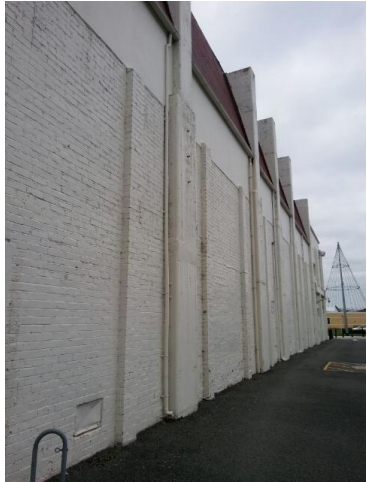
Location	Masterton Town Hall, External, 004, West External Wall		Sample Number	8 (S)

Item / Position	Lead Paint			
	Material:	Painted Surface			
	Extent	200m ²			
	Asbestos Type	83 mg/kg - Lead Below Threshold Value			
	Comments:

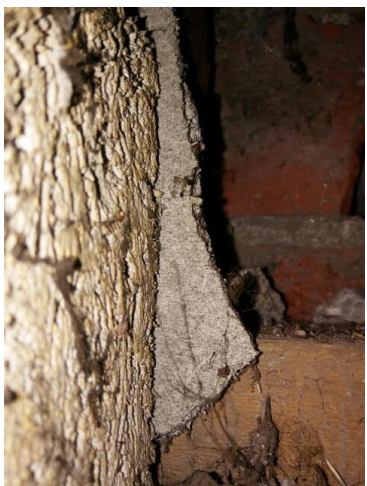
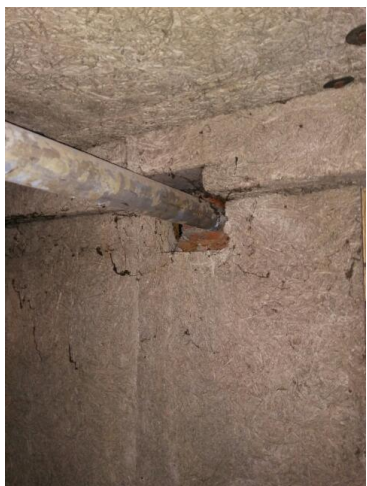
Location	Masterton Town Hall, Basement, 005, Generator Room		Sample Number	9 (S)

Item / Position	Cement Board		
	Material:	Cement Product		
	Extent	Unknown		
	Product Type	Asbestos reinforced composites etc.	1	
	Condition	Low damage	1	
	Surface Treatment	Surface sealed	1	
	Asbestos Type	Amosite / Chrysotile	2	
	Material Assessment	Low	5	
	Recommendation	Remove		
	Comments:	Cement board concealed behind low density chip board. Full extent unknown. Interim action - Encapsulate, Mangle and Label.

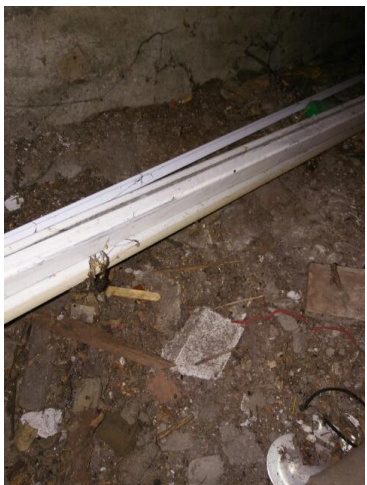
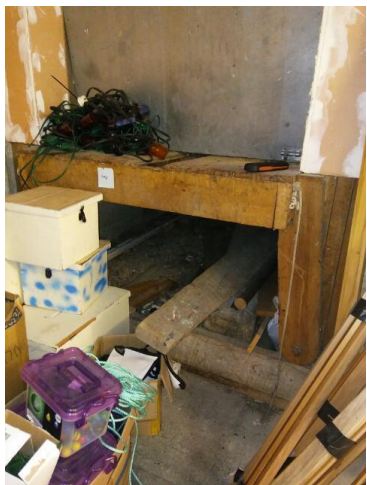
Location	Masterton Town Hall, Basement, 006, Underfloor Space		Sample Number	10 (S)

Item / Position	Debris		
	Material:	Cement Product		
	Extent	Unknown		
	Product Type	Asbestos reinforced composites etc.	1	
	Condition	High damage	3	
	Surface Treatment	Partially unsealed	2	
	Asbestos Type	Amosite / Crocidolite / Chrysotile	3	
	Material Assessment	Medium	9	
	Recommendation	Remove		
	Comments:	Debris located at underfloor space access point. Limited access to ascertain extent. Interim action - Restrict access to underfloor space, PPE/RPE required for entry.

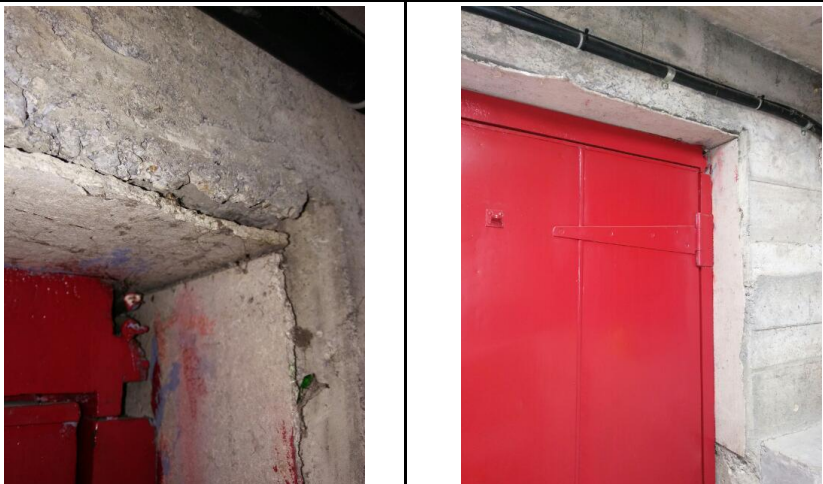
Location	Masterton Town Hall, Basement, 007, Stairwell		Sample Number	11 (S)

Item / Position	Cement Board		
	Material:	Cement Product		
	Extent	1m ²		
	Product Type	Asbestos reinforced composites etc.	1	
	Condition	Medium damage	2	
	Surface Treatment	Surface sealed	1	
	Asbestos Type	Amosite / Chrysotile	2	
	Material Assessment	Low	6	
	Recommendation	Remove		
	Comments:	Interim action - Encapsulate, Manage and Label.

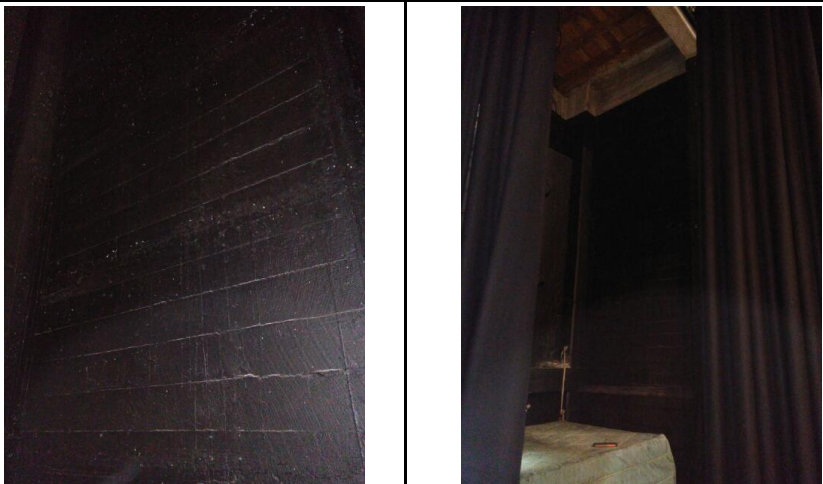
Location	Masterton Town Hall, Ground Floor, 008, Stage		Sample Number	12 (S)

Item / Position	Lead Paint -Black		
	Material:	Painted Surface		
	Extent	150m ²		
	Asbestos Type	8 mg/kg - Lead Below Threshold Value		
	Comments:

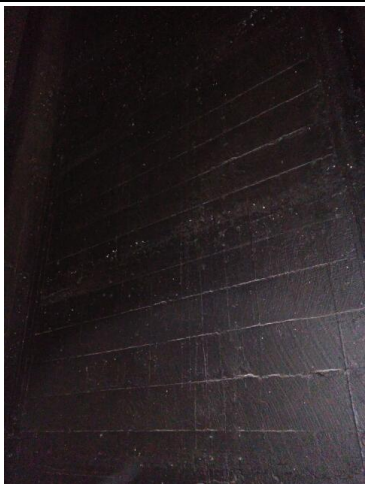
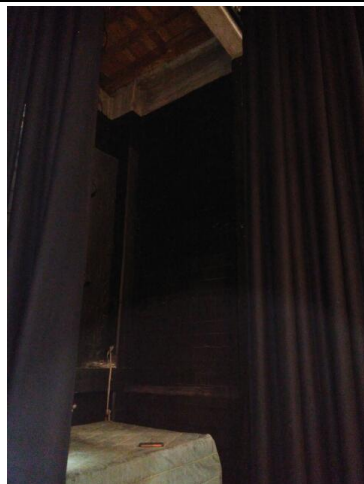
Location	Masterton Town Hall, Ground Floor, 008, Stage	Sample Number	13 (S)

Item / Position	Paint	
	Material:	Painted Surface	
	Extent	150m ²	
	Product Type	N/A	N/A
	Condition	N/A	N/A
	Surface Treatment	N/A	N/A
	Asbestos Type	NAD	N/A
	Material Assessment	N/A	0
	Recommendation	No further action required	
	Comments:

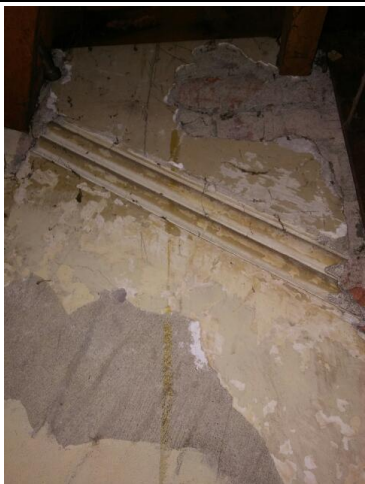
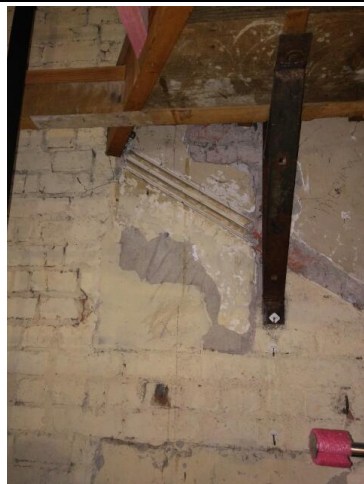
Location	Masterton Town Hall, Ground Floor, 008, Stage	Sample Number	14 (S)

Item / Position	Wall Lining	
	Material:	Cement Product	
	Extent	All	
	Product Type	N/A	N/A
	Condition	N/A	N/A
	Surface Treatment	N/A	N/A
	Asbestos Type	NAD	N/A
	Material Assessment	N/A	0
	Recommendation	No further action required	
	Comments:	Material is remnants of original aggregate render and plaster wall lining to brick work.

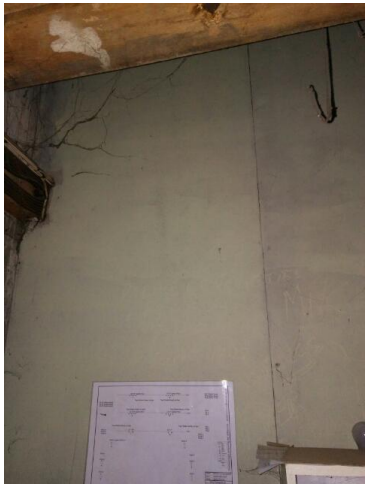
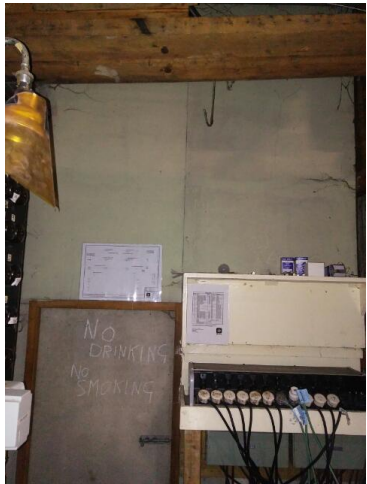
Location	Masterton Town Hall, 1st Floor, 009, Lighting Platform		Sample Number	15 (S)

Item / Position	Cement Board		
	Material:	Cement Product		
	Extent	100m ²		
	Product Type	Asbestos reinforced composites etc.	1	
	Condition	Low damage	1	
	Surface Treatment	Surface sealed	1	
	Asbestos Type	Amosite / Chrysotile	2	
	Material Assessment	Low	5	
	Recommendation	Remove		
	Comments:	Cement boards extend around and above stage front area. Interim action - Manage and Label. Restrict access to platform and other areas where boards are accessible. An environmental clean of dust in vicinity of the boards should also be conducted, and the boards encapsulated, if they will remain in place in the medium to long term.

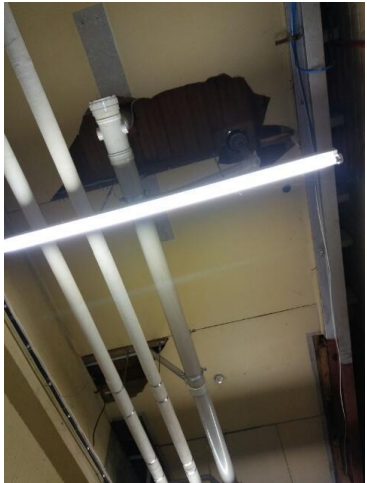
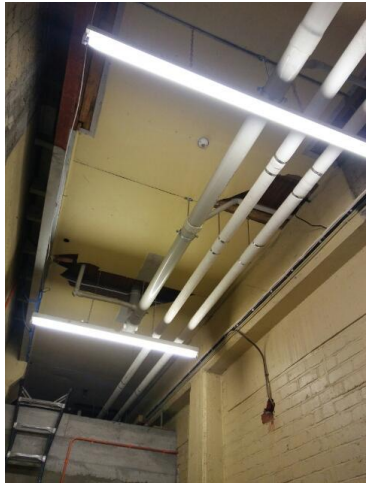
Location	Masterton Town Hall, Ground Floor, 010, Central Passageway		Sample Number	16 (S)

Item / Position	Ceiling Lining		
	Material:	Cement Product		
	Extent	20m ²		
	Product Type	Asbestos reinforced composites etc.	1	
	Condition	Medium damage	2	
	Surface Treatment	Surface sealed	1	
	Asbestos Type	Amosite / Chrysotile	2	
	Material Assessment	Low	6	
	Recommendation	Remove		
	Comments:	Interim action - Encapsulate and repair broken/damaged areas, Manage and Label.

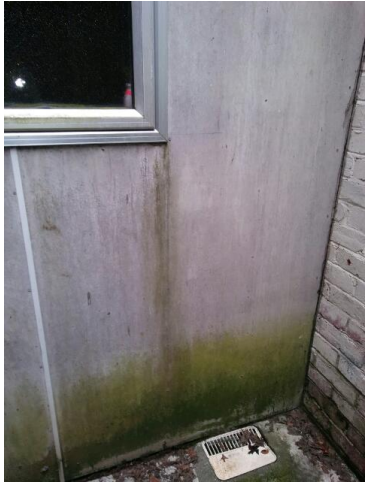
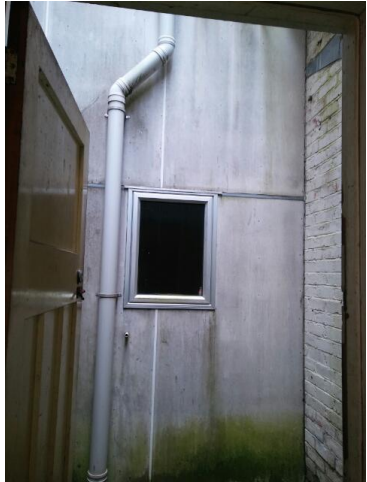
Location		Masterton Town Hall, External, 011, Central Void		Sample Number	17 (S)

Item / Position	Cement Cladding		
		Material:	Cement Product		
		Extent	10m ²		
		Product Type	N/A	N/A	
		Condition	N/A	N/A	
		Surface Treatment	N/A	N/A	
		Asbestos Type	NAD	N/A	
		Material Assessment	N/A	0	
		Recommendation	No further action required		
		Comments:

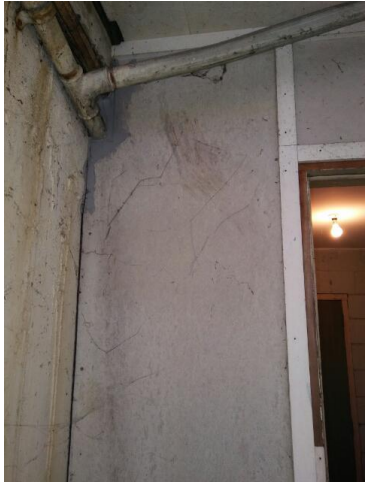
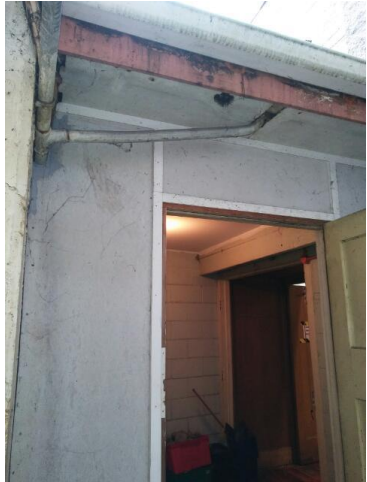
Location		Masterton Town Hall, External, 011, Central Void		Sample Number	18 (S)

Item / Position	Cement Cladding		
		Material:	Cement Product		
		Extent	3m ²		
		Product Type	Asbestos reinforced composites etc.	1	
		Condition	Low damage	1	
		Surface Treatment	Surface sealed	1	
		Asbestos Type	Amosite / Chrysotile	2	
		Material Assessment	Low	5	
		Recommendation	Remove		
		Comments:	Interim action - Manage & Label. Encapsulate if boards are to remain.

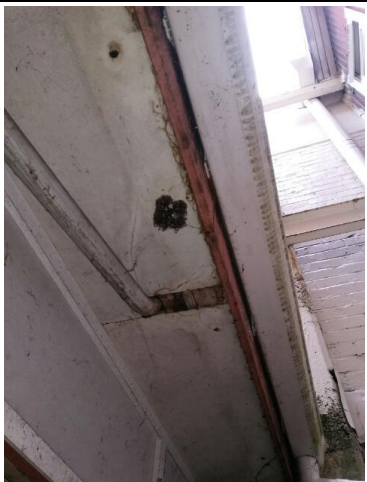
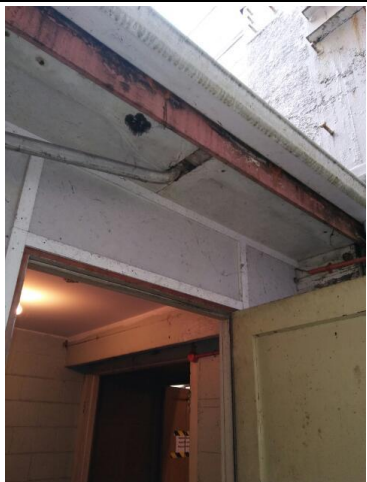
Location	Masterton Town Hall, External, 011, Central Void		Sample Number	19 (S)

Item / Position	Soffit		
	Material:	Cement Product		
	Extent	1m ²		
	Product Type	Asbestos reinforced composites etc.	1	
	Condition	Low damage	1	
	Surface Treatment	Surface sealed	1	
	Asbestos Type	Amosite / Chrysotile	2	
	Material Assessment	Low	5	
	Recommendation	Remove		
	Comments:	Interim action - Manage & Label. Encapsulate if soffit is to remain.

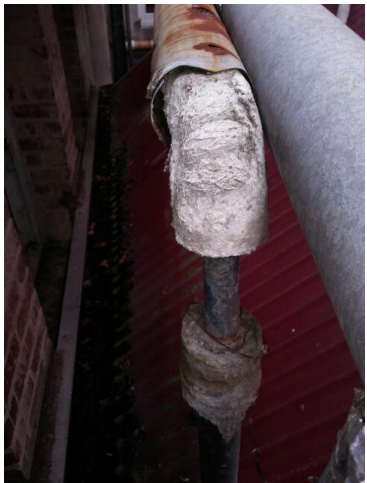
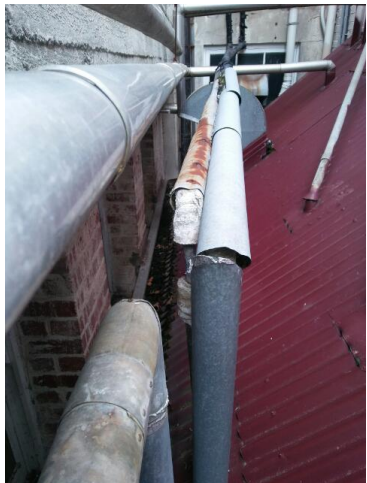
Location	Masterton Town Hall, External, 011, Central Void		Sample Number	20 (S)

Item / Position	Pipe Lagging		
	Material:	Insulation		
	Extent	Unknown		
	Product Type	Thermal insulation (eg pipe and boiler lagging), sprayed asbestos, loose asbestos, asbestos mattresses and packing.	3	
	Condition	High damage	3	
	Surface Treatment	Unsealed	3	
	Asbestos Type	Chrysotile	1	
	Material Assessment	High	10	
	Recommendation	Remove		
	Comments:	Restrict all access to area until removal/remediation of damaged sections can be completed. Full extent unknown. All enclosed pipework should be presumed to contain asbestos unless proven otherwise.

External	011 / Central Void	Yes	Restrict all access to area until removal/remediation of damaged sections can be completed. Full extent unknown. All enclosed pipework should be presumed to contain asbestos unless proven otherwise.	Pipe Lagging - Insulation	S020	Chrysotile	Remove

Particular attention should be given to the central boiler room area where asbestos pipe lagging with high damage and associated debris has been identified.

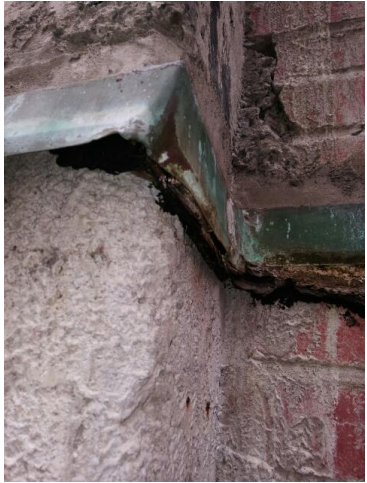
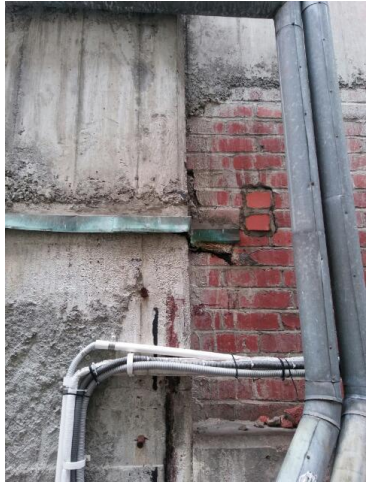
Location	Masterton Town Hall, External, 011, Central Void		Sample Number	21 (S)

Item / Position	Bitumen		
	Material:	Bituminous Product		
	Extent	10m ²		
	Product Type	N/A	N/A	
	Condition	N/A	N/A	
	Surface Treatment	N/A	N/A	
	Asbestos Type	NAD	N/A	
	Material Assessment	N/A	0	
	Recommendation	No further action required		
	Comments:

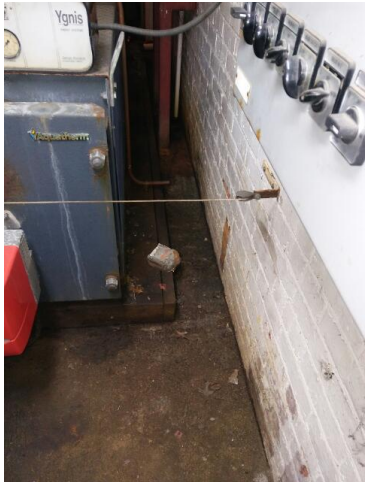
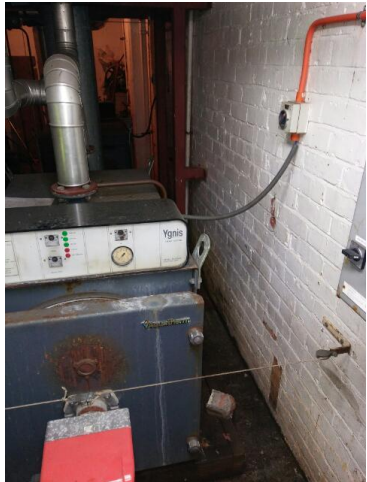
Location	Masterton Town Hall, External, 012, Boiler Room		Sample Number	22 (S)

Item / Position	ACD - Swab		
	Material:	Insulation		
	Extent	All		
	Product Type	Thermal insulation (eg pipe and boiler lagging), sprayed asbestos, loose asbestos, asbestos mattresses and packing.	3	
	Condition	High damage	3	
	Surface Treatment	Unsealed	3	
	Asbestos Type	Amosite	2	
	Material Assessment	High	11	
	Recommendation	Remove		
	Comments:	Restrict access to boiler room until area can be subjected to an environmental clean.

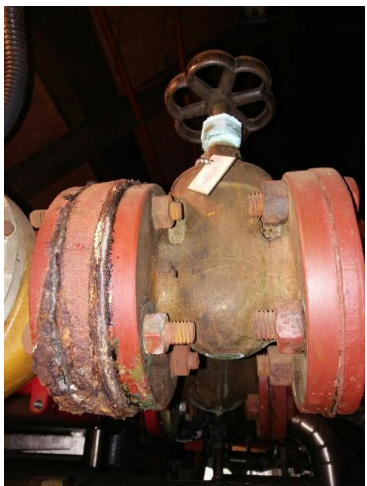
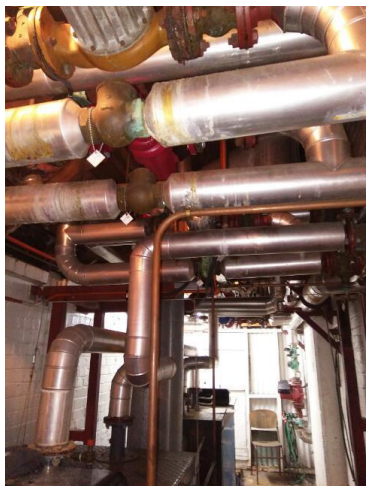
Location	Masterton Town Hall, External, 012, Boiler Room		Sample Number	23 (S)

Item / Position	Gaskets		
	Material:	Gaskets (compressed)		
	Extent	All		
	Product Type	Asbestos reinforced composites etc.	1	
	Condition	Low damage	1	
	Surface Treatment	Surface sealed	1	
	Asbestos Type	Chrysotile	1	
	Material Assessment	Very Low	4	
	Recommendation	Remove		
	Comments:	All non-rubber compressed gaskets should be presumed to contain asbestos as a precaution, unless individually sampled to prove otherwise. Interim action - Manage and Label.

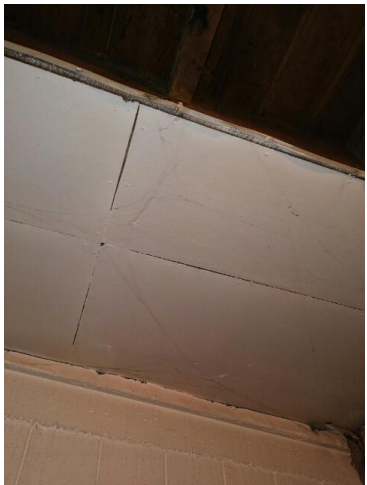
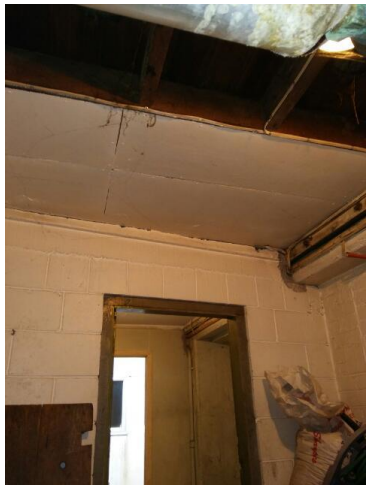
Location	Masterton Town Hall, External, 012, Boiler Room		Sample Number	24 (S)

Item / Position	Ceiling Lining		
	Material:	Cement Product		
	Extent	2m ²		
	Product Type	Asbestos reinforced composites etc.	1	
	Condition	Low damage	1	
	Surface Treatment	Completely sealed	0	
	Asbestos Type	Amosite / Chrysotile	2	
	Material Assessment	Very Low	4	
	Recommendation	Remove		
	Comments:	Interim action - Manage & Label.

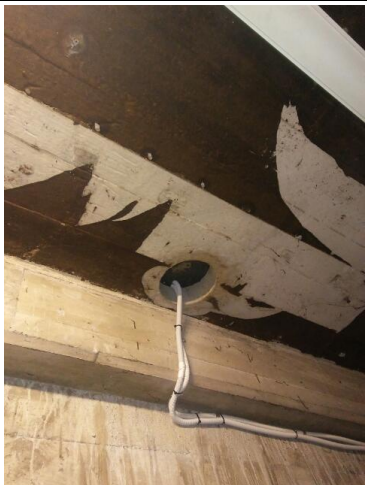
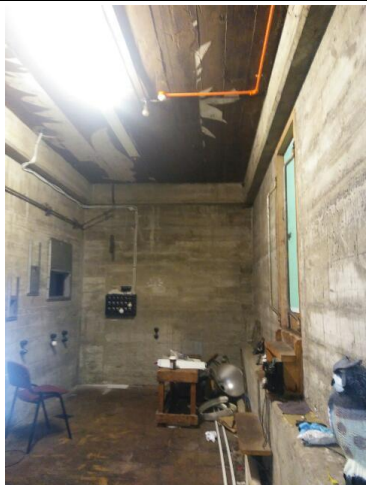
Location	Masterton Town Hall, 2nd Floor, 013, Projection Room	Sample Number	25 (S)

Item / Position	Bitumen Paper	
	Material:	Bituminous Product	
	Extent	10m ²	
	Product Type	N/A	N/A
	Condition	N/A	N/A
	Surface Treatment	N/A	N/A
	Asbestos Type	NAD	N/A
	Material Assessment	N/A	0
	Recommendation	No further action required	
	Comments:

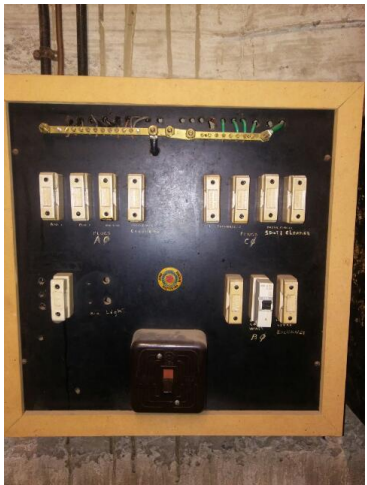
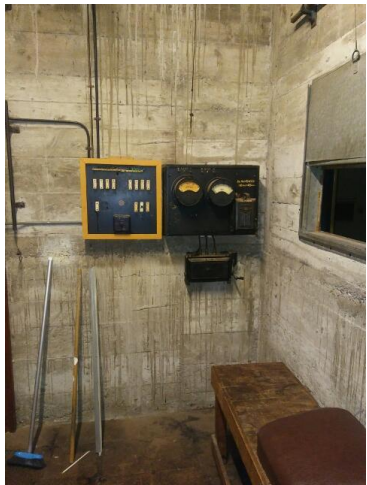
Location	Masterton Town Hall, 2nd Floor, 013, Projection Room	Sample Number	26 (S)

Item / Position	Switchboard	
	Material:	Bituminous Product	
	Extent	3no	
	Product Type	Asbestos reinforced composites etc.	1
	Condition	Good condition	0
	Surface Treatment	Completely sealed	0
	Asbestos Type	Chrysotile	1
	Material Assessment	Very Low	2
	Recommendation	Remove	
	Comments:	Interim action - Manage & Label.

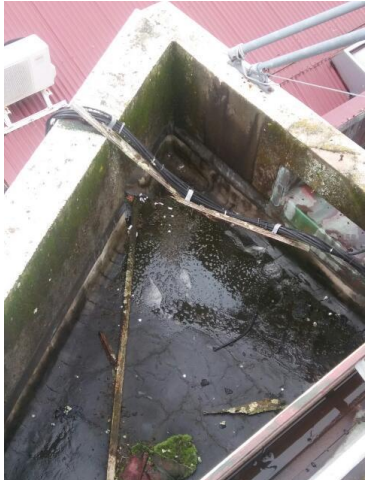
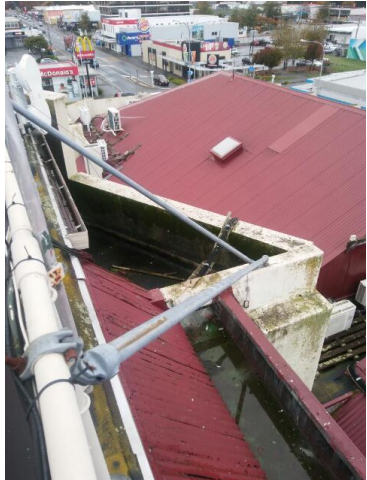
Location	Masterton Town Hall, External, 014, Roof	Sample Number	27 (S)

Item / Position	Bitumen Roofing	
		Material:	Bituminous Product	
		Extent	5m ²	
		Product Type	N/A	N/A
		Condition	N/A	N/A
		Surface Treatment	N/A	N/A
		Asbestos Type	NAD	N/A
		Material Assessment	N/A	0
		Recommendation	No further action required	
		Comments:

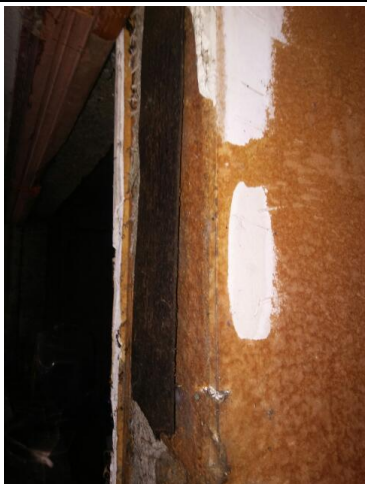
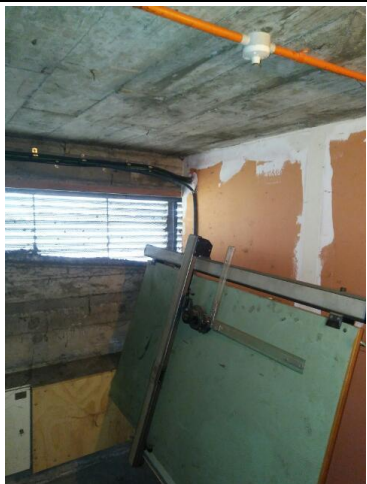
Location	Masterton Town Hall, Basement, 015, Basement	Sample Number	29 (S)

Item / Position	Damp proof course	
	Material:	Bituminous Product	
	Extent	Unknown	
	Product Type	N/A	N/A
	Condition	N/A	N/A
	Surface Treatment	N/A	N/A
	Asbestos Type	NAD	N/A
	Material Assessment	N/A	0
	Recommendation	No further action required	
	Comments:

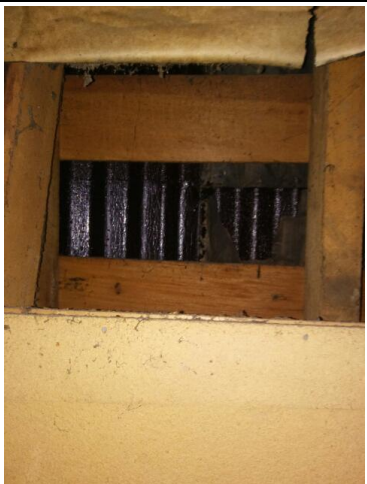
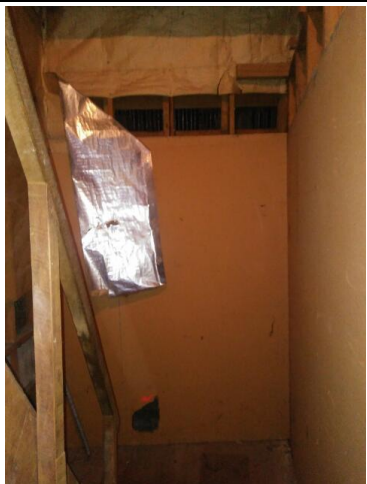
Location	Masterton Town Hall, 2nd Floor, 017, Attic area	Sample Number	30 (S)

Item / Position	Bitumen Coating	
	Material:	Bituminous Product	
	Extent	1500m ²	
	Product Type	Asbestos reinforced composites etc.	1
	Condition	Good condition	0
	Surface Treatment	Completely sealed	0
	Asbestos Type	Chrysotile	1
	Material Assessment	Very Low	2
	Recommendation	Remove	
	Comments:	Bituminous coating to interior of metal roof sheets. Interim action - Manage & Label.

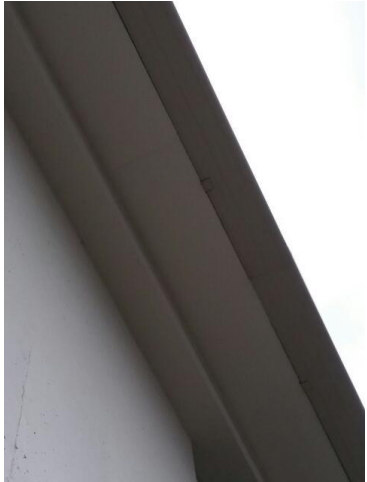
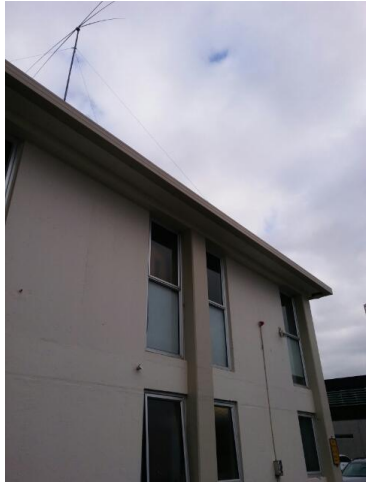
Location	Masterton Town Hall, External, 003, North External Wall	Sample Number	4 (X)

Item / Position	Soffit	
	Material:	Cement Product	
	Extent	20lin m	
	Product Type	N/A	N/A
	Condition	N/A	N/A
	Surface Treatment	N/A	N/A
	Asbestos Type	NAD	N/A
	Material Assessment	N/A	0
	Recommendation	No further action required	
	Comments:

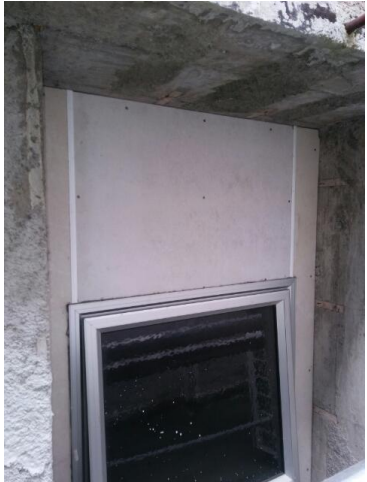
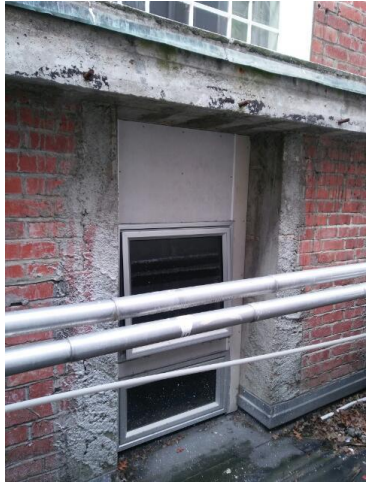
Location	Masterton Town Hall, External, 011, Central Void	Sample Number	18 (X)

Item / Position	Window Surround	
	Material:	Cement Product	
	Extent	1m ²	
	Product Type	Asbestos reinforced composites etc.	1
	Condition	Low damage	1
	Surface Treatment	Surface sealed	1
	Asbestos Type	Amosite / Chrysotile	2
	Material Assessment	Low	5
	Recommendation	Remove	
	Comments:	Interim action - Manage & Label. Encapsulate if boards are to remain.

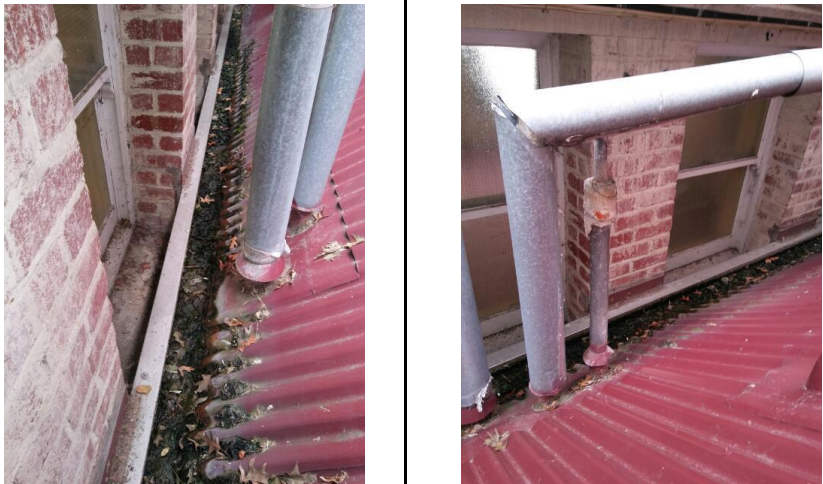
Location	Masterton Town Hall, External, 011, Central Void	Sample Number	20 (X)

Item / Position	Debris	
	Material:	Insulation	
	Extent	Unknown	
	Product Type	Thermal insulation (eg pipe and boiler lagging), sprayed asbestos, loose asbestos, asbestos mattresses and packing.	3
	Condition	High damage	3
	Surface Treatment	Unsealed	3
	Asbestos Type	Chrysotile	1
	Material Assessment	High	10
	Recommendation	Remove	
Comments:	Debris below pipe work must be disposed of as asbestos waste

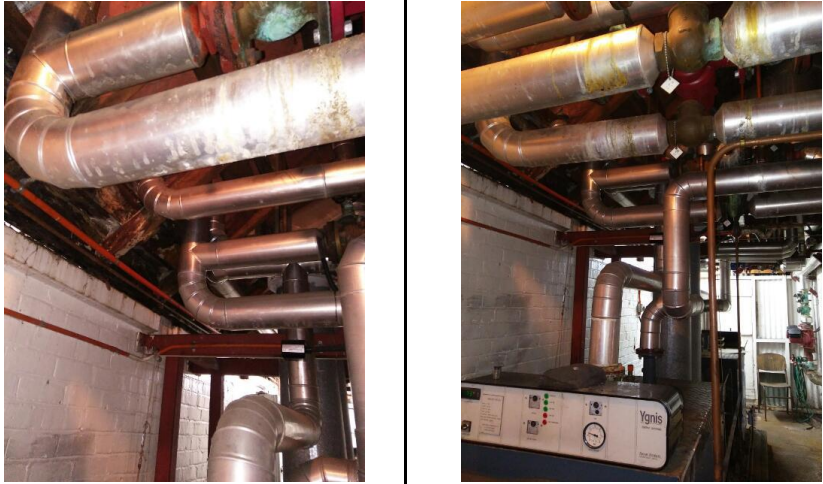
Location	Masterton Town Hall, External, 012, Boiler Room	Sample Number	20 (X)

Item / Position	Pipe Lagging	
	Material:	Insulation	
	Extent	All	
	Product Type	Thermal insulation (eg pipe and boiler lagging), sprayed asbestos, loose asbestos, asbestos mattresses and packing.	3
	Condition	Good condition	0
	Surface Treatment	Surface sealed	1
	Asbestos Type	Chrysotile	1
	Material Assessment	Low	5
	Recommendation	Remove	
Comments:	Pipework inside boiler room appears modern, however it is not clear where the transition from old asbestos lagged pipework to modern pipework occurs. Individual sections of pipework should be checked for asbestos lagging prior to disposal.

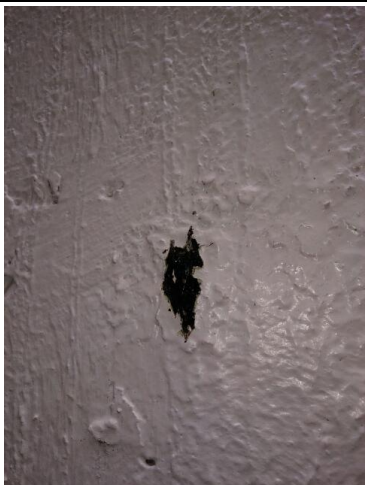
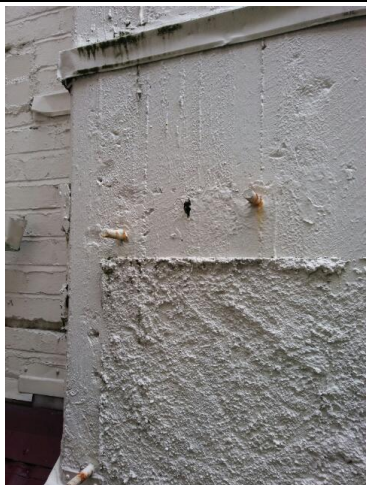
Location	Masterton Town Hall, External, 011, Central Void		Sample Number	21 (X)

Item / Position	Bitumen		
	Material:	Bituminous Product		
	Extent	10m ²		
	Product Type	N/A	N/A	
	Condition	N/A	N/A	
	Surface Treatment	N/A	N/A	
	Asbestos Type	NAD	N/A	
	Material Assessment	N/A	0	
	Recommendation	No further action required		
	Comments:

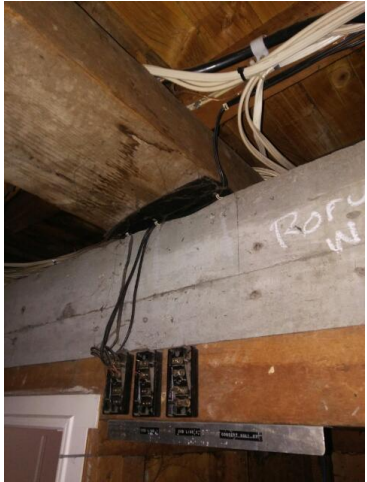
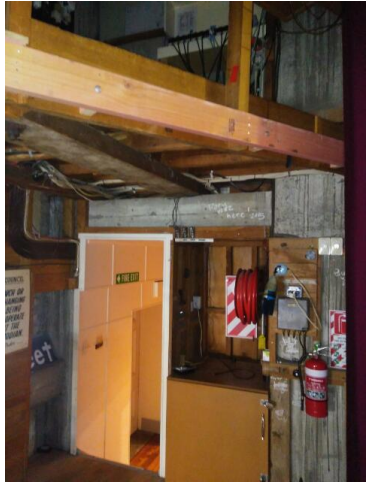
Item / Position	Damp proof course		
	Material:	Bituminous Product		
	Extent	1m ²		
	Product Type	N/A	N/A	
	Condition	N/A	N/A	
	Surface Treatment	N/A	N/A	
	Asbestos Type	NAD	N/A	
	Material Assessment	N/A	0	
	Recommendation	No further action required		
	Comments:

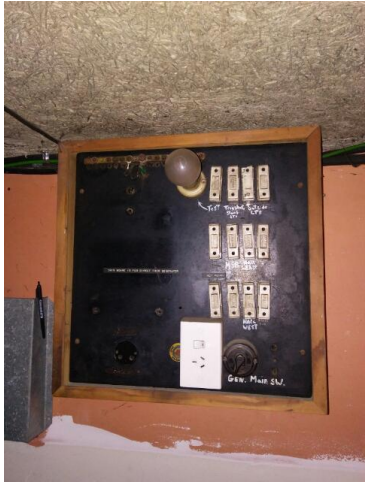
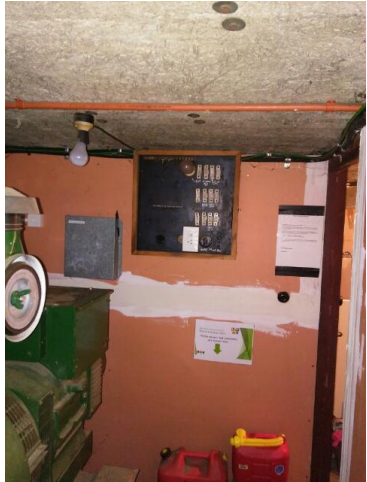
Item / Position	Switchboard		
	Material:	Bituminous Product		
	Extent	1no		
	Product Type	Asbestos reinforced composites etc.	1	
	Condition	Low damage	1	
	Surface Treatment	Surface sealed	1	
	Asbestos Type	Chrysotile	1	
	Material Assessment	Very Low	4	
	Recommendation	Remove		
	Comments:	Interim action - Manage and Label

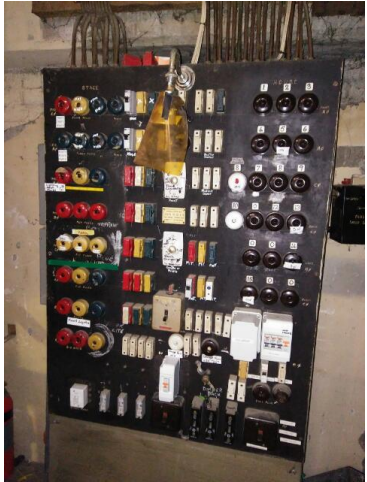
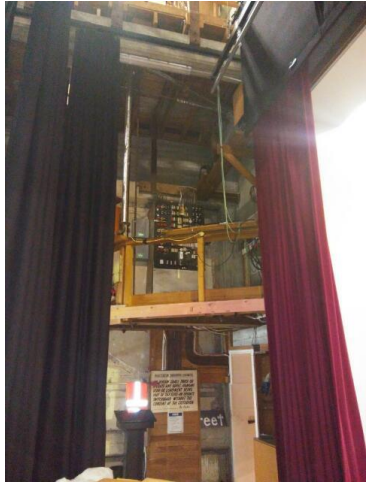
Item / Position	Switchboard		
	Material:	Bituminous Product		
	Extent	1no		
	Product Type	Asbestos reinforced composites etc.	1	
	Condition	Low damage	1	
	Surface Treatment	Surface sealed	1	
	Asbestos Type	Chrysotile	1	
	Material Assessment	Very Low	4	
	Recommendation	Remove		
	Comments:	Interim action - Manage and Label.

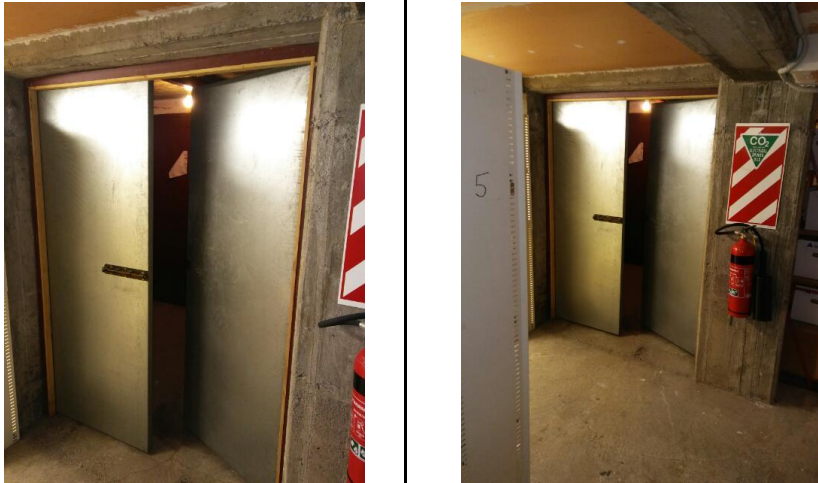
Item / Position	Fire Doors		
	Material:	Insulating Board		
	Extent	2no		
	Product Type	AIB, Millboards, other low-density insulation boards, asbestos textiles, gaskets, ropes and woven textiles, asbestos paper and felt	2	
	Condition	Good condition		0
	Surface Treatment	Completely sealed		0
	Asbestos Type	Presumed Asbestos		3
	Material Assessment	Low		5
	Recommendation	Remove		
Comments:	Fire doors commonly contain asbestos insulating boards and item should be presumed to contain asbestos as a precaution, unless proven otherwise. Interim action - Manage and Label.

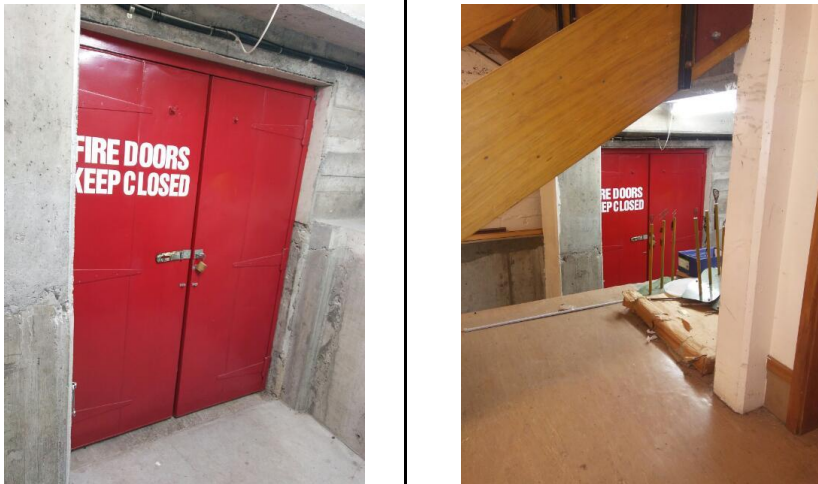
Item / Position	Fire Doors		
	Material:	Insulating Board		
	Extent	2no		
	Product Type	AIB, Millboards, other low-density insulation boards, asbestos textiles, gaskets, ropes and woven textiles, asbestos paper and felt	2	
	Condition	Good condition		0
	Surface Treatment	Completely sealed		0
	Asbestos Type	Presumed Asbestos		3
	Material Assessment	Low		5
	Recommendation	Remove		
Comments:	Fire doors commonly contain asbestos insulating boards and item should be presumed to contain asbestos as a precaution, unless proven otherwise. Interim action - Manage and Label.

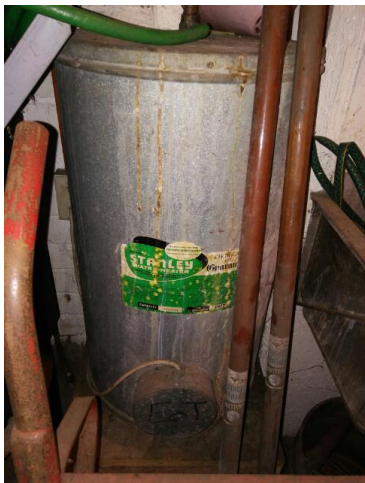
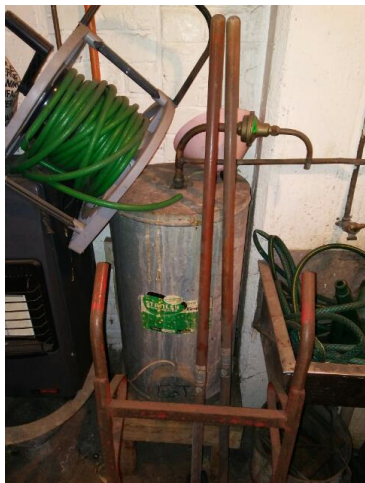
Item / Position	Hot Water Cylinder		
	Material:	Suspected Asbestos		
	Extent	1no		
	Product Type	Thermal insulation (eg pipe and boiler lagging), sprayed asbestos, loose asbestos, asbestos mattresses and packing.	3	
	Condition	Good condition	0	
	Surface Treatment	Surface sealed	1	
	Asbestos Type	Presumed Asbestos	3	
	Material Assessment	Medium	7	
	Recommendation	Remove		
	Comments:	Hot Water Cylinders can contain a variety of ACMs such as insulation, wiring, gaskets and reinforced plastics, and should therefore be presumed to contain asbestos unless proven otherwise. Interim action - Manage and Label.

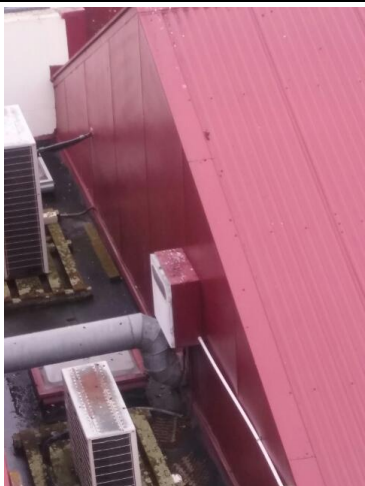
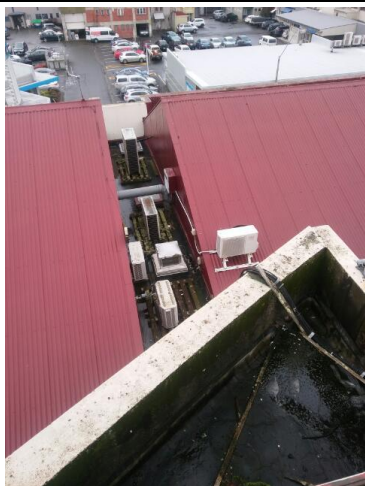
Item / Position	Cement Board		
	Material:	Cement Product		
	Extent	12m ²		
	Product Type	Asbestos reinforced composites etc.	1	
	Condition	Good condition	0	
	Surface Treatment	Completely sealed	0	
	Asbestos Type	Presumed Asbestos	3	
	Material Assessment	Very Low	4	
	Recommendation	Inspect and sample as required prior to disturbance		
	Comments:	Too wet to access safely at the time of the survey
