Geotechnical Seismic Assessment - Site Investigation Masterton Municipal Building & Town Hall

Tonkin & Taylor Ltd (T+T) was engaged by Masterton District Council (MDC) to provide a geotechnical seismic assessment and investigation of the Masterton Municipal Building and Town, 64 Chapel Street, Masterton. T+T have carried out this work in accordance with our letter of engagement, dated 30 January 2017.

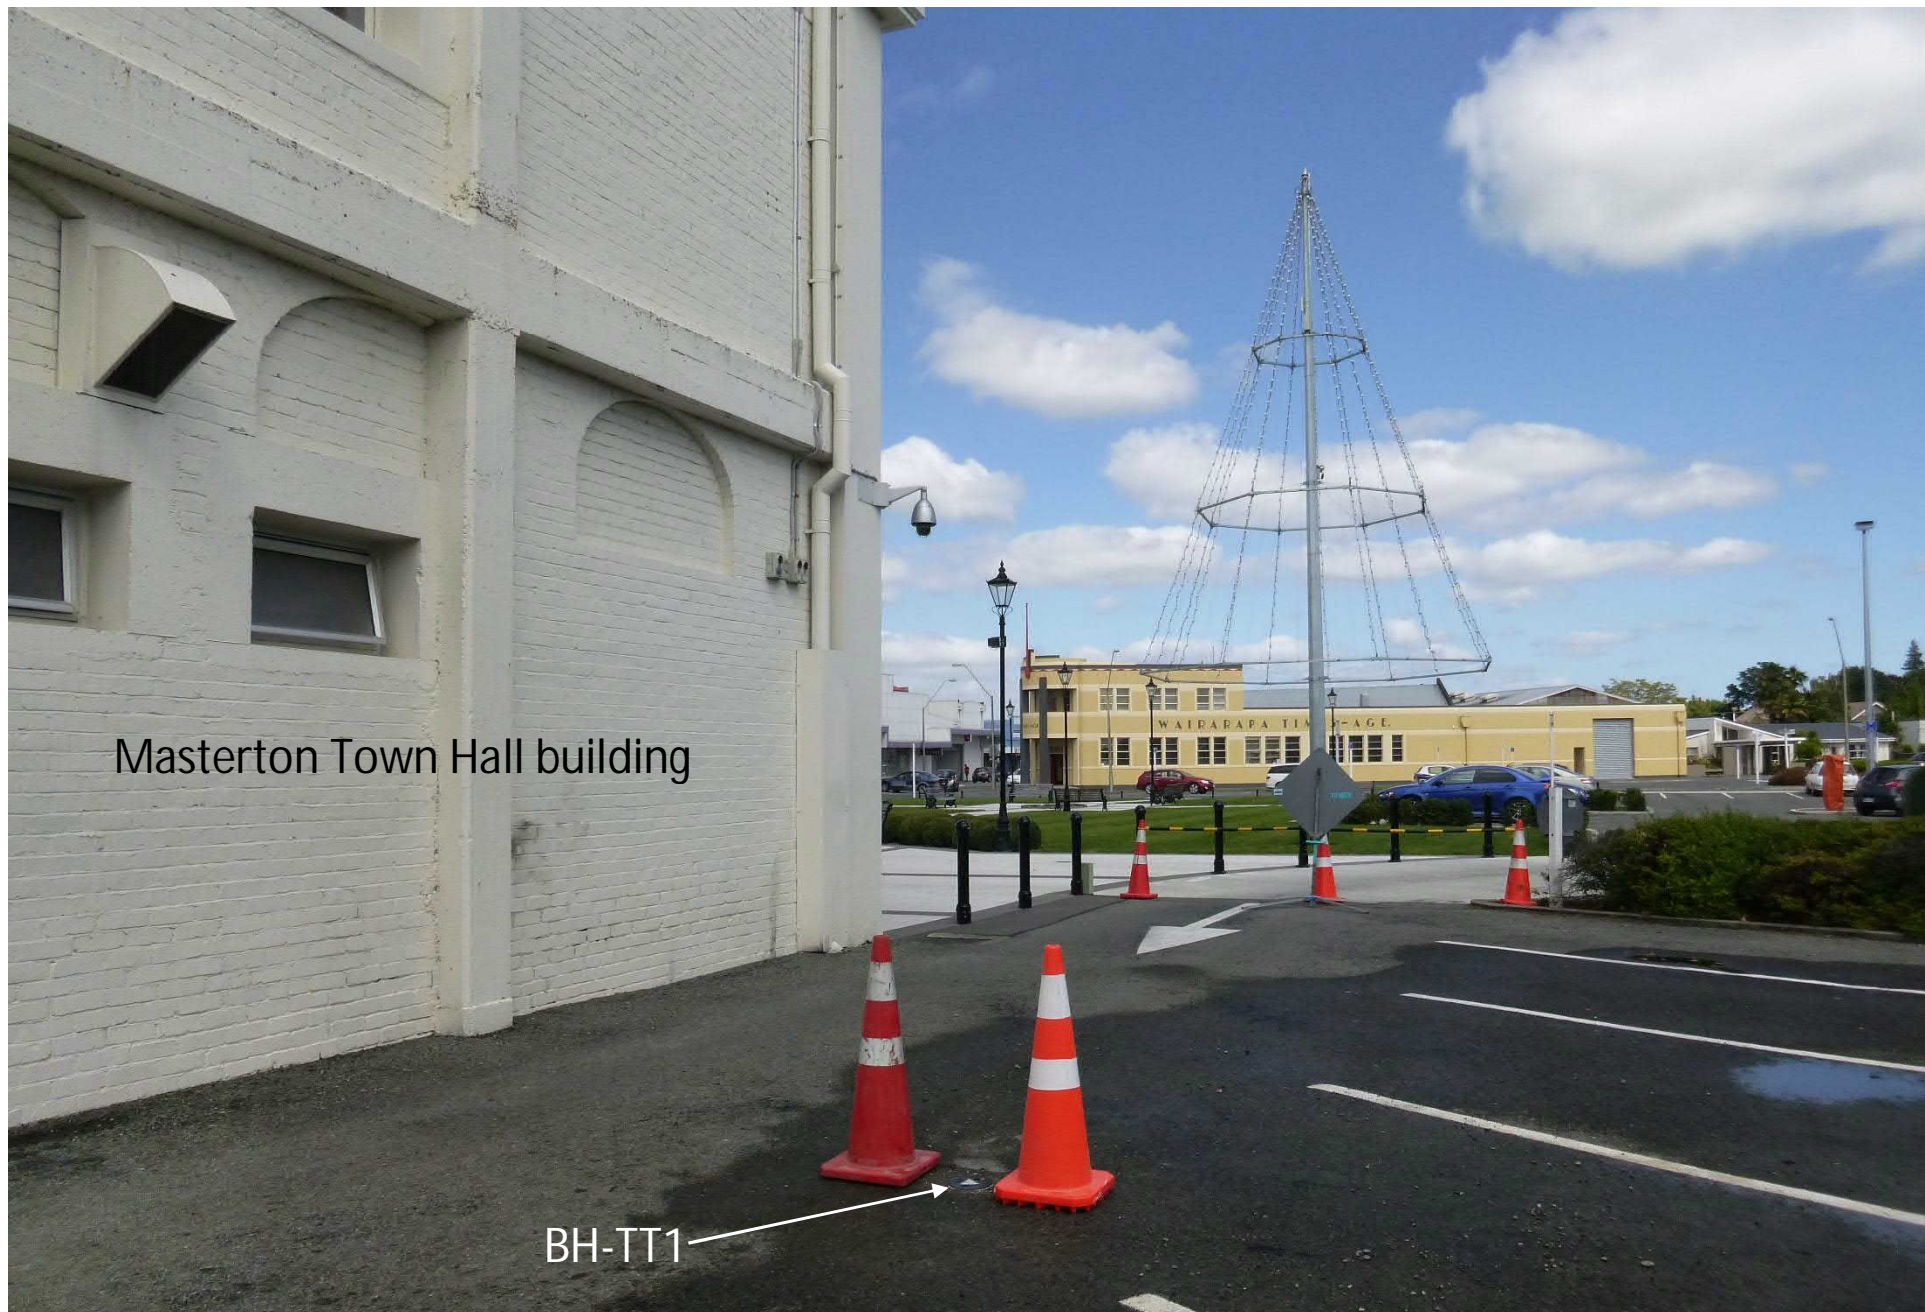
Figure A2: Location of BH-TT1 relative to the Masterton Town Hall building. NB: BH-TT1 includes a standpipe piezometer, finished with a flush-mount toby cover.
