APPENDIX A

Seismic Assessment Update
 8th July 2016

Title: Assessment of Existing	Job Number: 1223	Rev: A
Project: Seismic Improvement Scheme Masterton Municipal Building		Sheet Number: A1

Title: **First Floor Gravity Support**
 Project: **Seismic Improvement Scheme Masterton Municipal Building**

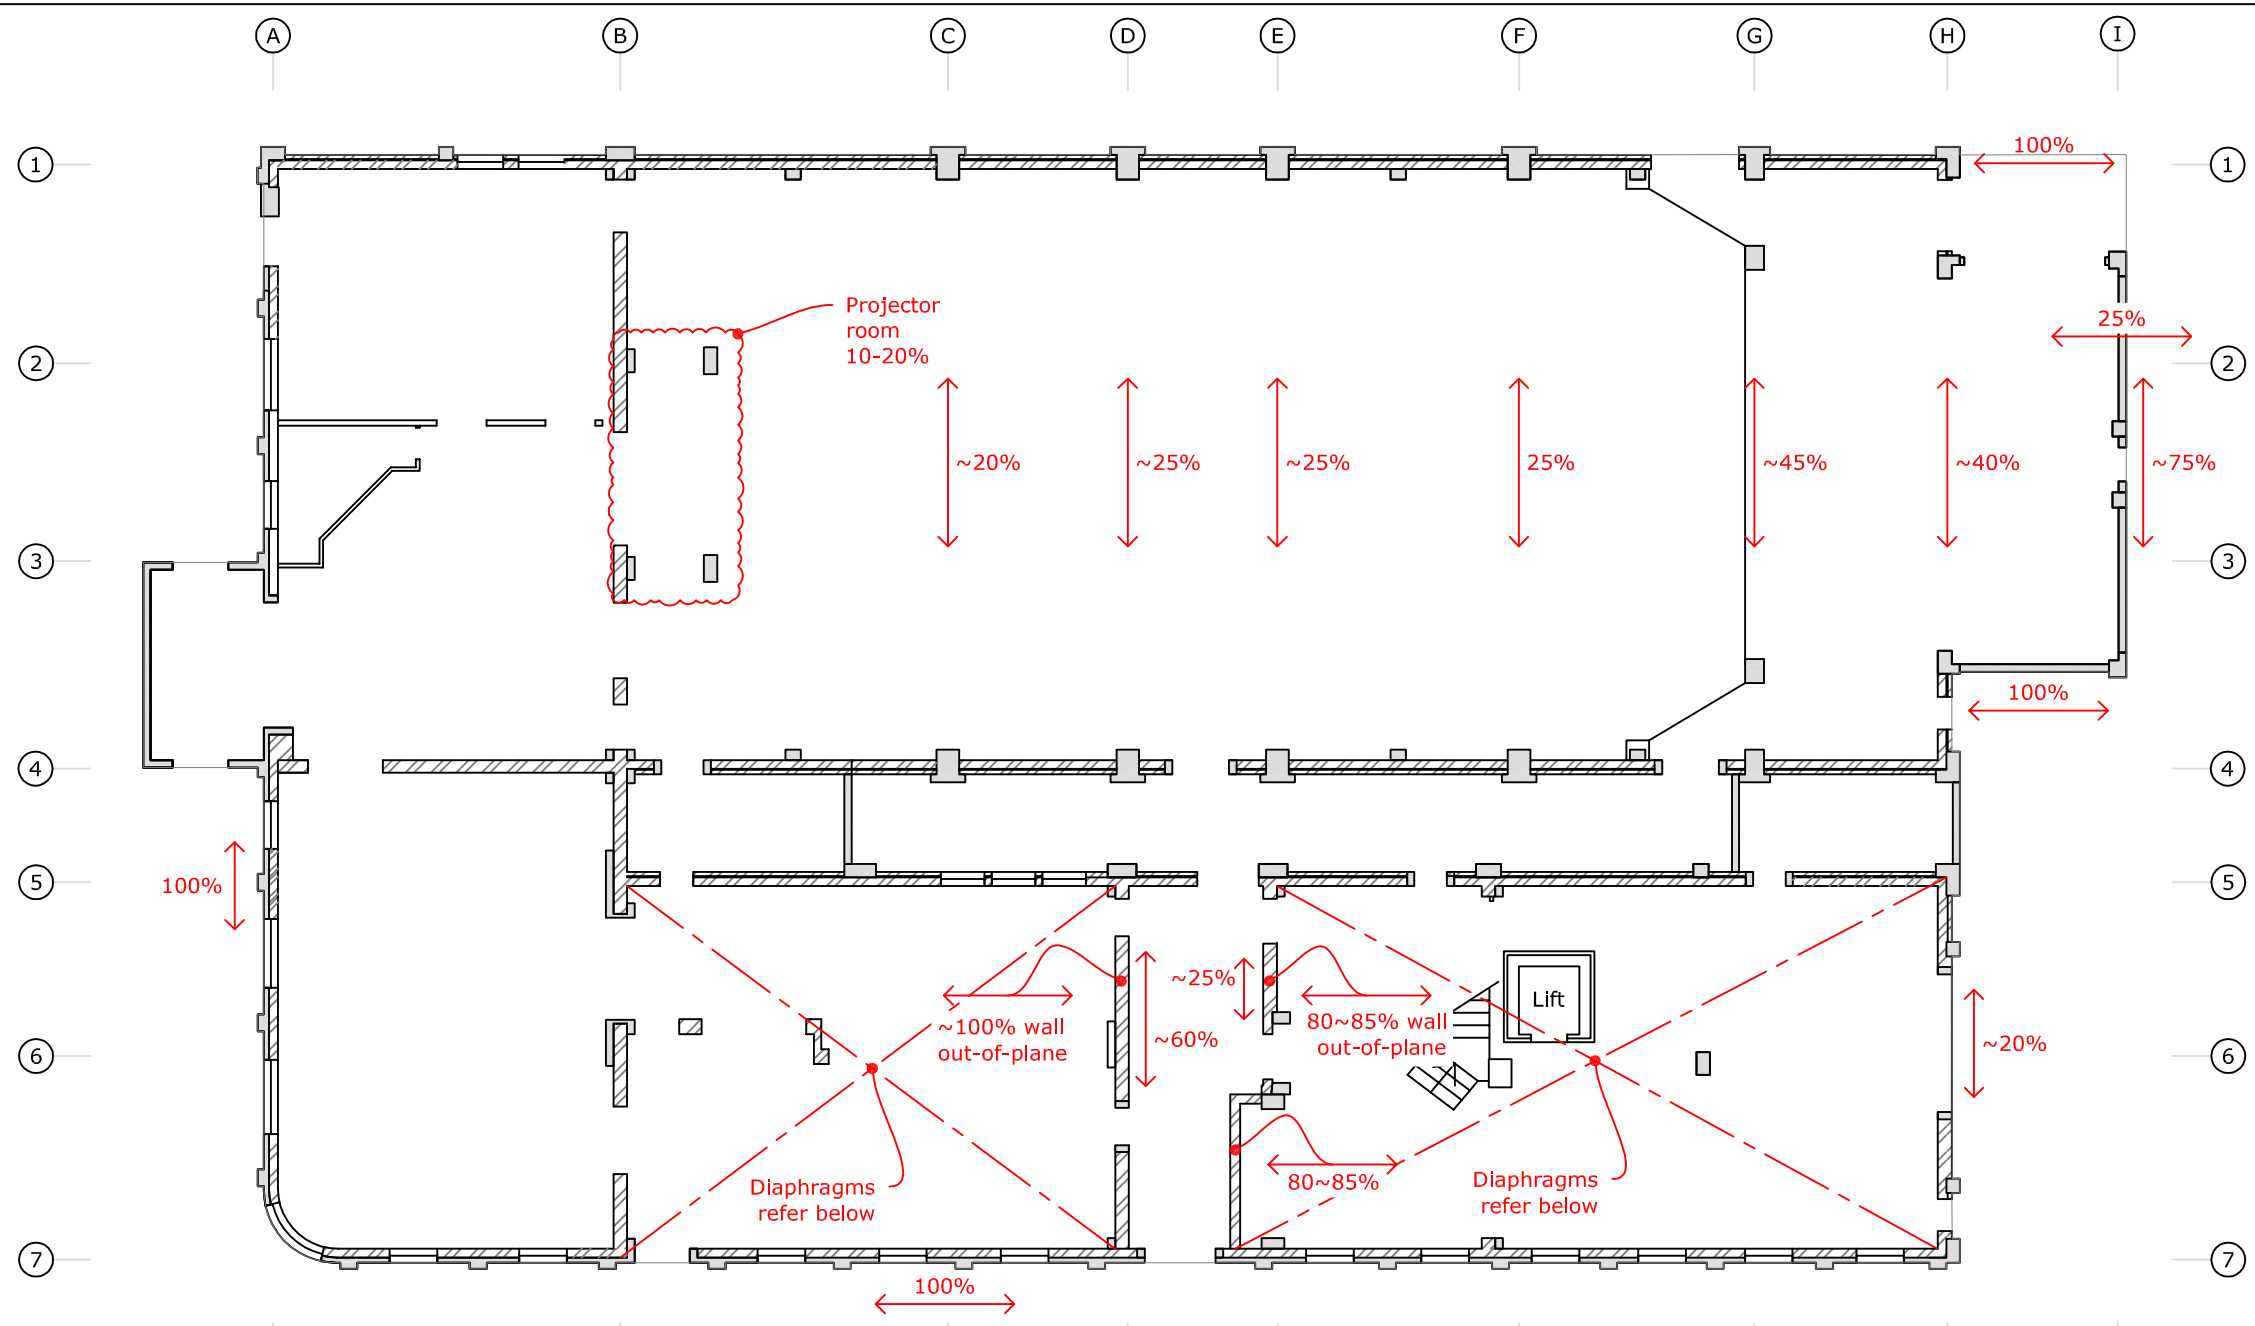
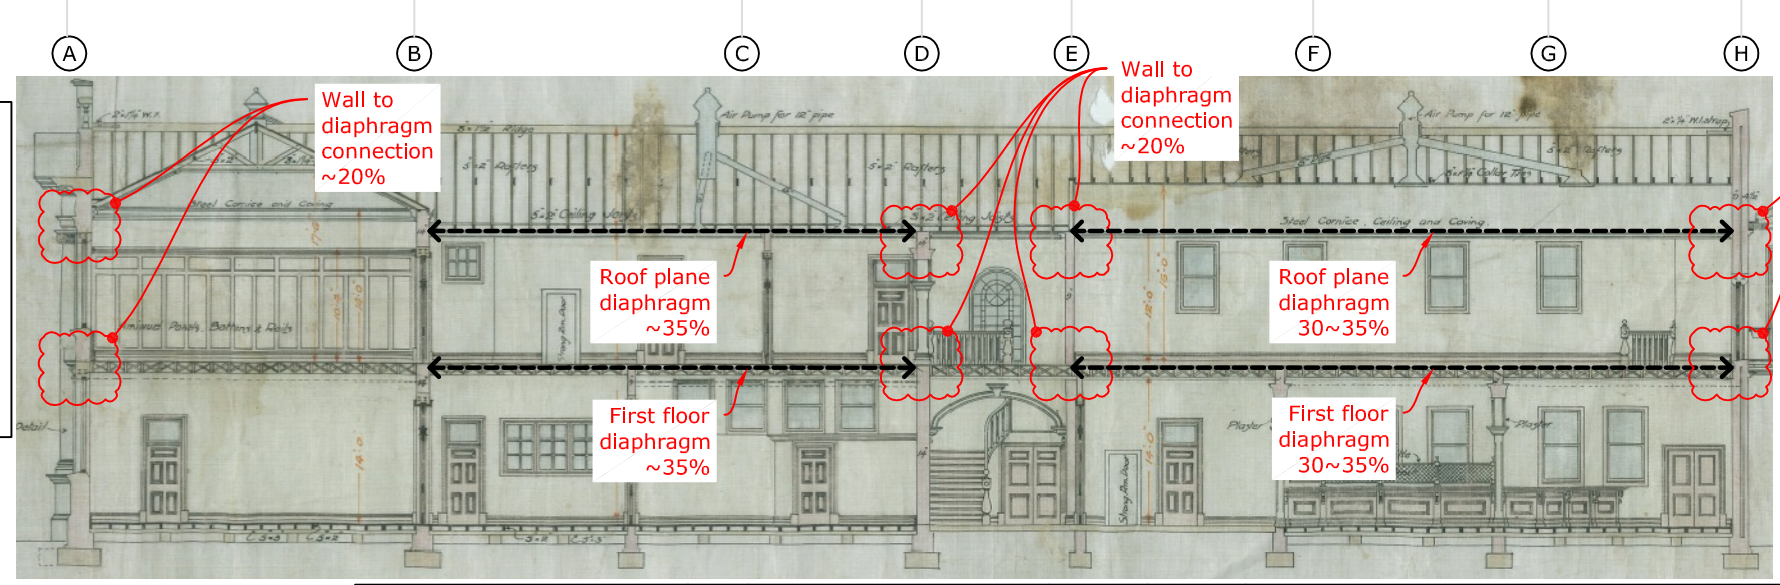
-Schematic showing results for Assessment of Existing

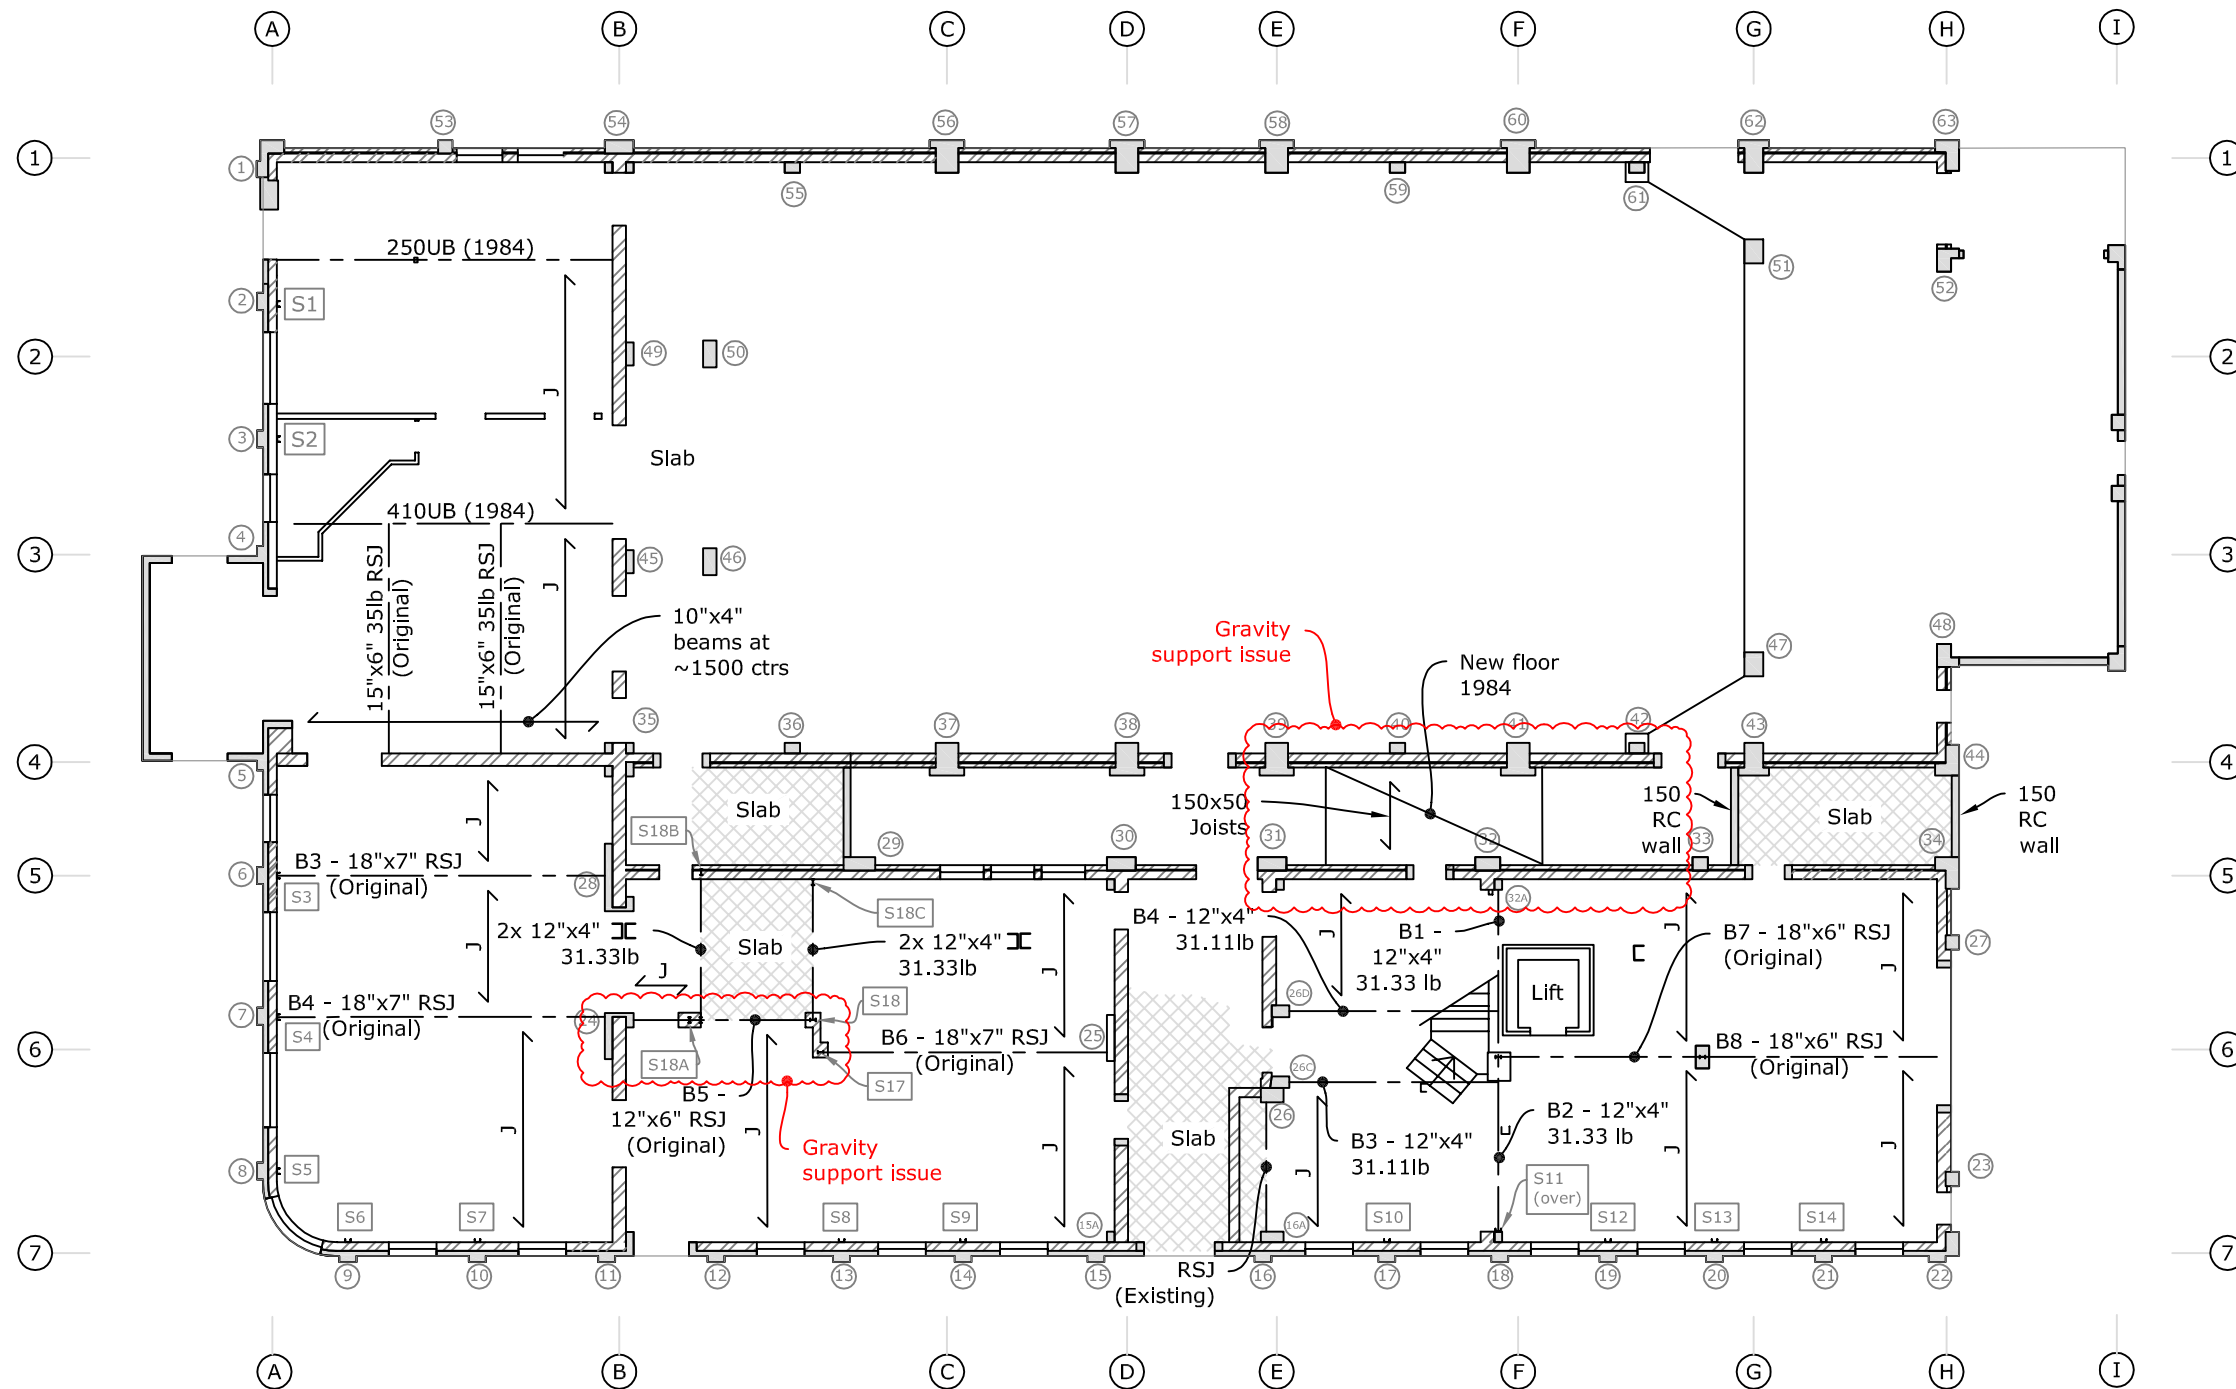
First Floor Plan
 (Shown over Ground floor walls)
 1:200

**Potential gravity support issues
under seismic displacements.**
