## MASTERTON DISTRICT COUNCIL MUNICIPAL BUILDING & TOWN HALL

# *Structural Report on the Masterton Town Hall and Masterton Municipal Building*

Date: 27<sup>th</sup> September 2016

Project Reference: 1223

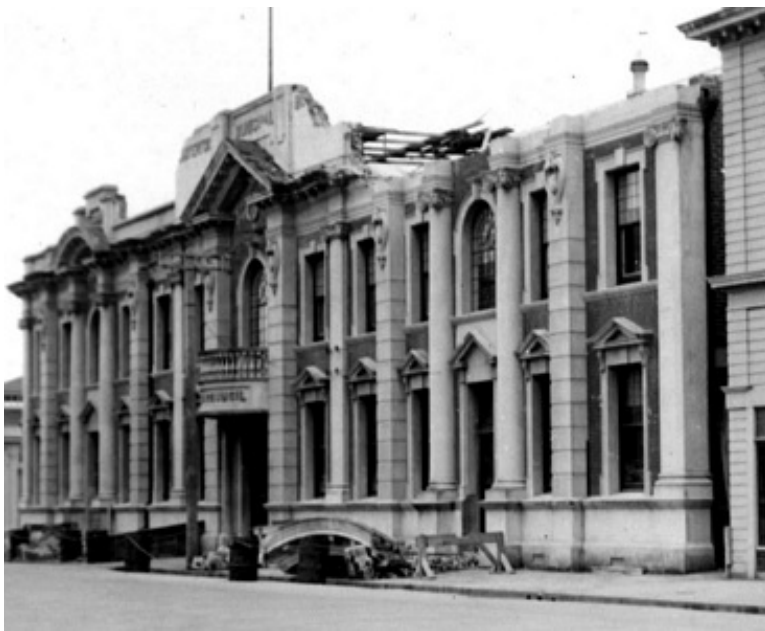
The Municipal building suffered some damage at the time, with a photograph available of the Chapel St frontage. This photograph shows damage to the parapets on Chapel St, with brick sections falling to the street.

Figure 7 – Post 1942 earthquake showing minor damage.

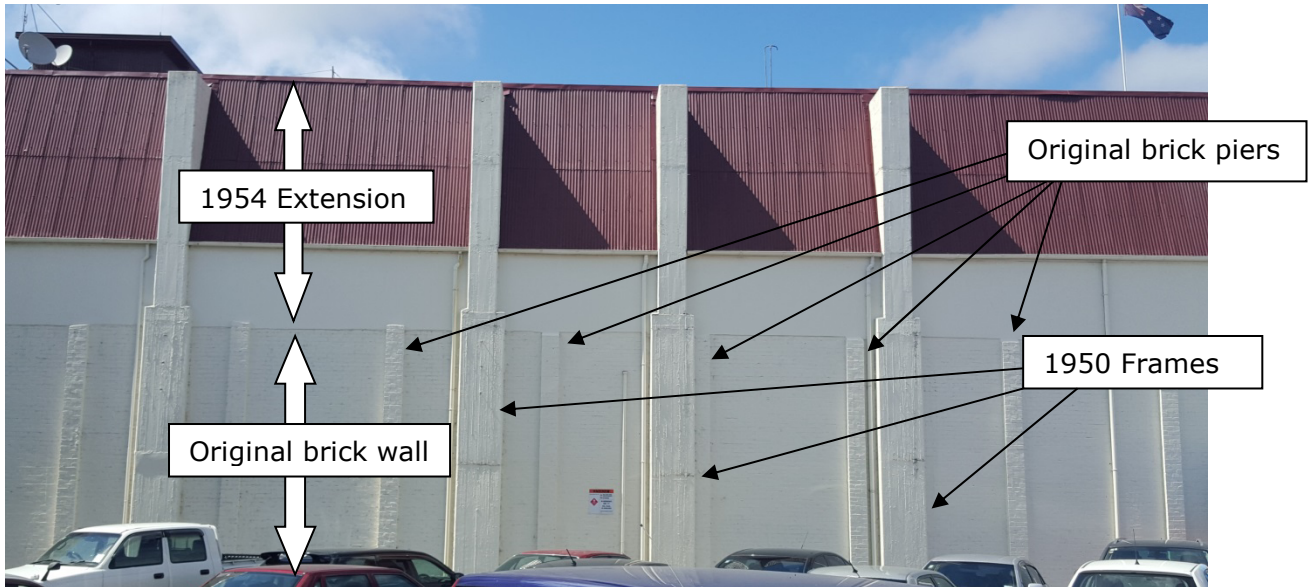
Figure 8 – Side wall of Hall – new frames marked, original brick side wall visible

The frames are reasonably well detailed for their era, however they are lightly reinforced.

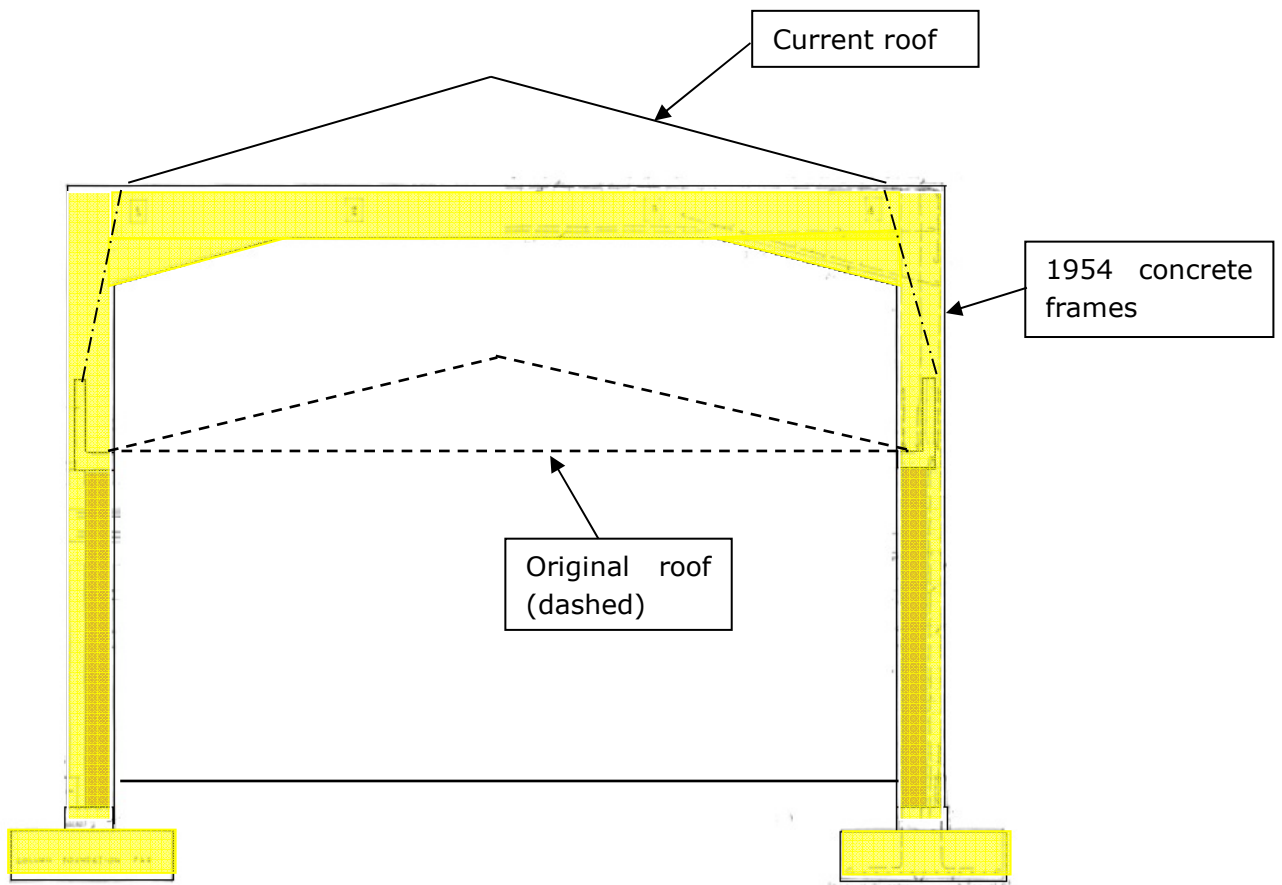
Figure 9 – Hall Transverse Frames

The capacity of the Town Hall frames in the transverse direction has been reviewed. The ductility of the concrete frames was assessed using Response2000, adopting a maximum concrete strain of 0.04. This provided an available section ductility of 2. The mechanism for these frames is yielding in the columns.

In the transverse direction, the Hall frames are able to achieve 25-30%NBS. Note that this correlates well to the Spencer Holmes assessment of 40% for Soil Type C.

The requirements for the Hall would be to basically replicate the existing 'frames'. This would involve;

- Removing all internal wall and ceiling linings
- Cutting into the existing brick section
- Excavating locally for new foundations
- Constructing the new transverse frames. Full scaffolding would be required at each location to allow for construction.

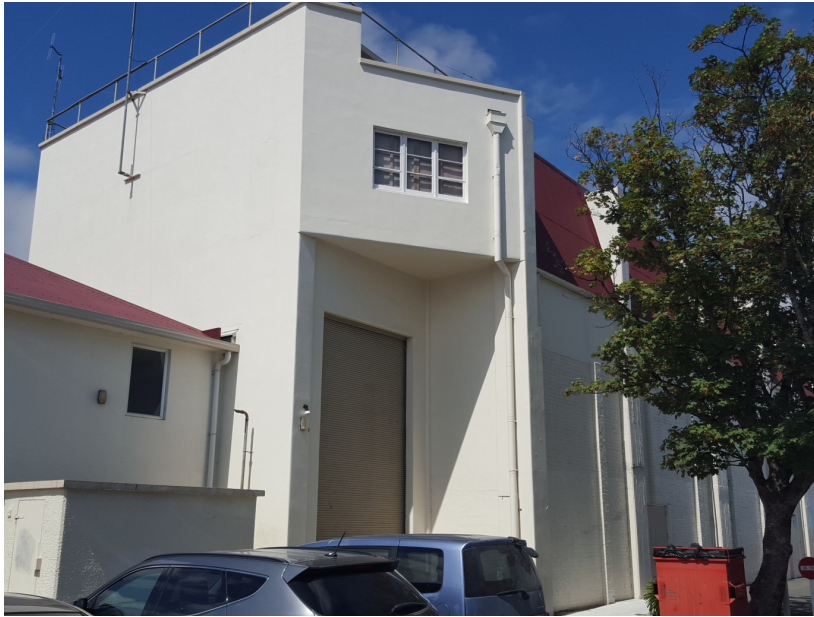
The rear of the Town Hall was extended to form the current stage area. This extension was formed with reinforced concrete walls. The quality of the construction is typical of the era, with areas on “boney” concrete visible and exposed sections of reinforcing steel.

*Figure 10 – Rear of Hall showing reinforced concrete extension*

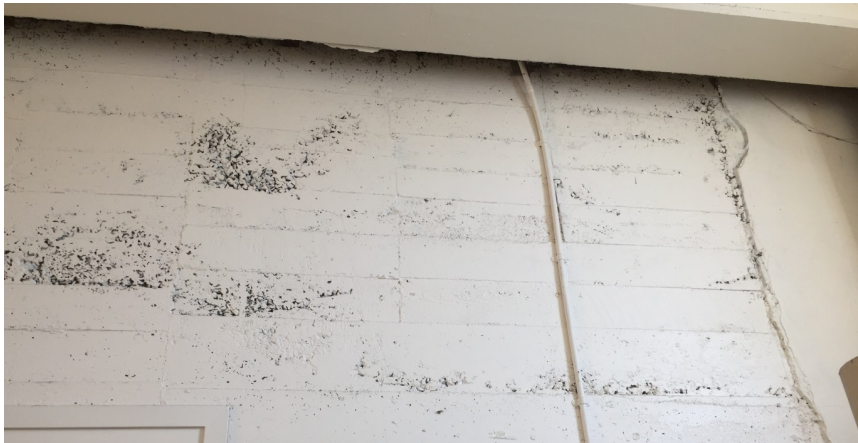
*Figure 11 – View of hall extension "boney" concrete – poorly vibrated concrete resulting in exposed aggregate.*

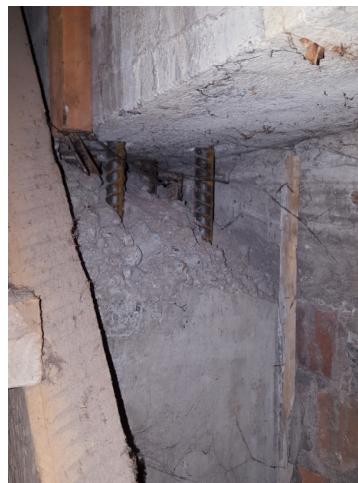
Figure 12c – Poor construction details evident in this beam to column joint

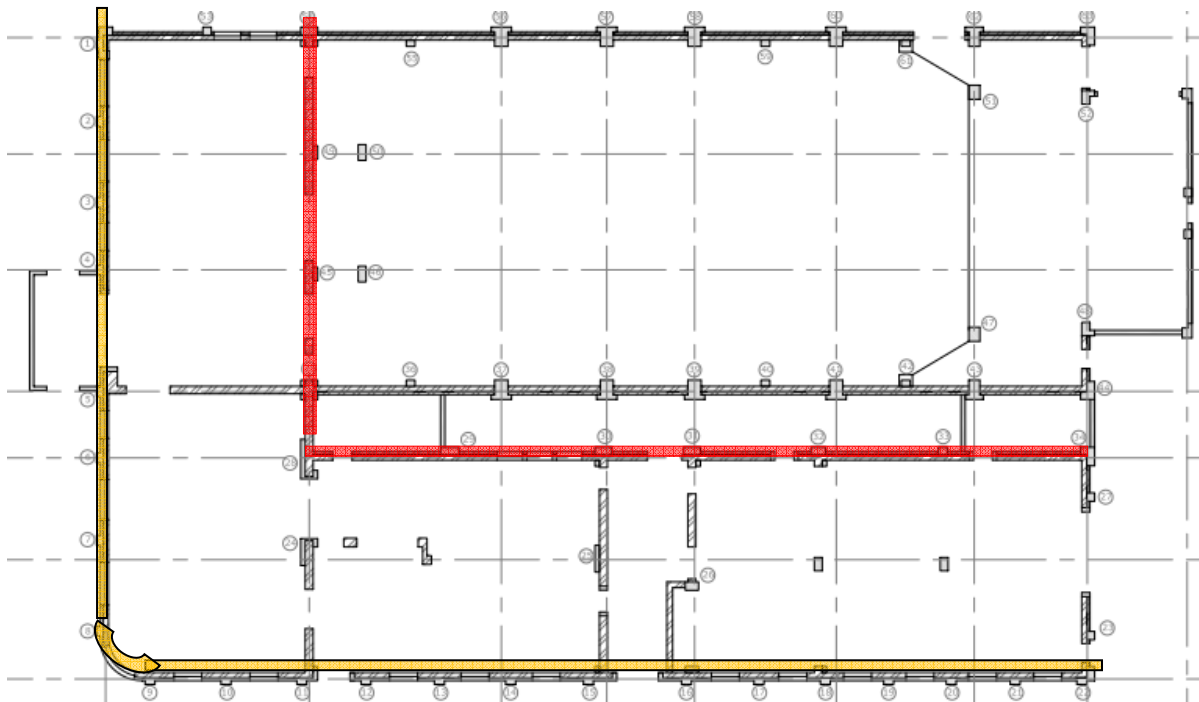
Though the façade (shown in yellow in figure 13) had a complete and substantial reinforced concrete 'skin' wrapped around it, the rear wall line (shown in red in figure 13) of the Municipal office building was left largely as original, (ie 9" thick brick with veneer). The rear wall lines had reinforced concrete bands installed in and around the brick work. The bands do not form a complete frame system, and are offset where

Figure 13 – Ground floor plan. Façade concrete highlighted yellow. Rear wall line shown in red.

This means that the lateral load resisting system along these external wall lines is still original 9" brick wall.

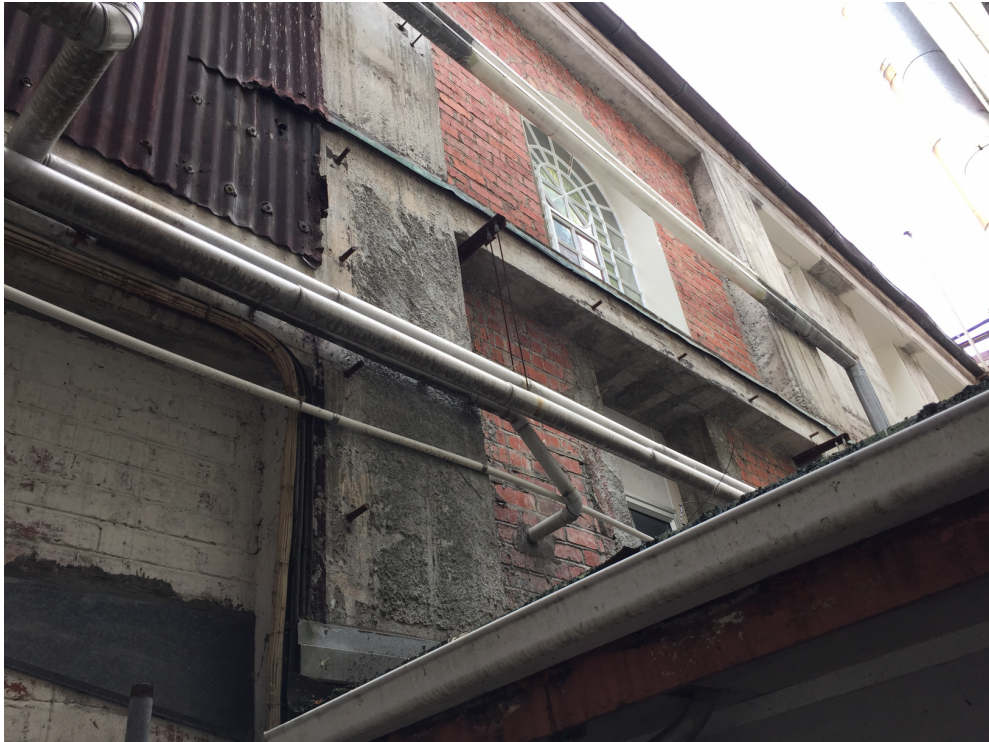
Figure 15 – External view of wall line at rear of Municipal building (shown in red in figure 13)

- Demolition of the URM wall sections along the rear wall line (Grids B and 5) to reduce seismic mass and remove the requirement to strengthen the walls out-of-plane. Removing this weight means the new transverse portal frames are of a more economical size, and the existing first floor and roof plane diaphragms are acceptable.

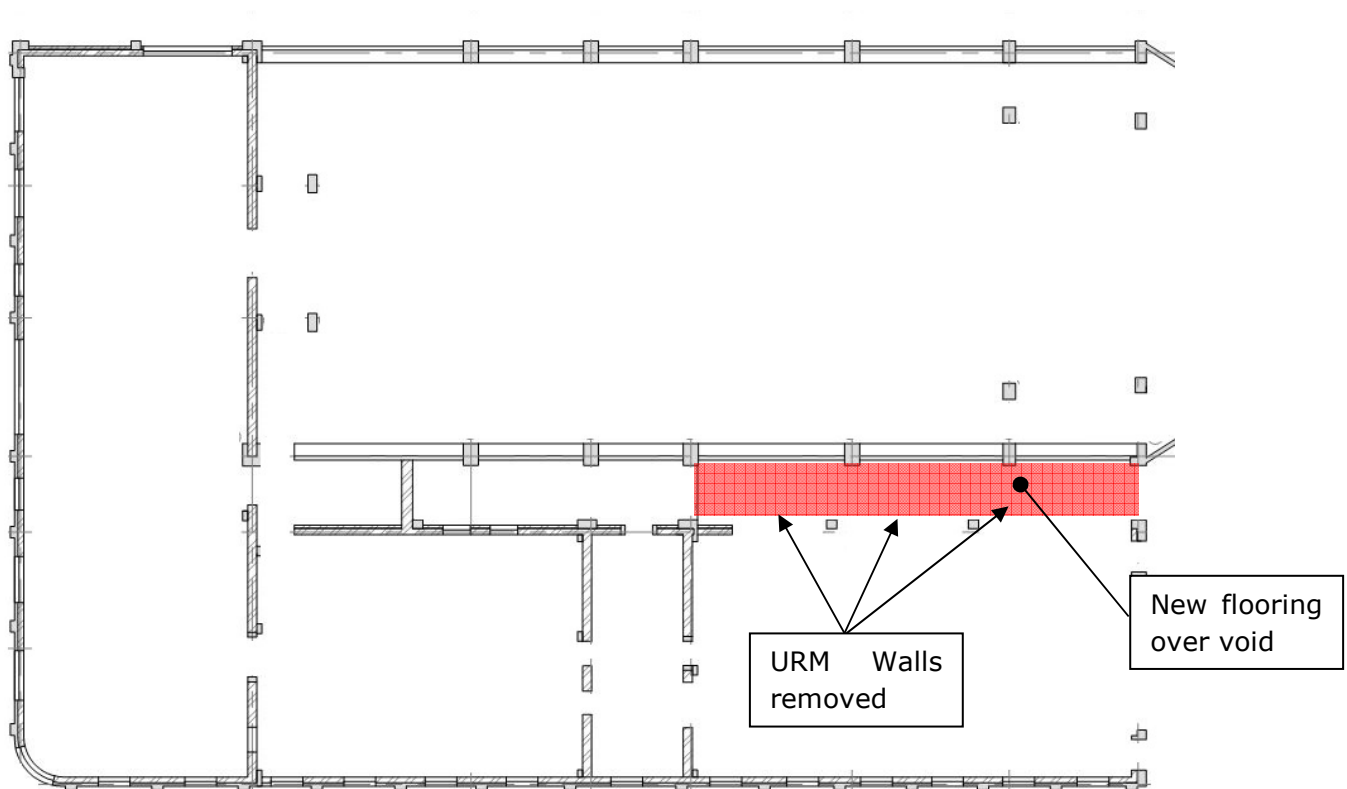
Also during the 1950s strengthening work, on the first floor of the Municipal building the roofing was extended over the void between this building and the Hall. Floor joists were placed across the void to form additional office floor space. The first floor brick wall was entirely removed from this section of the building.

Figure 16 – First Floor Plan after 1950s work – note walls removed

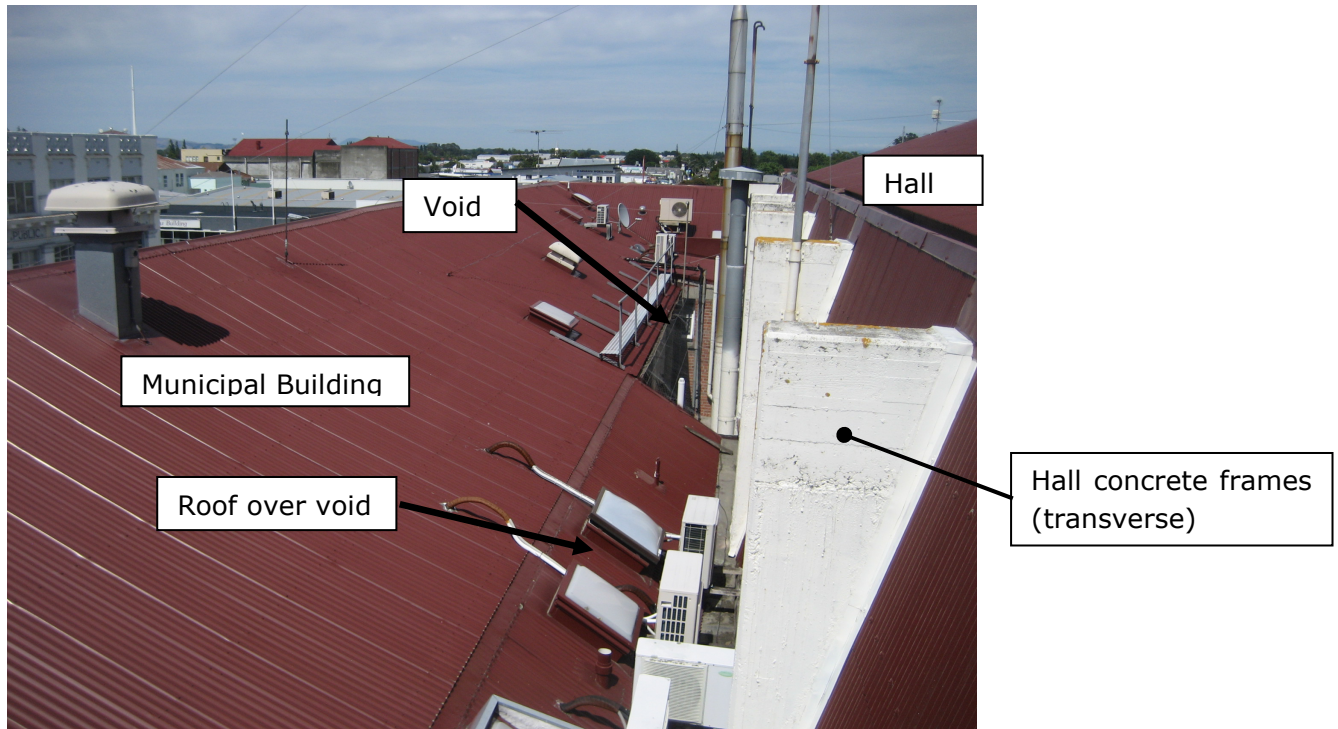
The Hall and the Municipal building are two different structures, ie one has very high concrete frames in the transverse direction (see figure9), while the other is two storied with in-plane URM walls. This means the buildings are likely to move out-of-sync relative to each other during an earthquake. The new flooring spans the void between the two buildings, and is supported on a stringer attached to the Hall. This means there is a potential loss of gravity support to this section of flooring during a seismic event.

Figure 17 – Roof Plan – note new roof bridging the gap between the Hall and Municipal Building

The main area is the flooring which has been erected over the void between the Hall and the Municipal building. This flooring is supported on a stringer bolted to the hall, and has been previously discussed.

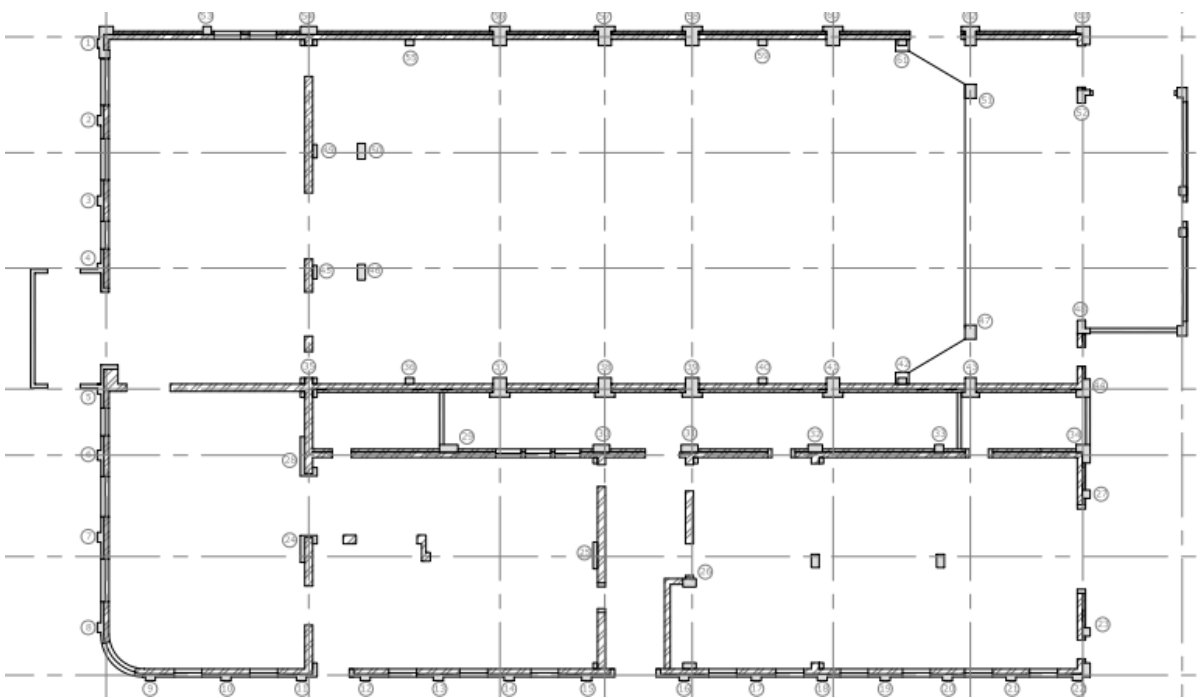
The Municipal Building has also had ongoing alterations, particularly to the ground floor. Internal sections of URM wall have been removed as required to accommodate refurbishments.

Figure 17b - Current floor plan – note internal walls removed

Removing these wall elements has had the effect of increasing the seismic demand on the diaphragms, and reducing the structural elements available to resist seismic loads.
