Geotechnical Assessment Proposed Plan Change Cashmere Oaks Drive, Masterton

Report prepared for: Welhom Developments Limited

Report reference: 210422-E (Issue 2.0)

Date: 29 April 2022

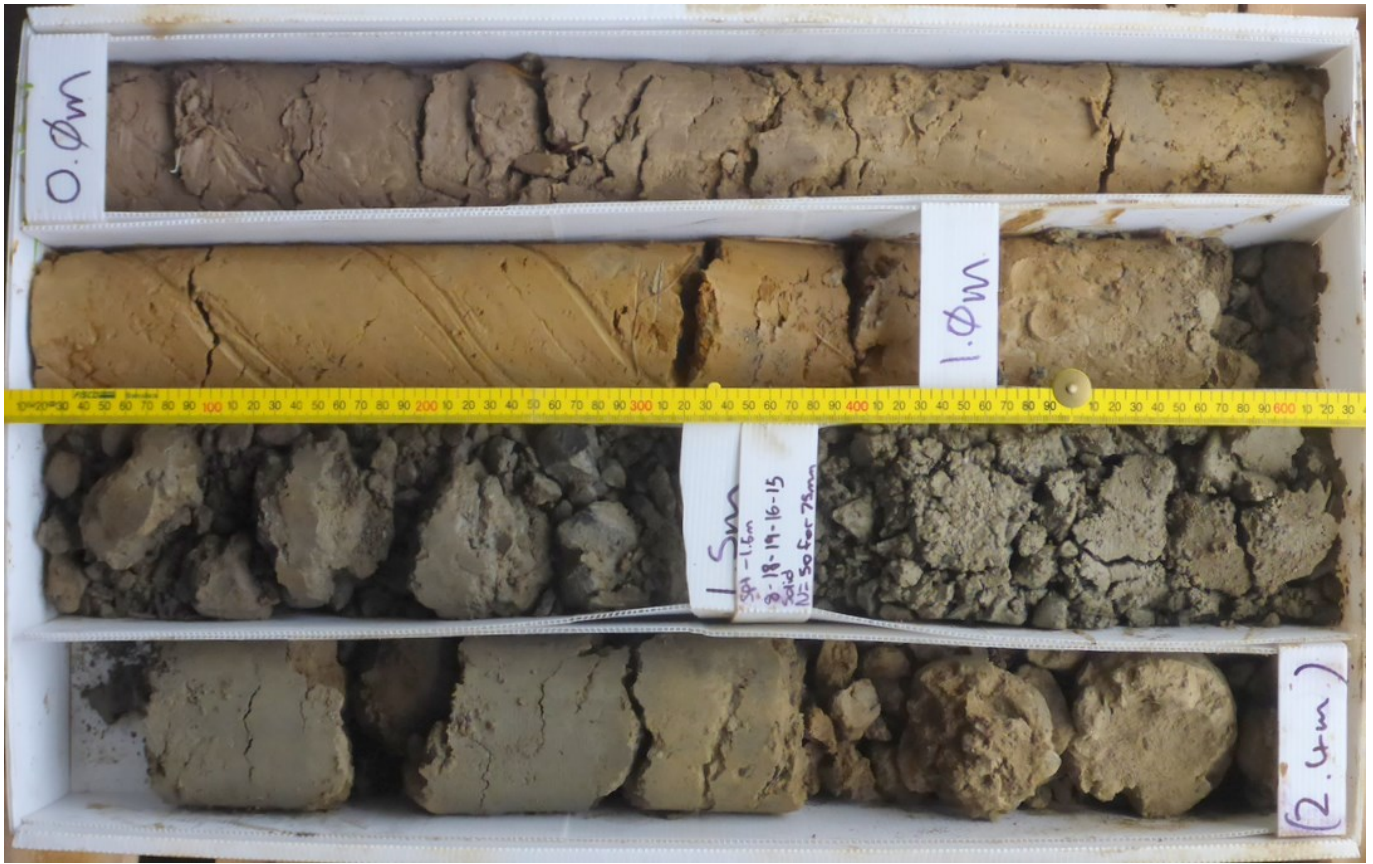
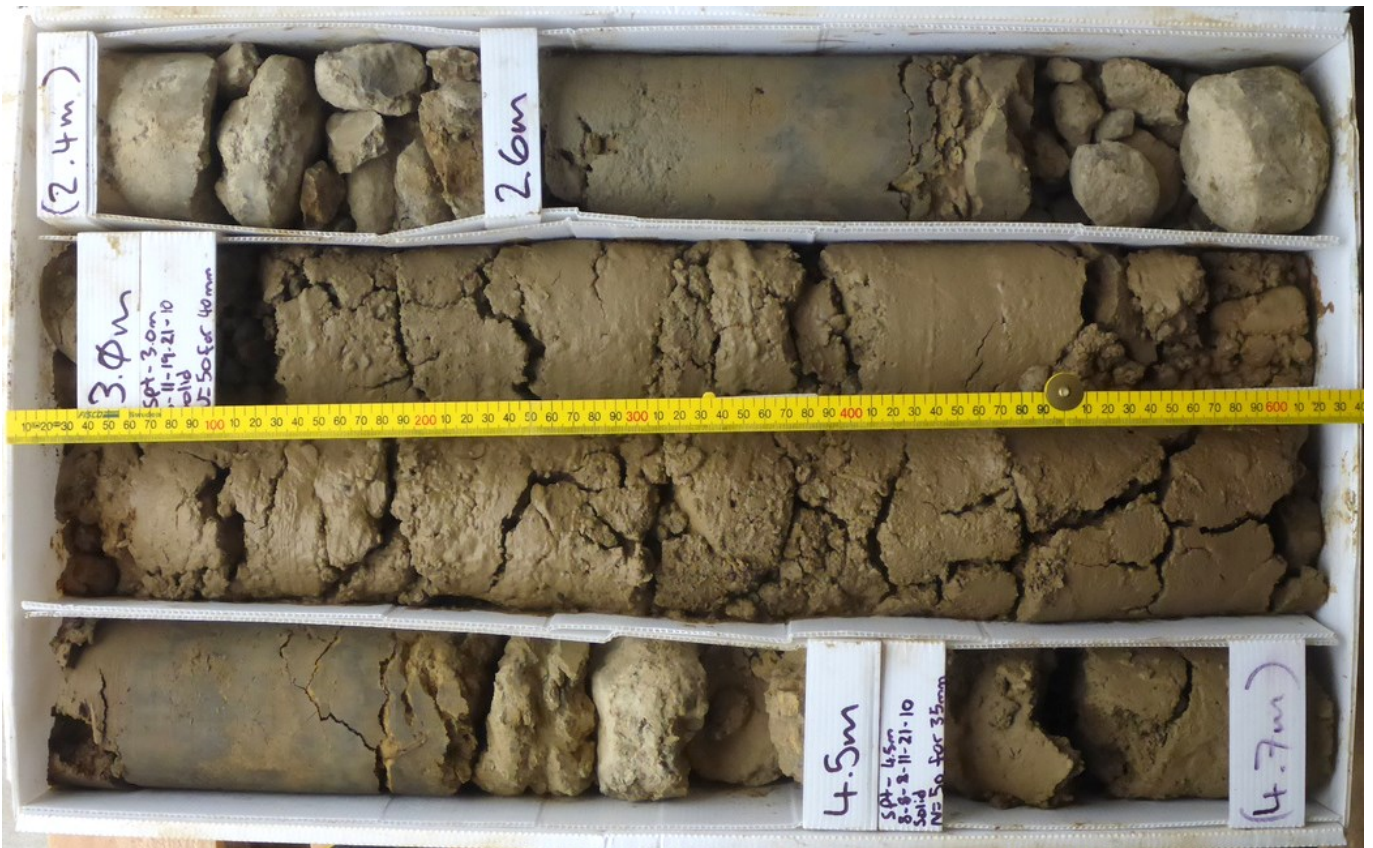
Client / Project:	WELHOM DEVELOPMENTS LTD GEOTECHNICAL ASSESSMENT DUE DILIGENCE BOREHOLE CORE PHOTOS	Hole ID:	BH01

Date:	Sep 2021	
Notes:	1. Drill sampling method: Rotary Sonic (approx. 78mm sample diameter). 2. Markers: start/end of run in metres; "CL" indicates core loss in metres; brackets indicate run split between boxes	Box No(s).	1 and 2 of 7	
		Depth from (m):	0.00m	
		Depth To (m):	4.70m	
Project No.	210422	Interval (m):	4.70m

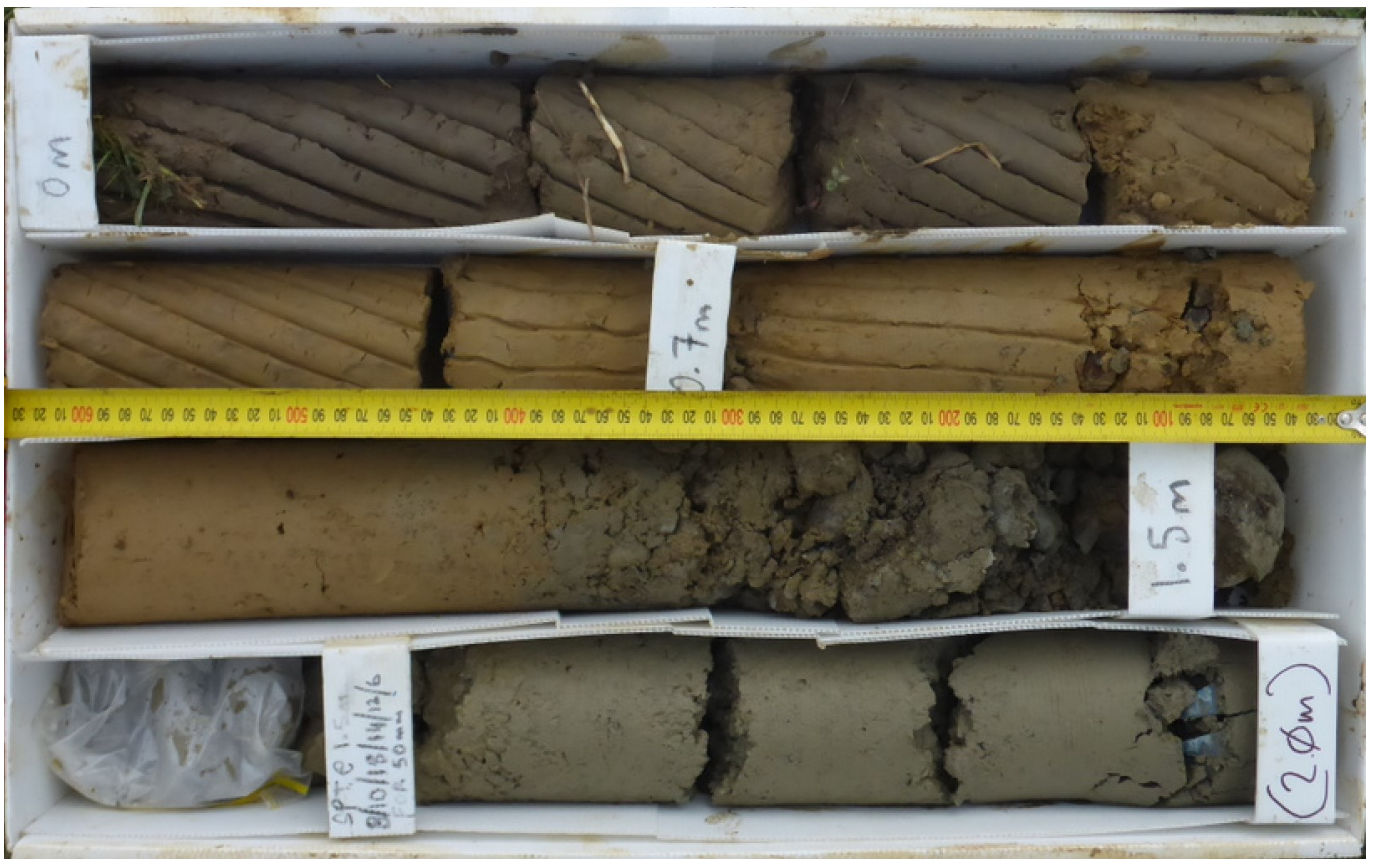
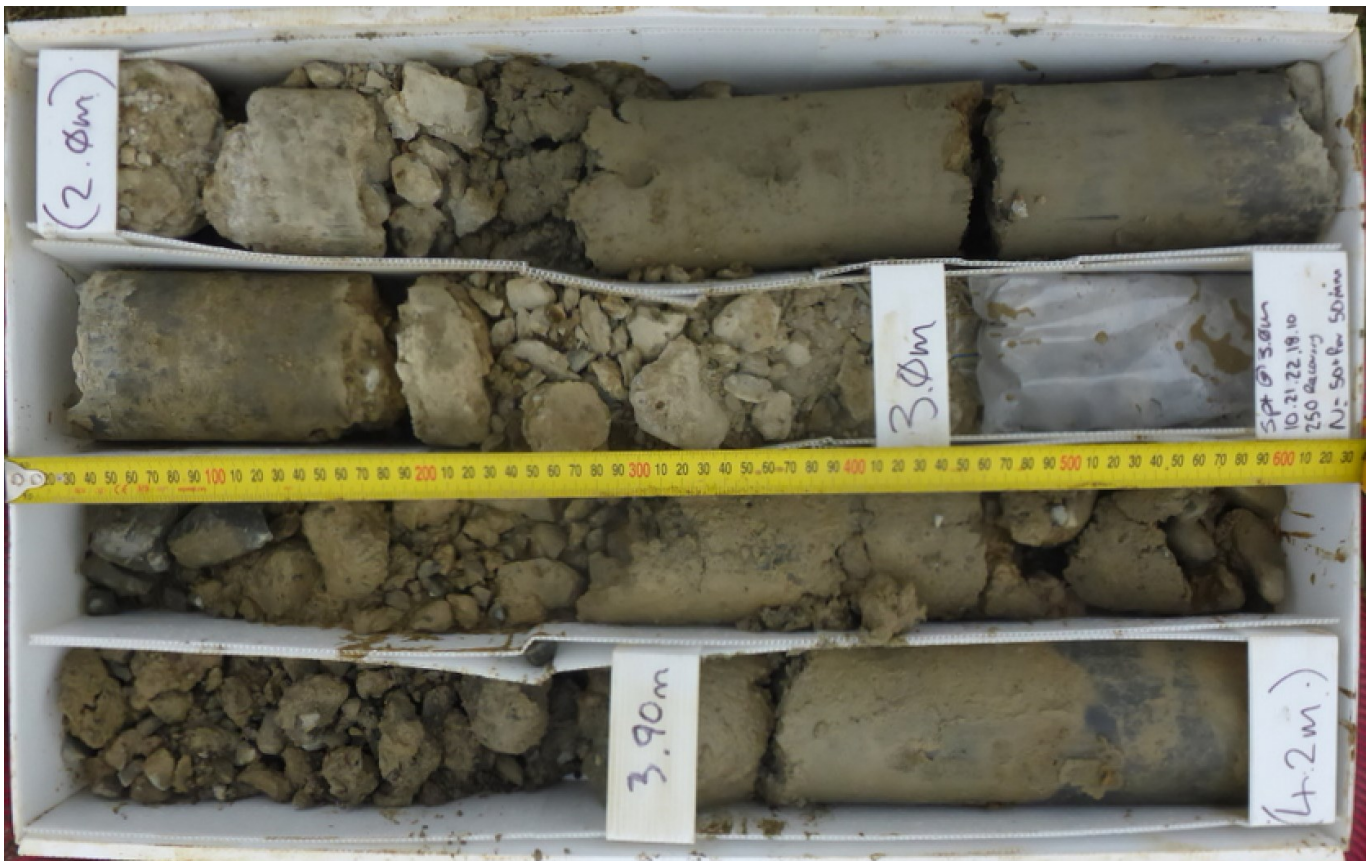
Client / Project:	WELHOM DEVELOPMENTS LTD GEOTECHNICAL ASSESSMENT DUE DILIGENCE BOREHOLE CORE PHOTOS	Hole ID:	BH02

Date:	Sep 2021	
Notes:	1. Drill sampling method: Rotary Sonic (approx. 78mm sample diameter). 2. Markers: start/end of run in metres; "CL" indicates core loss in metres; brackets indicate run split between boxes	Box No(s).	1 and 2 of 7	
		Depth from (m):	0.00m	
		Depth To (m):	4.20m	
		Interval (m):	4.20m	
Project No.	210422
