STRUCTURAL REPORT

MASTERTON DISTRICT COUNCIL MUNICIPAL BUILDING & TOWN HALL

Structural Report on the Masterton Town Hall and Masterton Municipal Building

Date: 27th September 2016

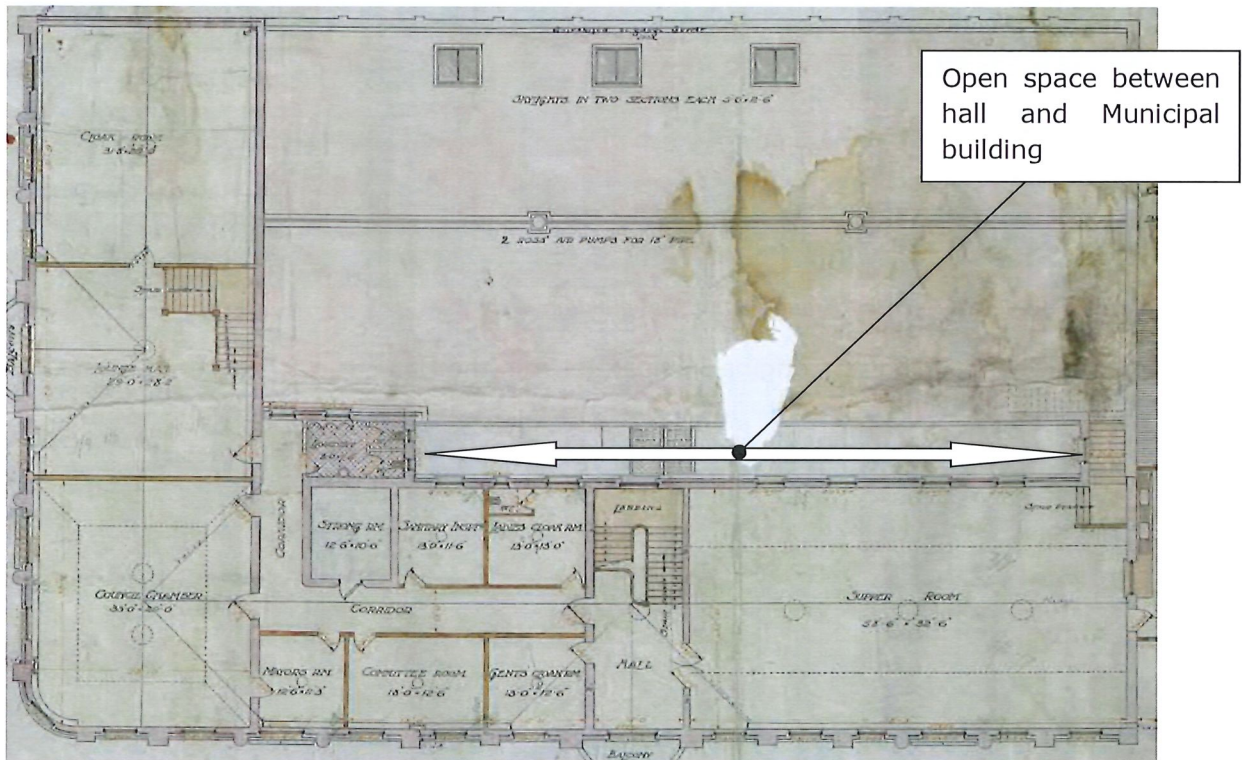
The Municipal building was originally separate from the Hall structure, with an open void between the buildings.

Figure 6 – Original 1915 First Floor Plan – note space between hall and offices

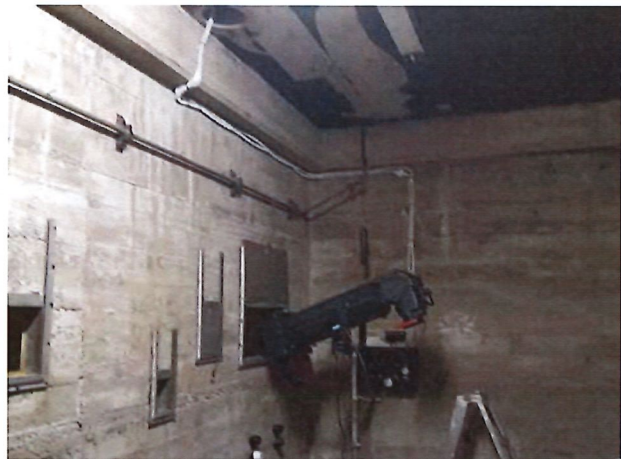
Figure 12b – Projector room

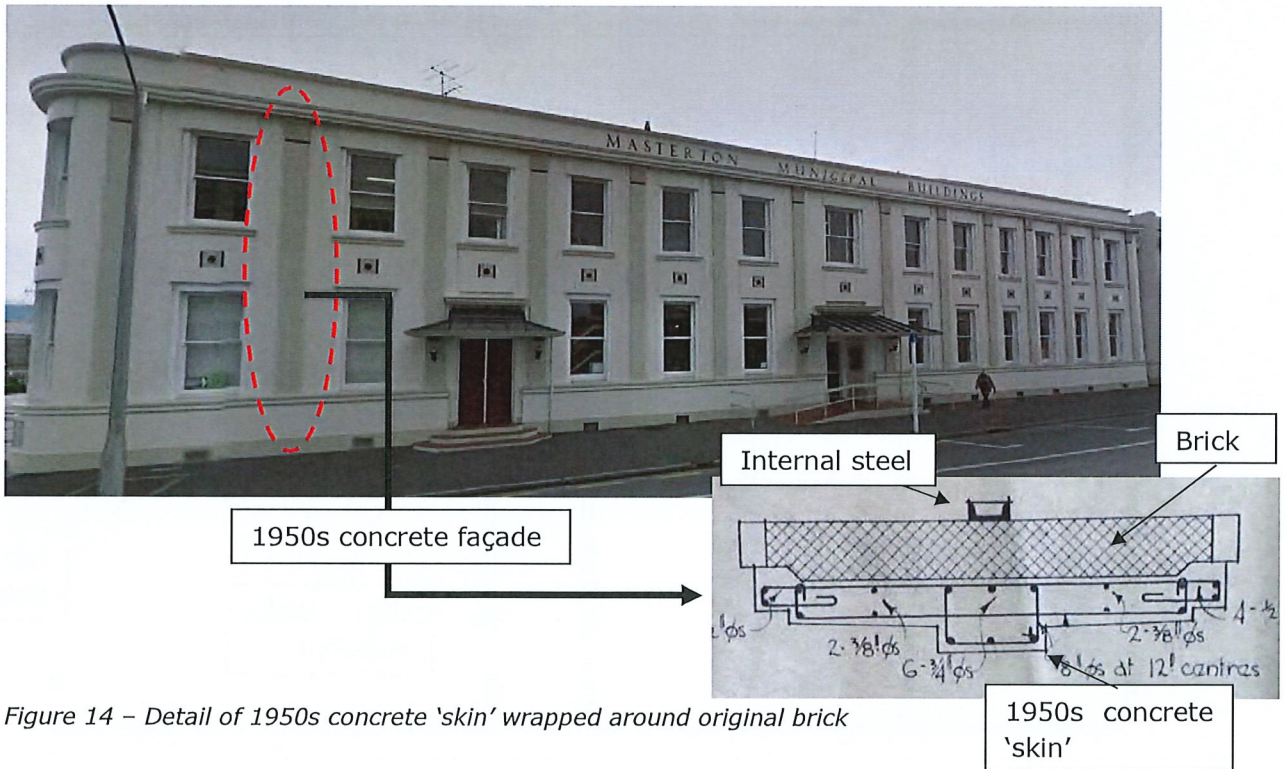
Though the façade (shown in yellow in figure 13) had a complete and substantial reinforced concrete 'skin' wrapped around it, the rear wall line (shown in red in figure 13) of the Municipal office building was left largely as original, (ie 9" thick brick with veneer). The rear wall lines had reinforced concrete bands installed in and around the brick work. The bands do not form a complete frame system, and are offset where

This means that the lateral load resisting system along these external wall lines is still original 9" brick wall.

Figure 14 – Detail of 1950s concrete 'skin' wrapped around original brick

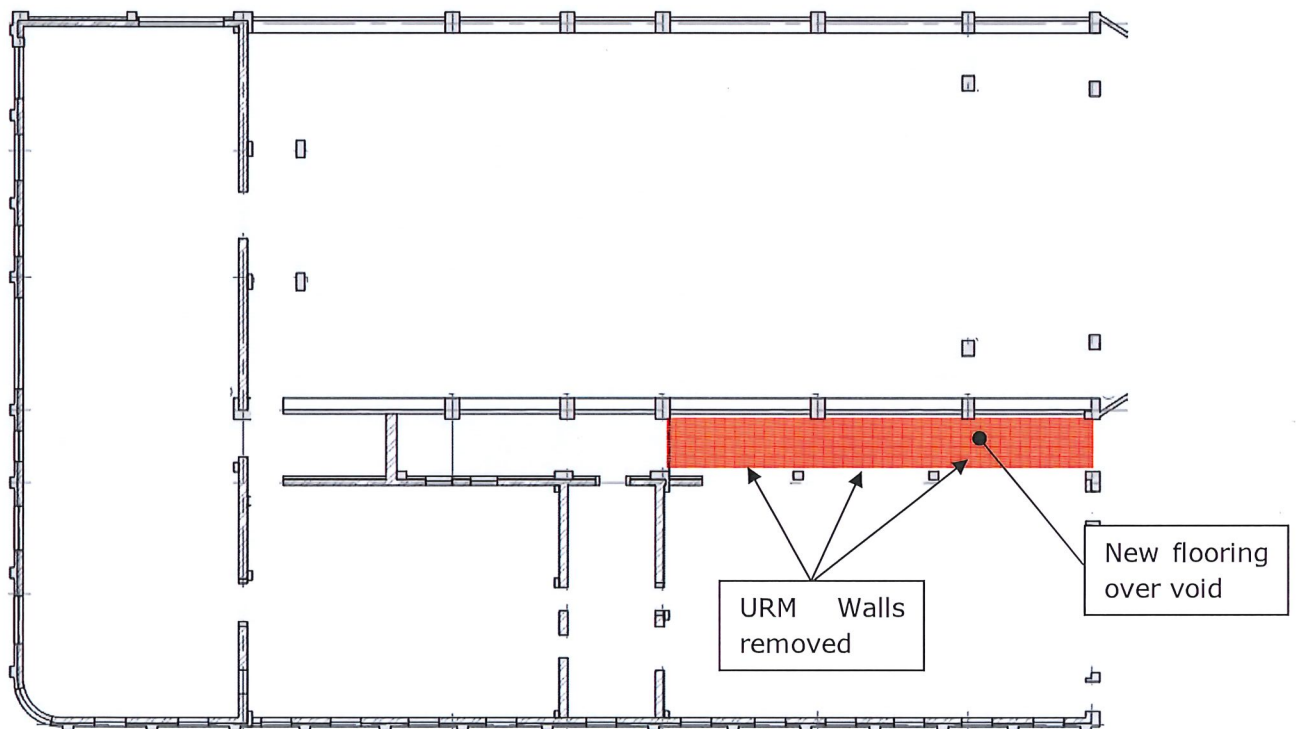
Figure 16 – First Floor Plan after 1950s work – note walls removed

The Hall and the Municipal building are two different structures, ie one has very high concrete frames in the transverse direction (see figure9), while the other is two storied with in-plane URM walls. This means the buildings are likely to move out-of-sync relative to each other during an earthquake. The new flooring spans the void between the two buildings, and is supported on a stringer attached to the Hall. This means there is a potential loss of gravity support to this section of flooring during a seismic event.

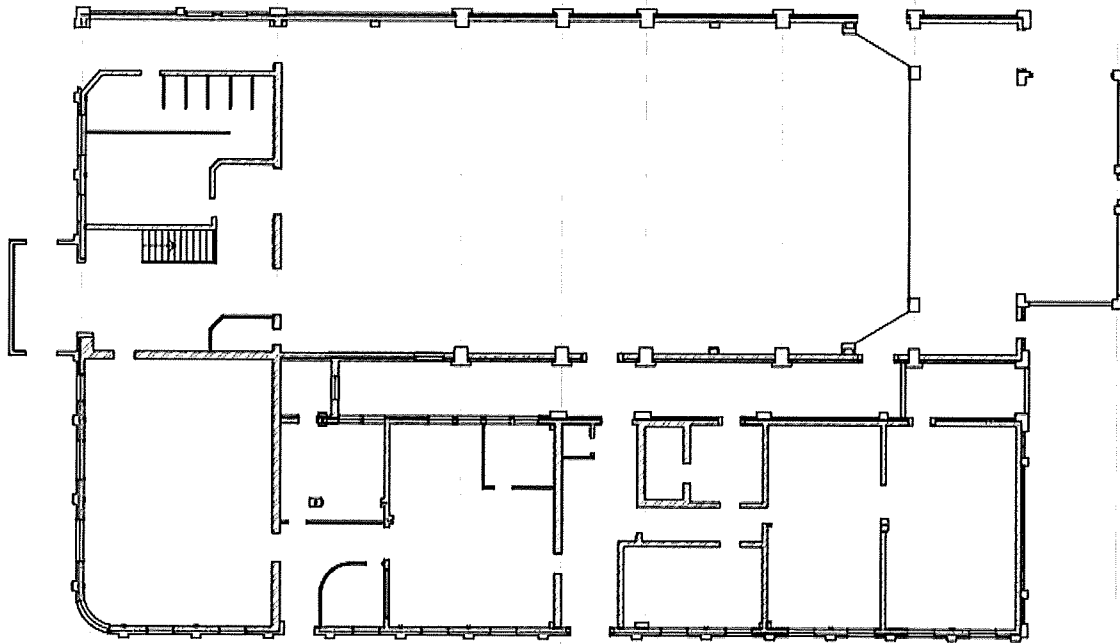
The Municipal Building has also had ongoing alterations, particularly to the ground floor. Internal sections of URM wall have been removed as required to accommodate refurbishments.

Figure 17a - Circa 1920s floor plan

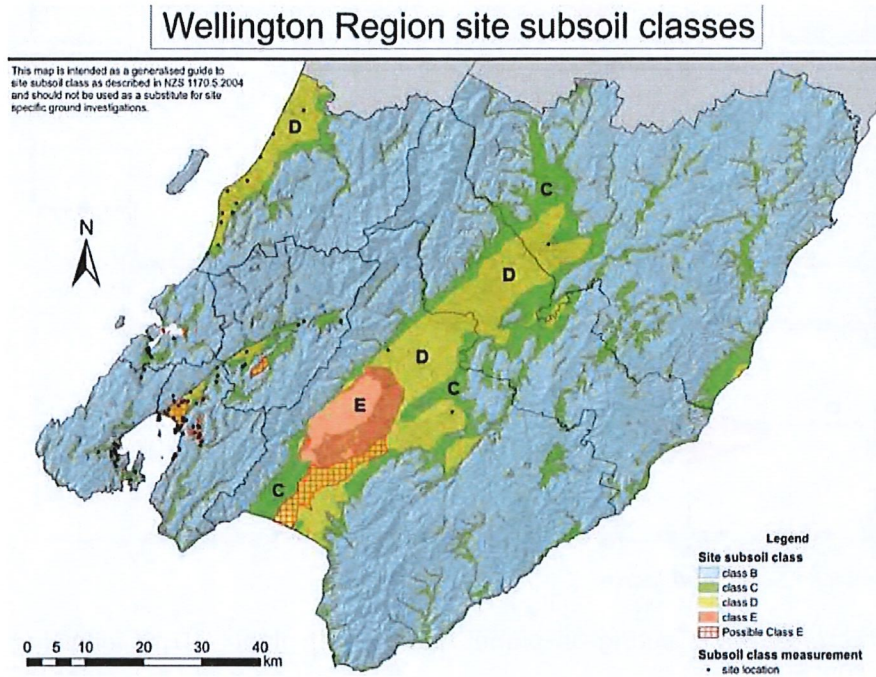
In 2008, GNS Science provided a draft sub-soil map for the greater Wellington region. This map designates the Masterton urban area as sub-soil class 'D'.

Figure 18 – DRAFT GNS sub-soil map for the Wairarapa

For seismic design, the site sub-soil class directly influences the magnitude of forces a building must be designed for. A structure being designed on a site with a sub-soil class of 'D' must be designed for approximately 30% greater loads than the same structure on a site with a sub-soil class of 'C'.

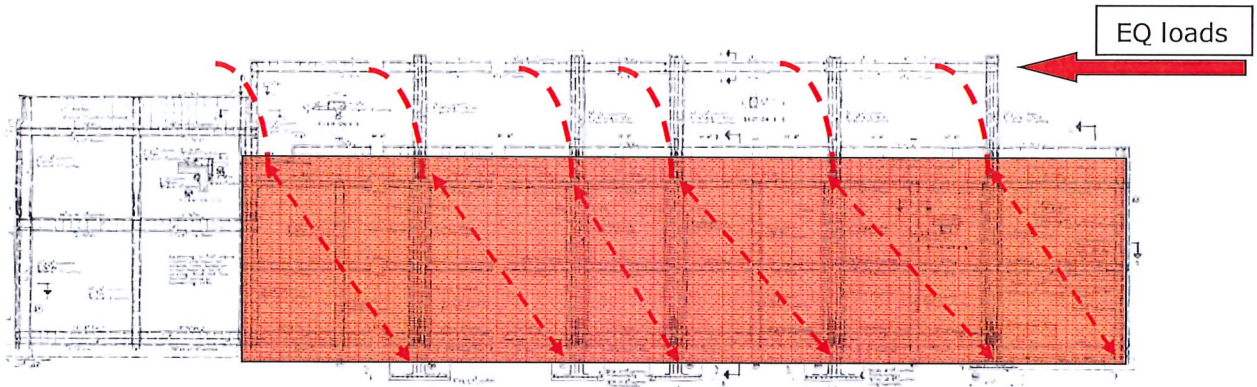
In the Longitudinal direction the loads at roof level are taken by the frame columns bending about their weak axis above the parapet line. The loads are then taken by the brick walls acting in-plane.

Figure 21 – Schematic of Longitudinal Load path through Town Hall Side Walls

A similar ductility has been allowed for the frame columns in this direction as that used for the transverse assessment. Based on this, these columns are able to accommodate 100% of seismic demand.
