Asbestos Demolition Survey & Lead Paint Sampling Report

Masterton Town Hall
64 Chapel Street
Masterton, 5810

Masterton District Council

Reference: W-01393

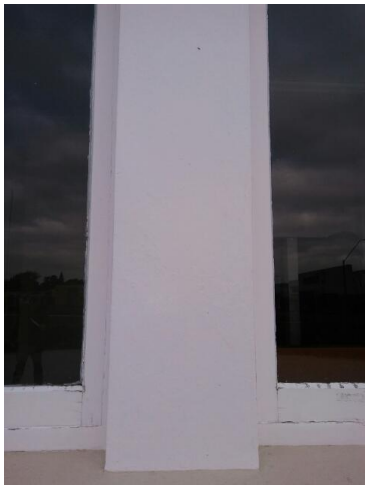
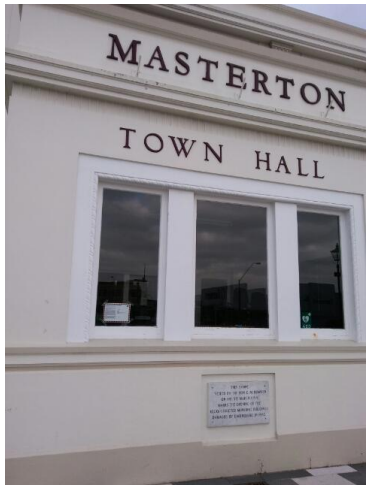
Location	Masterton Town Hall, External, 001, South External Wall		Sample Number	2 (S)

Item / Position	Lead Paint - White		
	Material:	Painted Surface		
	Extent	50m ²		
	Asbestos Type	111 mg/kg - Lead Below Threshold Value		
	Comments:	Surrounding windows

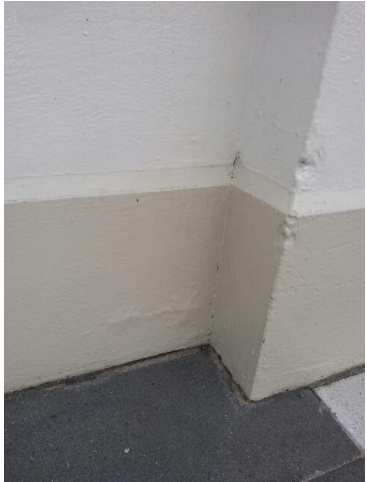
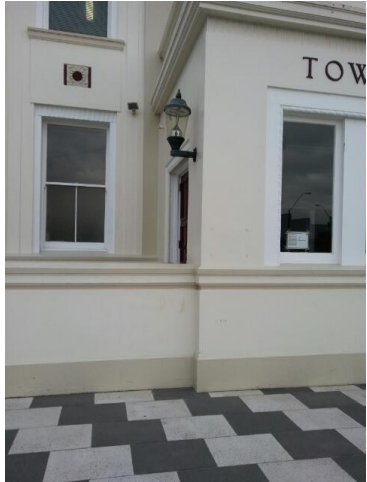
Location	Masterton Town Hall, External, 001, South External Wall		Sample Number	3 (S)

Item / Position	Lead Paint		
	Material:	Painted Surface - Beige		
	Extent	100m ²		
	Asbestos Type	5800 mg/kg - Lead Above Threshold Value		
	Comments:	Note: Lead-based paint is any paint or other coating that contains lead equal to or more than 5000 mg/kg or 1 mg/cm ² of painted surface.

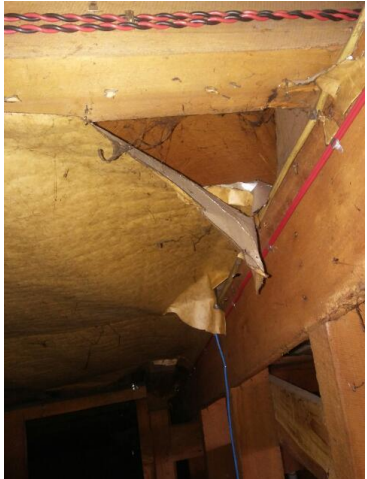
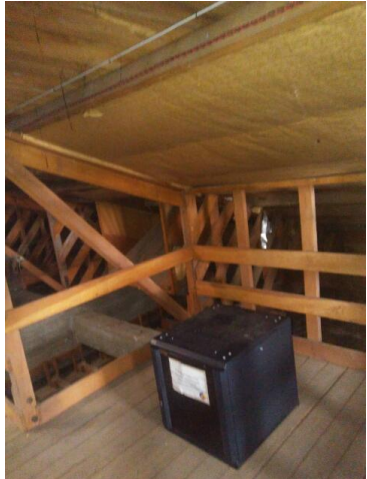
Location	Masterton Town Hall, 2nd Floor, 014, Attic area	Sample Number	28 (S)

Item / Position	Bitumen Paper	
		Material:	Bituminous Product	
		Extent	Roof	
		Product Type	N/A	N/A
		Condition	N/A	N/A
		Surface Treatment	N/A	N/A
		Asbestos Type	NAD	N/A
		Material Assessment	N/A	0
		Recommendation	No further action required	
		Comments:
