Geotechnical Seismic Assessment - Site Investigation Masterton Municipal Building & Town Hall

Tonkin & Taylor Ltd (T+T) was engaged by Masterton District Council (MDC) to provide a geotechnical seismic assessment and investigation of the Masterton Municipal Building and Town, 64 Chapel Street, Masterton. T+T have carried out this work in accordance with our letter of engagement, dated 30 January 2017.

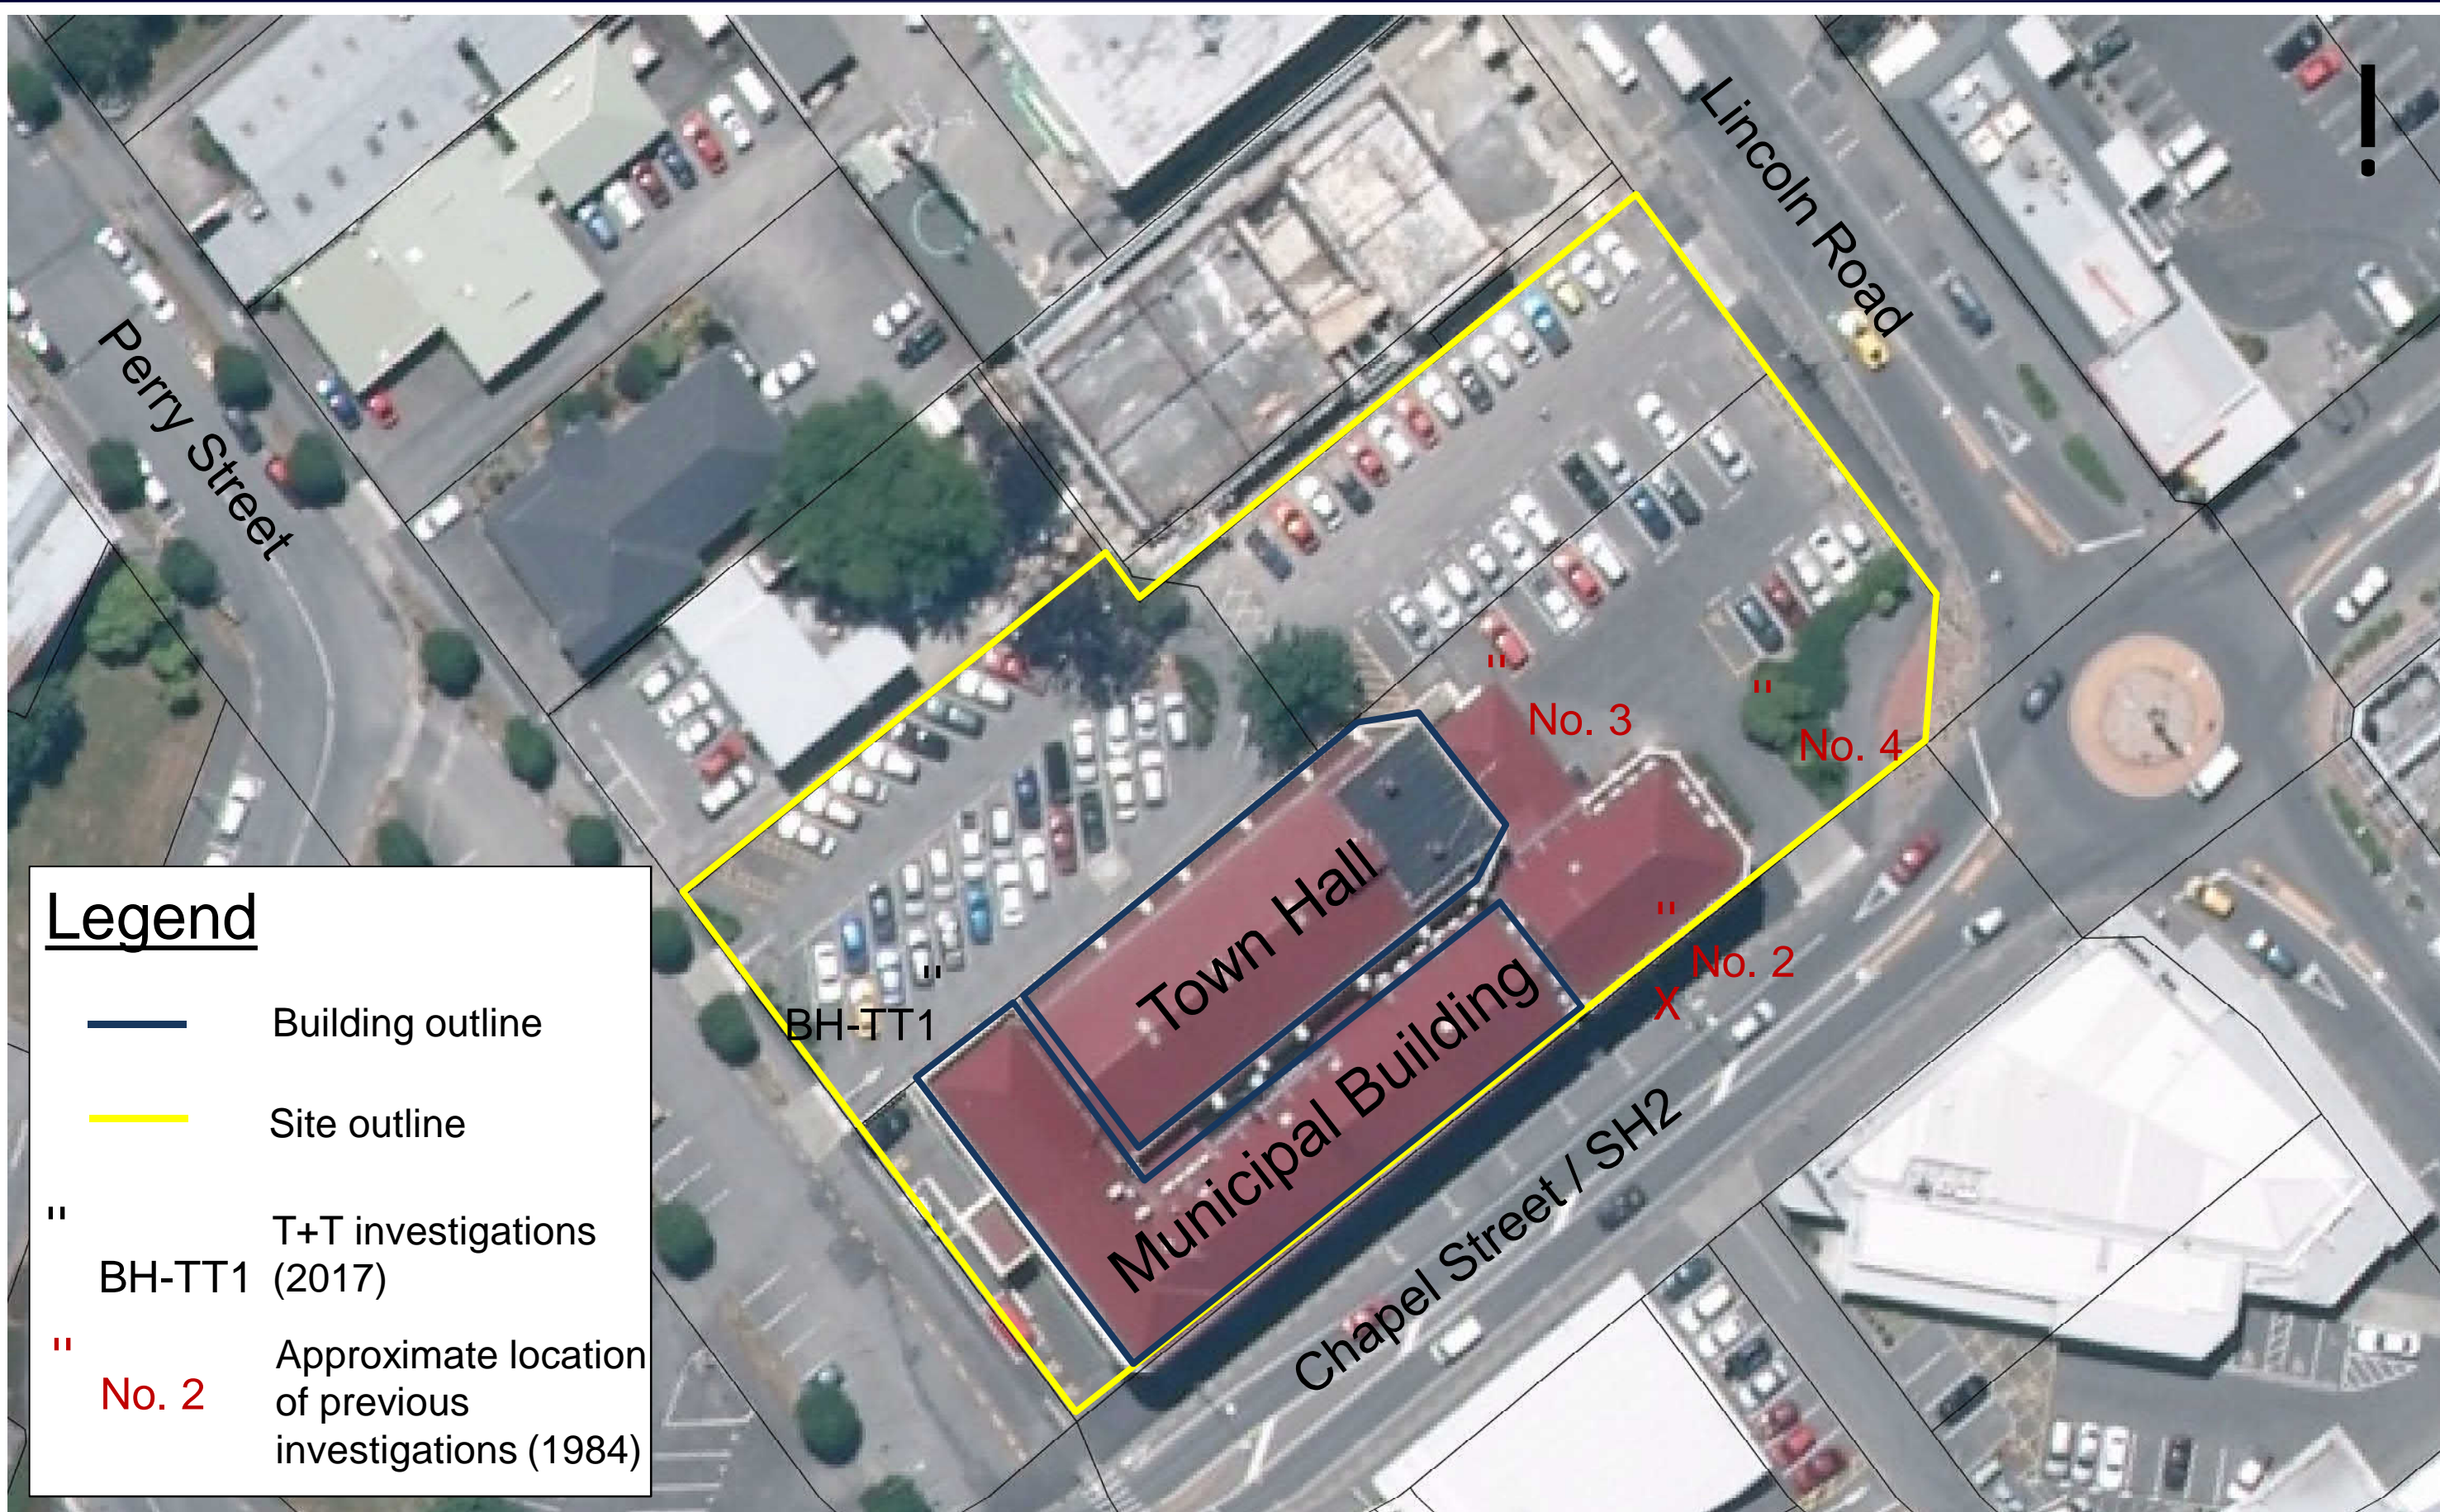
The borehole location was selected by T+T to further develop the understanding of geological conditions at the site, with consideration to access and buried services constraints. The location of the borehole is shown in Figure A1, Appendix A.
