## MASTERTON DISTRICT COUNCIL MUNICIPAL BUILDING & TOWN HALL

# *Structural Report on the Masterton Town Hall and Masterton Municipal Building*

Date: 27<sup>th</sup> September 2016

Project Reference: 1223

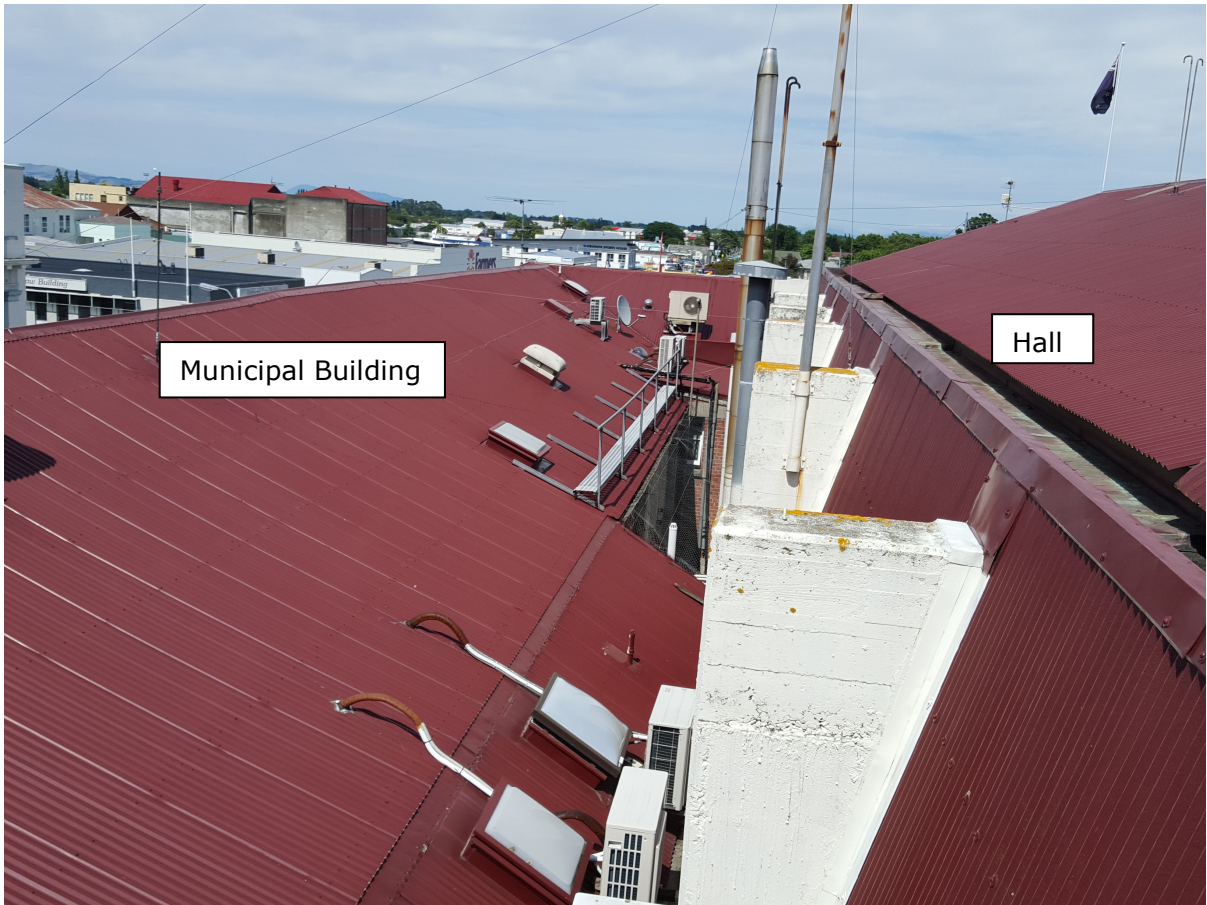
The Municipal building was originally separate from the Hall structure, with an open void between the buildings.

Figure 6 – Photo of roof – note space between the Hall & Municipal Building

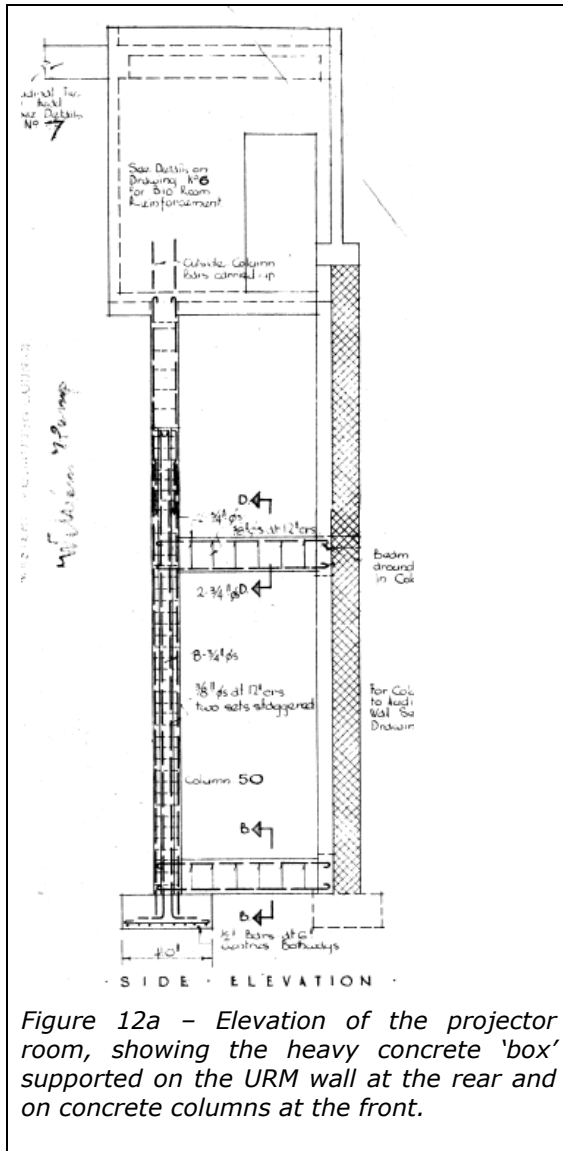
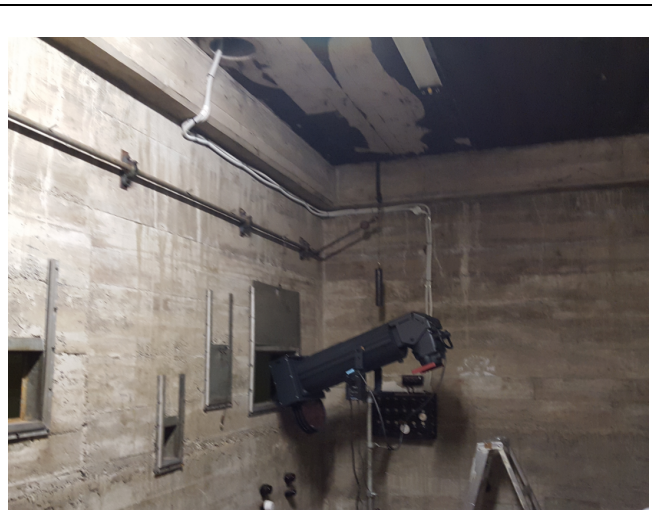
Figure 12b – Projector room

New elevated seating was erected which is supported on a fabricated steel beam spanning across the hall. A new projector room was also constructed. This projector room is formed with reinforced concrete walls, floor and roof. It is supported at the rear via the original brick wall, and the front by two slender reinforced concrete columns

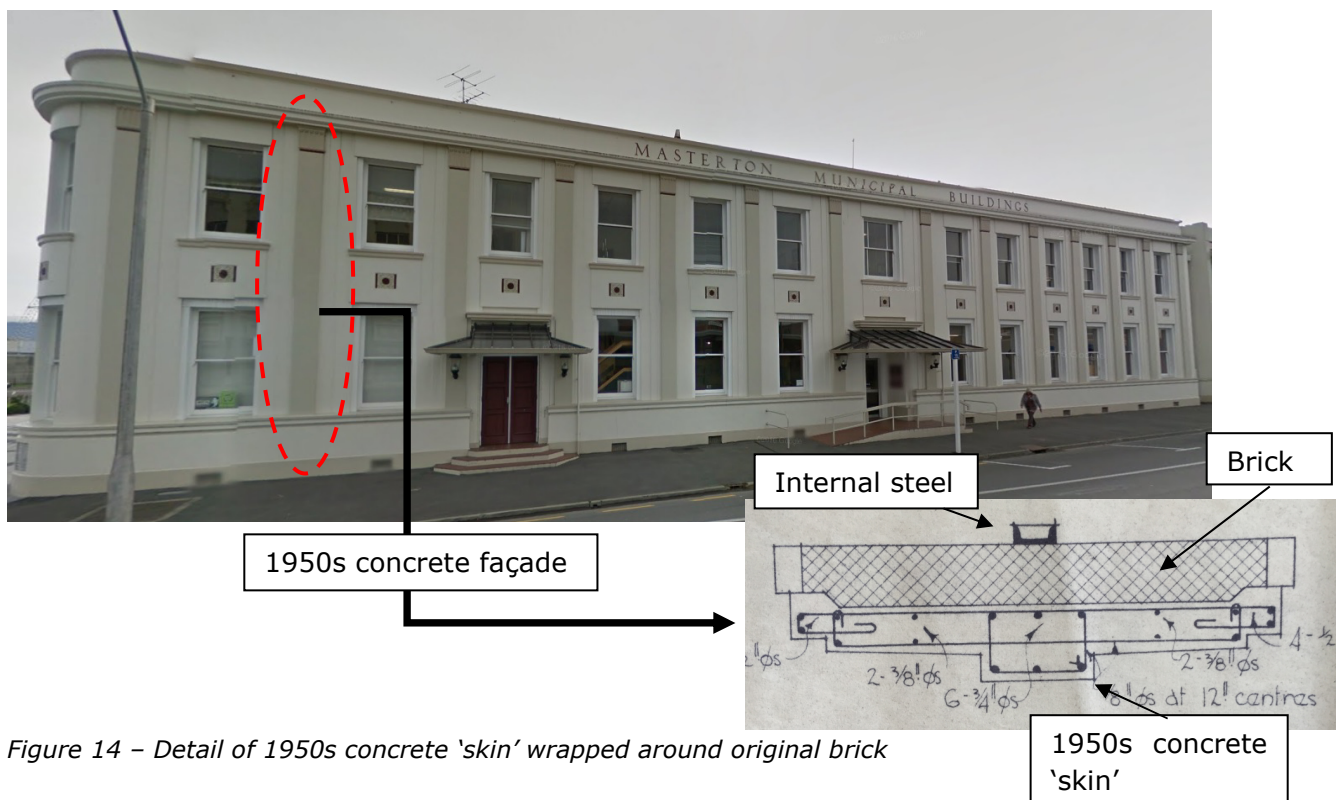
Though the façade (shown in yellow in figure 13) had a complete and substantial reinforced concrete 'skin' wrapped around it, the rear wall line (shown in red in figure 13) of the Municipal office building was left largely as original, (ie 9" thick brick with veneer). The rear wall lines had reinforced concrete bands installed in and around the brick work. The bands do not form a complete frame system, and are offset where

This means that the lateral load resisting system along these external wall lines is still original 9" brick wall.

Figure 14 – Detail of 1950s concrete 'skin' wrapped around original brick

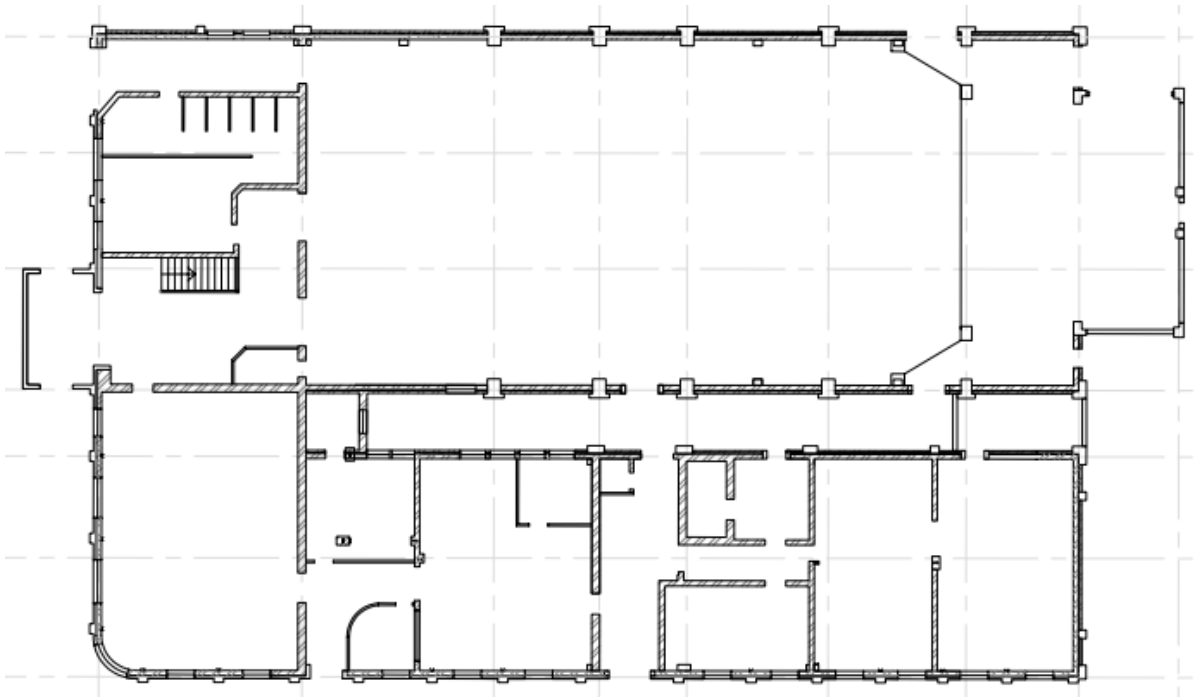
Figure 17a - Circa 1920s floor plan

The Municipal Building has also had ongoing alterations, particularly to the ground floor. Internal sections of URM wall have been removed as required to accommodate refurbishments.

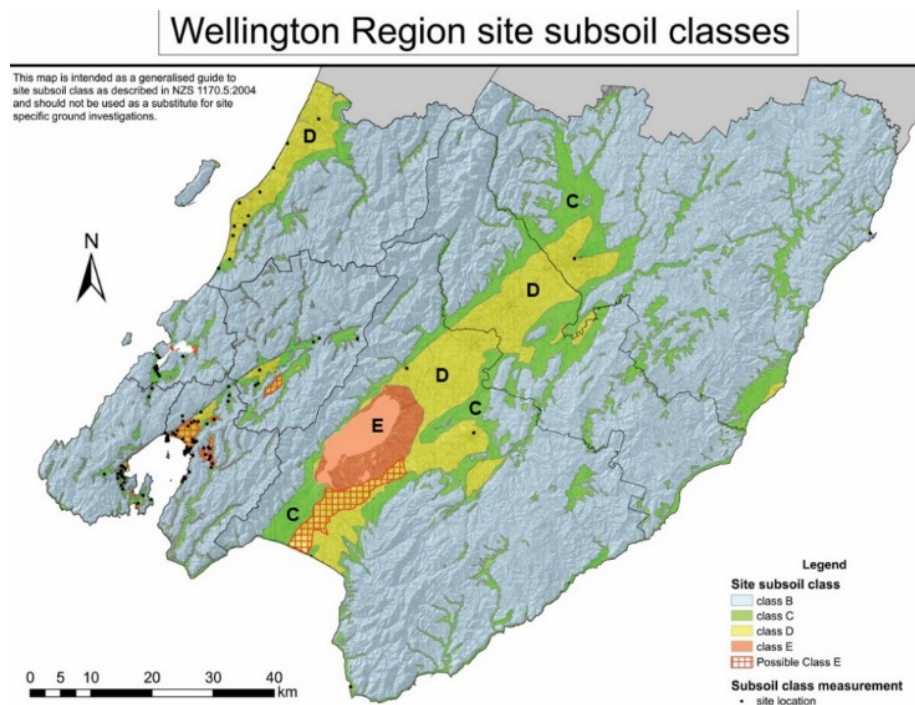
In 2008, GNS Science provided a draft sub-soil map for the greater Wellington region. This map designates the Masterton urban area as sub-soil class 'D'.

Figure 18 – DRAFT GNS sub-soil map for the Wairarapa

For seismic design, the site sub-soil class directly influences the magnitude of forces a building must be designed for. A structure being designed on a site with a sub-soil class of 'D' must be designed for approximately 30% greater loads than the same structure on a site with a sub-soil class of 'C'.

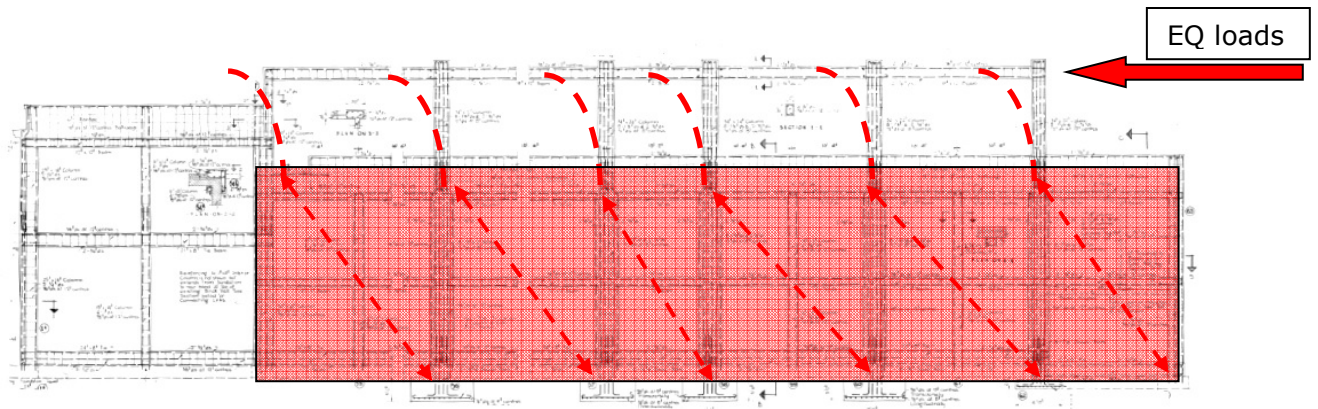
In the Longitudinal direction the loads at roof level are taken by the frame columns bending about their weak axis above the parapet line. The loads are then taken by the brick walls acting in-plane.

Figure 21 – Schematic of Longitudinal Load path through Town Hall Side Walls

A similar ductility has been allowed for the frame columns in this direction as that used for the transverse assessment. Based on this, these columns are able to accommodate 100% of seismic demand.
