Archaeological Assessment Masterton Town Hall Demolition

Masterton

15 August 2024

Geometria Ltd.

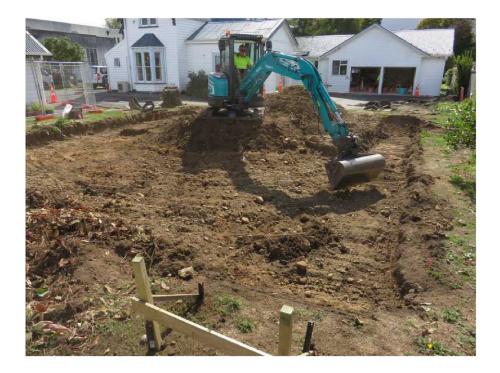
Illustration 1: Excavation for foundations for new residential units from Church Street facing north-east towards vicarage building (March 25th 2021).

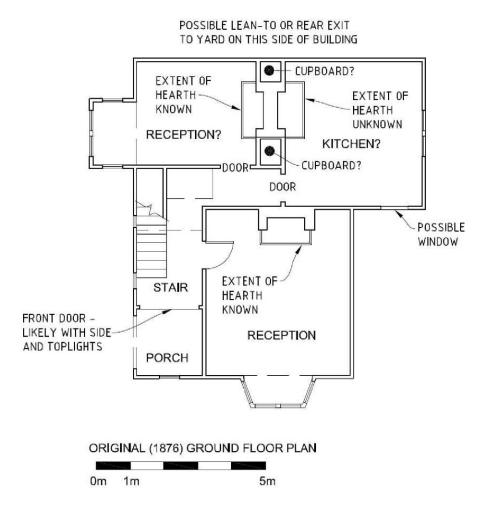
Illustration 2: Vicarage building -probable ground floor plan as at 1876 (image courtesy Chessa Stevens)

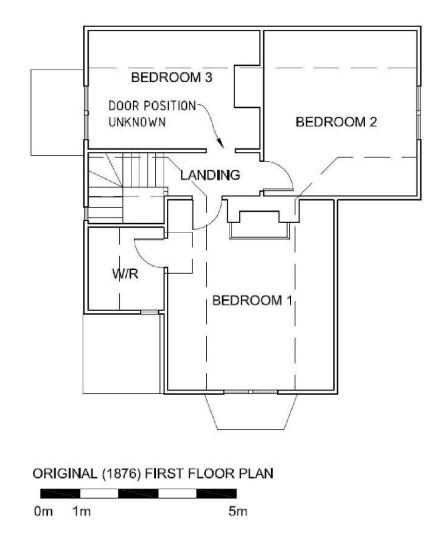
Illustration 3: Vicarage building- probable first floor plan as at 1876 (image courtesy Chessa Stevens)

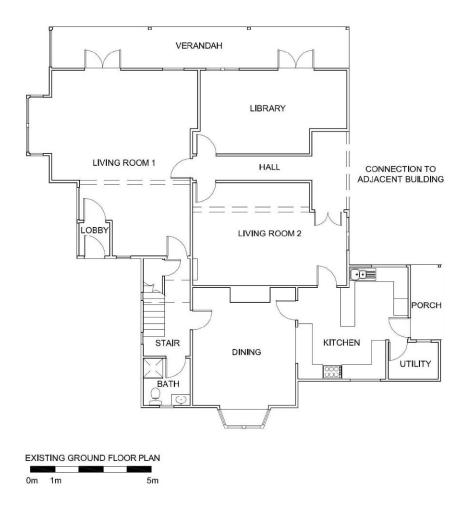
Illustration 4: Ground floor plan at time of building removal (image courtesy Chessa Stevens)

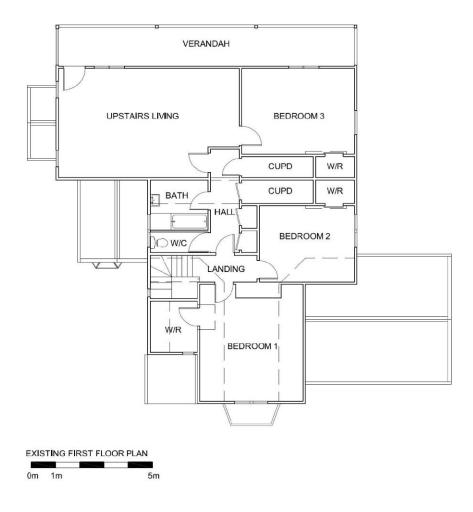
Illustration 5: First floor plan at time of building removal (image courtesy Chessa Stevens)

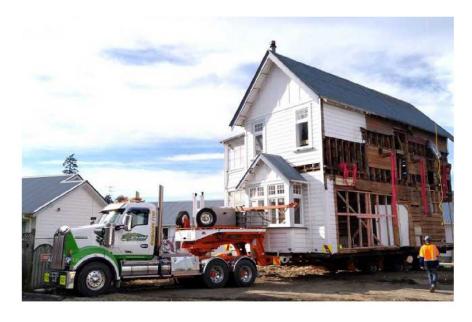
Illustration 7: Building removal in progress (4th April 2022 Chessa Stevens).

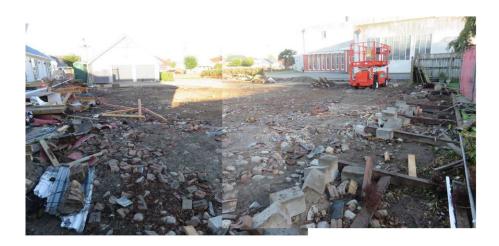
Illustration 12: Building footprint following vicarage removal (8th April 2022).

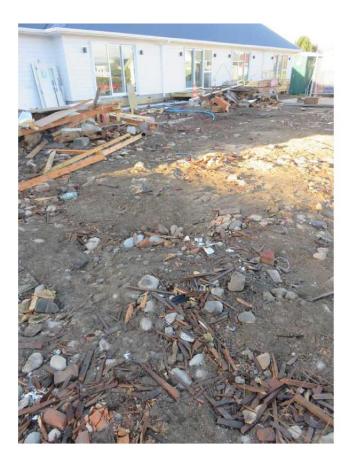
Illustration 15: Artifact scatter 2 facing towards new residential units prior to excavation (8th April 2022).

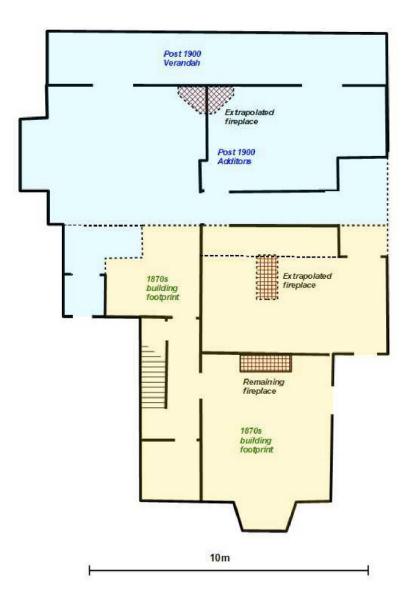
Illustration 16: Site plan showing building layout at time of removal. Dotted line denoted probable positions of former walls (information courtesy Chessa Stevens).

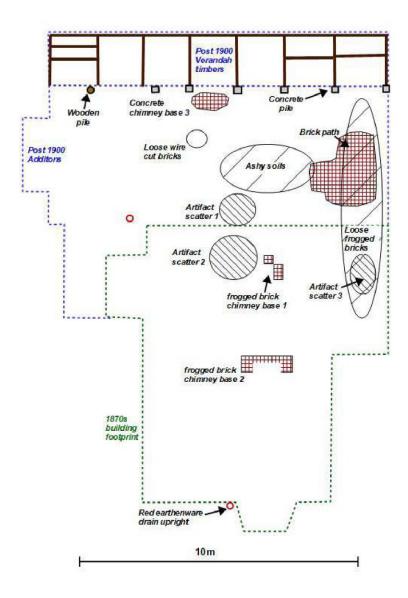
Illustration 17: Site plan showing building footprint and archaeological features post building removal.

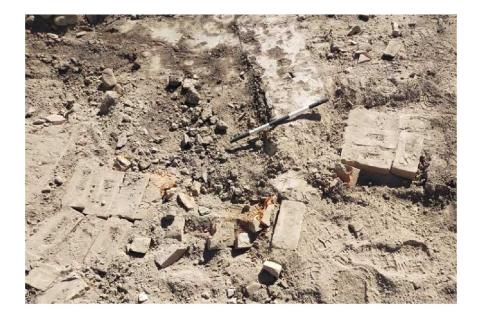
Illustration 18: Chimney Base 1 frogged bricks (8th April 2022). Scale in 10cm increments

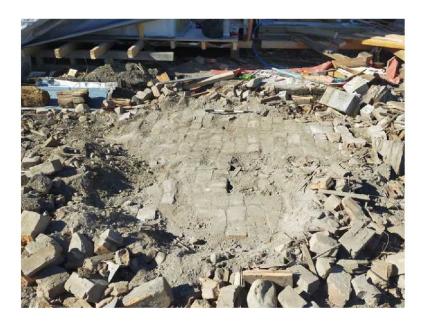
Illustration 19: Brick path behind rear of original house (8th April 2022). Scale in 10cm increments.
